6 Site Specific Analysis

6.1 Introduction

Table 6.1.
U.S. Route 13 Segment Locations.

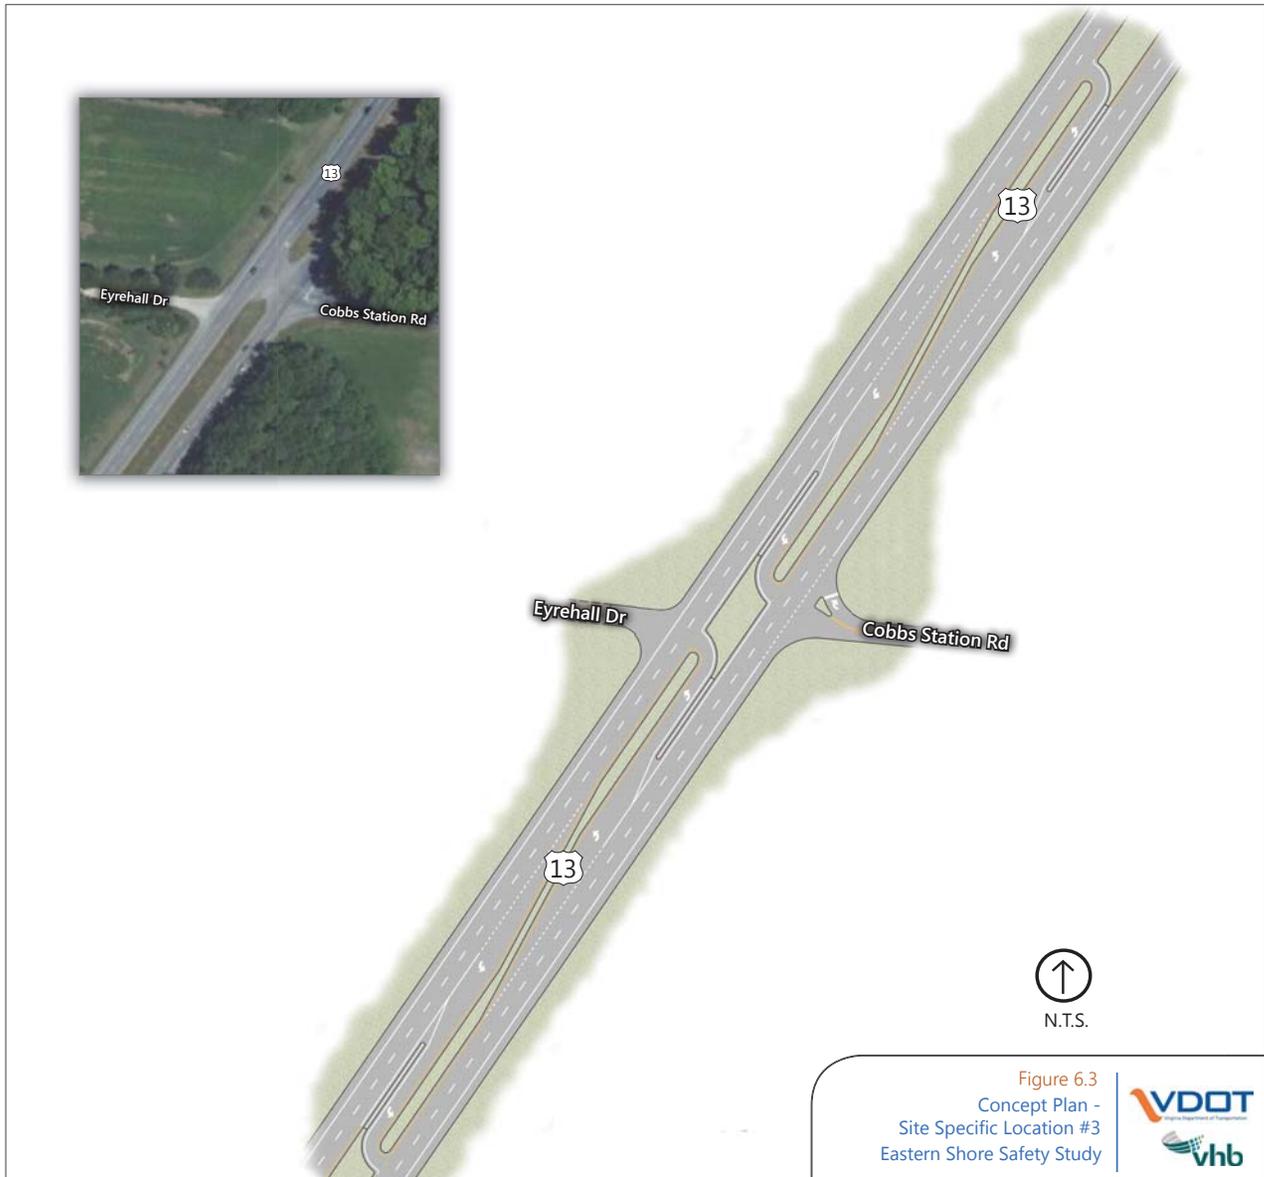
Figure 6.3
Concept Plan -
Site Specific Location #3
Eastern Shore Safety Study

Twenty (20) crashes occurred at this location including one fatal crash. Thirty-five (35) percent resulted in injuries. Half of the crashes involved deer, 30 percent were roadway departure crashes, and 20 percent were rear end crashes. Approximately half of the crashes occurred during dark or dawn conditions.

- ▶ Improve positive guidance and warning through intersection warning signs, post mounted delineators, wider 6-inch pavement markings, dynamic speed warning signs, and deer warning signs.
- ▶ Pave driveway and road apron onto U.S. Route 13.
- ▶ Install 12-inch street name signs to conform to MUTCD recommendation.

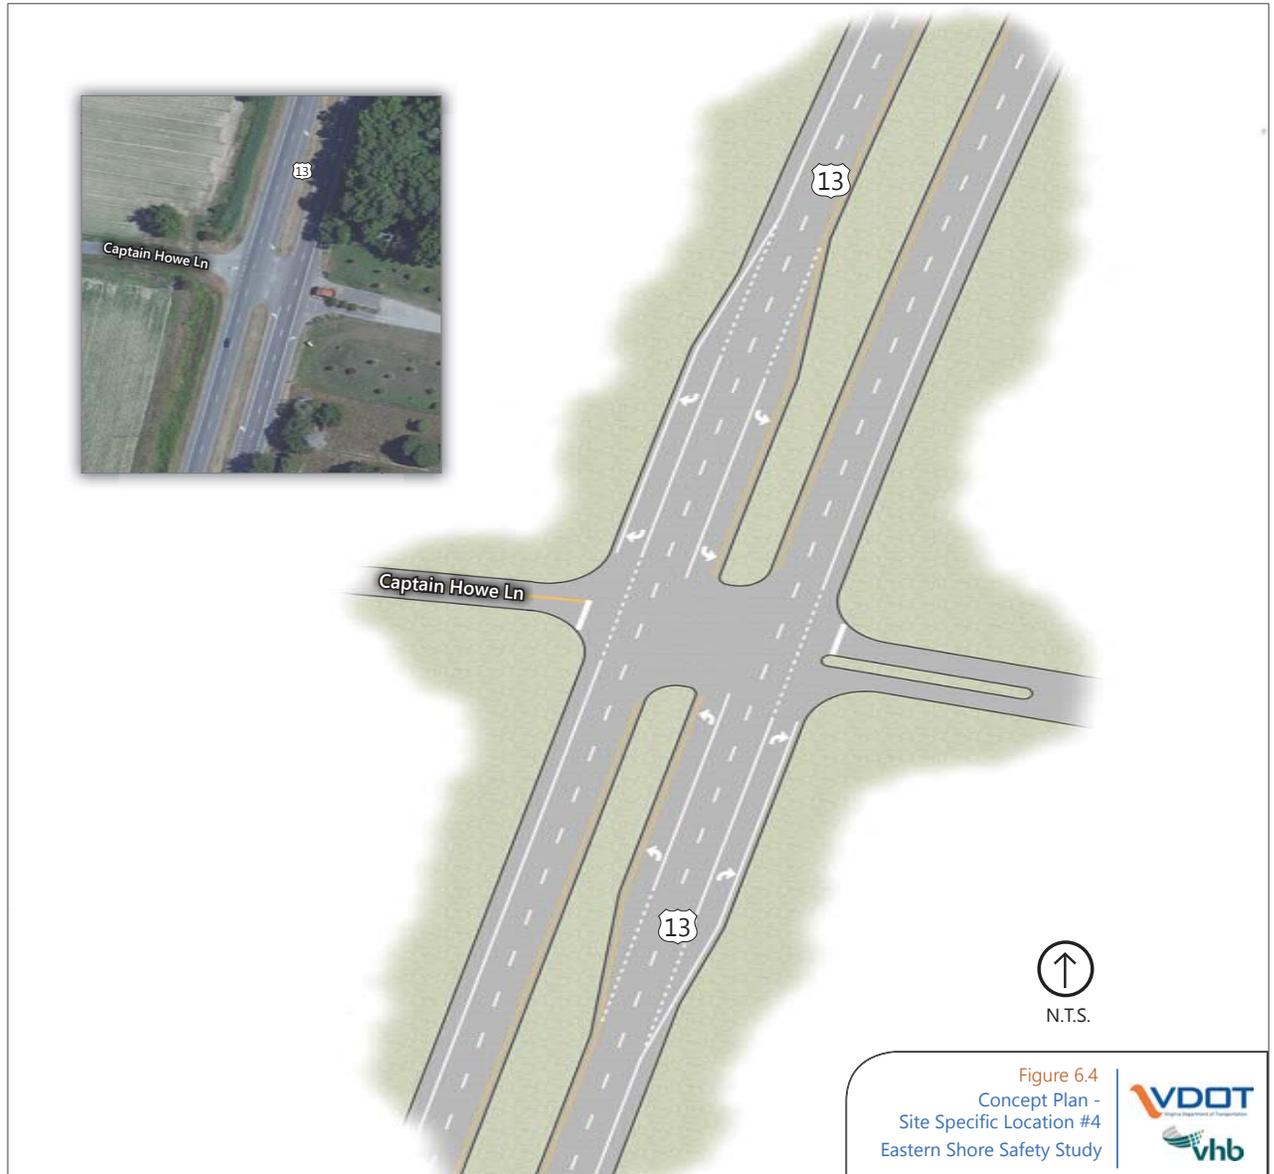
Figure 6.4
Concept Plan -
Site Specific Location #4
Eastern Shore Safety Study

- ◆ Grade change in median at paving joint causes an uneven transition for drivers and traps debris which could cause drivers to lose traction.
- ◆ Lack of right turn lanes in southbound direction limit southbound drivers' ability to slow down before turning onto Captain Howe Lane. Additionally, the northbound right turn lane is not adequately marked.
- ◆ Street signs are difficult to see from U.S. Route 13 due to the travel speeds; a single stop sign was placed on the median island on Captain Howe Lane and no stop sign on the right side of the intersection. These signs are not MUTCD compliant.

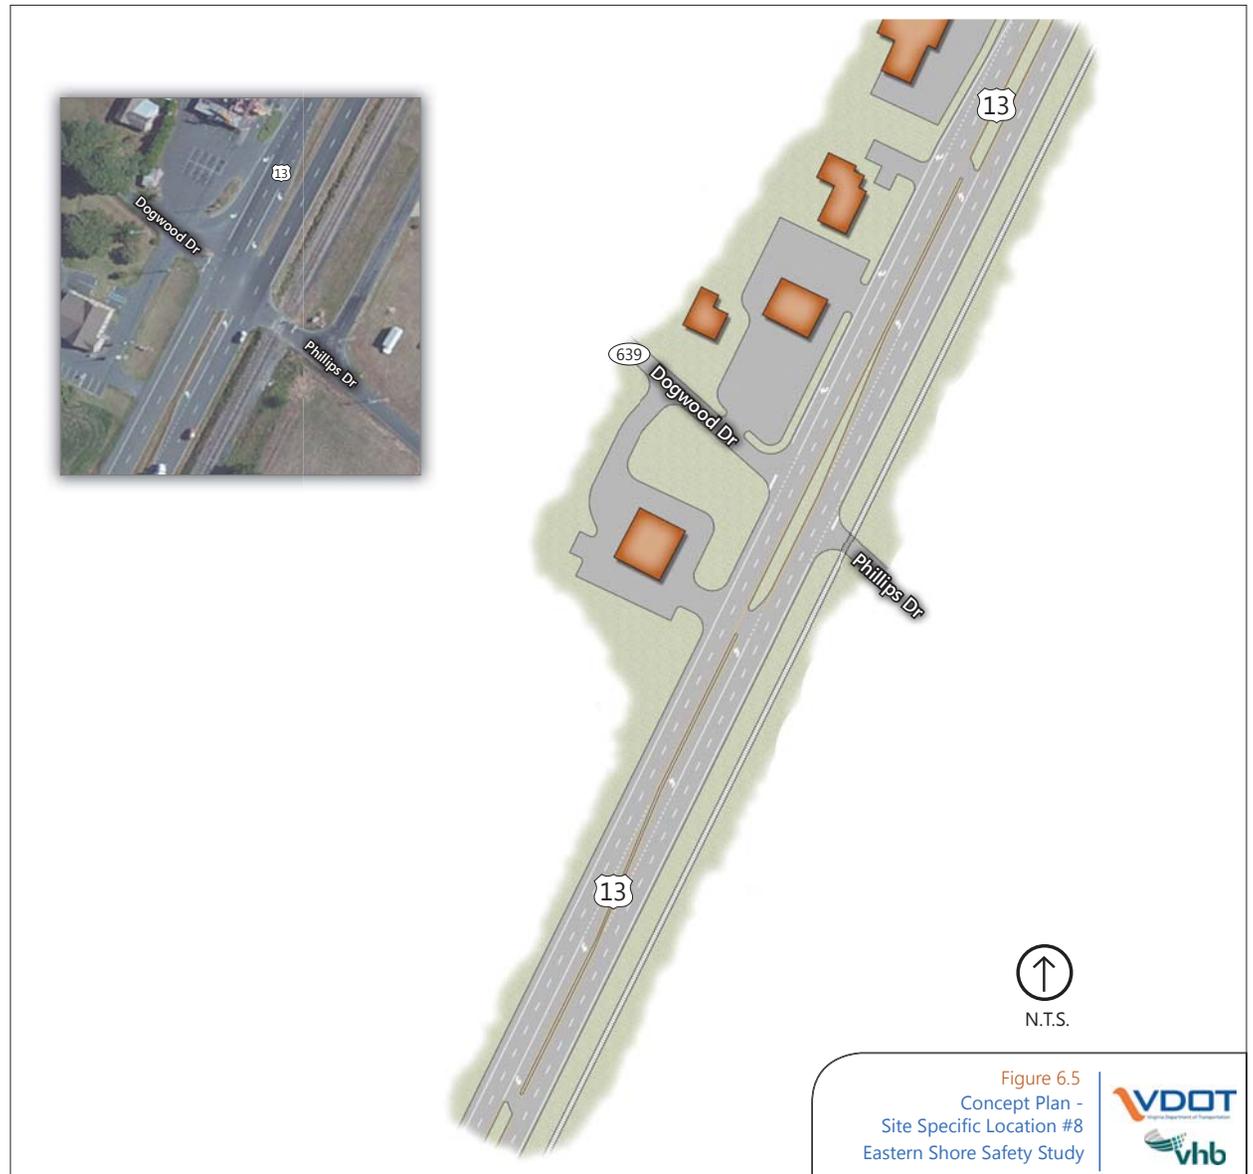
Figure 6.5
Concept Plan -
Site Specific Location #8
Eastern Shore Safety Study

- ▶ Insufficient space for drivers to slow down before turning onto intersecting streets or parking lot entrances.
- ◆ U-turn prohibition due to narrow median and speeds.
 - ▶ Signage is present but vehicles still conduct maneuver.
- ◆ Unclear signage
 - ▶ Some of the signs or sign posts are bent/damaged.
 - ▶ Street signs are difficult to see traveling at speed on U.S. Route 13.

- ▶ Repair or replace damaged signs and sign posts.
- ▶ Install 12-inch street name signs to conform to MUTCD recommendation.
- ▶ Improve intersection expectancy and visibility through advance intersection warning signs, flashing/dynamic warning beacons on warning signs or at intersection, reflective strips on signs posts, reflective post mounted delineators on intersection approaches and median.

- ▶ Reduce the entrance width and consolidate entrances at Tammy and Johnny's Restaurant through use of curbing, landscaping, etc., to close access points and reduce the number of conflict points.
- ▶ Lengthen substandard turn lanes to provide 200 feet of storage and 200 feet of taper for an overall minimum length of 400 feet.
- ▶ The installation of a northbound right turn lane is recommended; however, it is not feasible to construct the turn lane due to the limited space and elevation change between the existing travel lanes and the railroad tracks. The mainline would require a significant shift or elevation adjustment to add in the right turn lane.

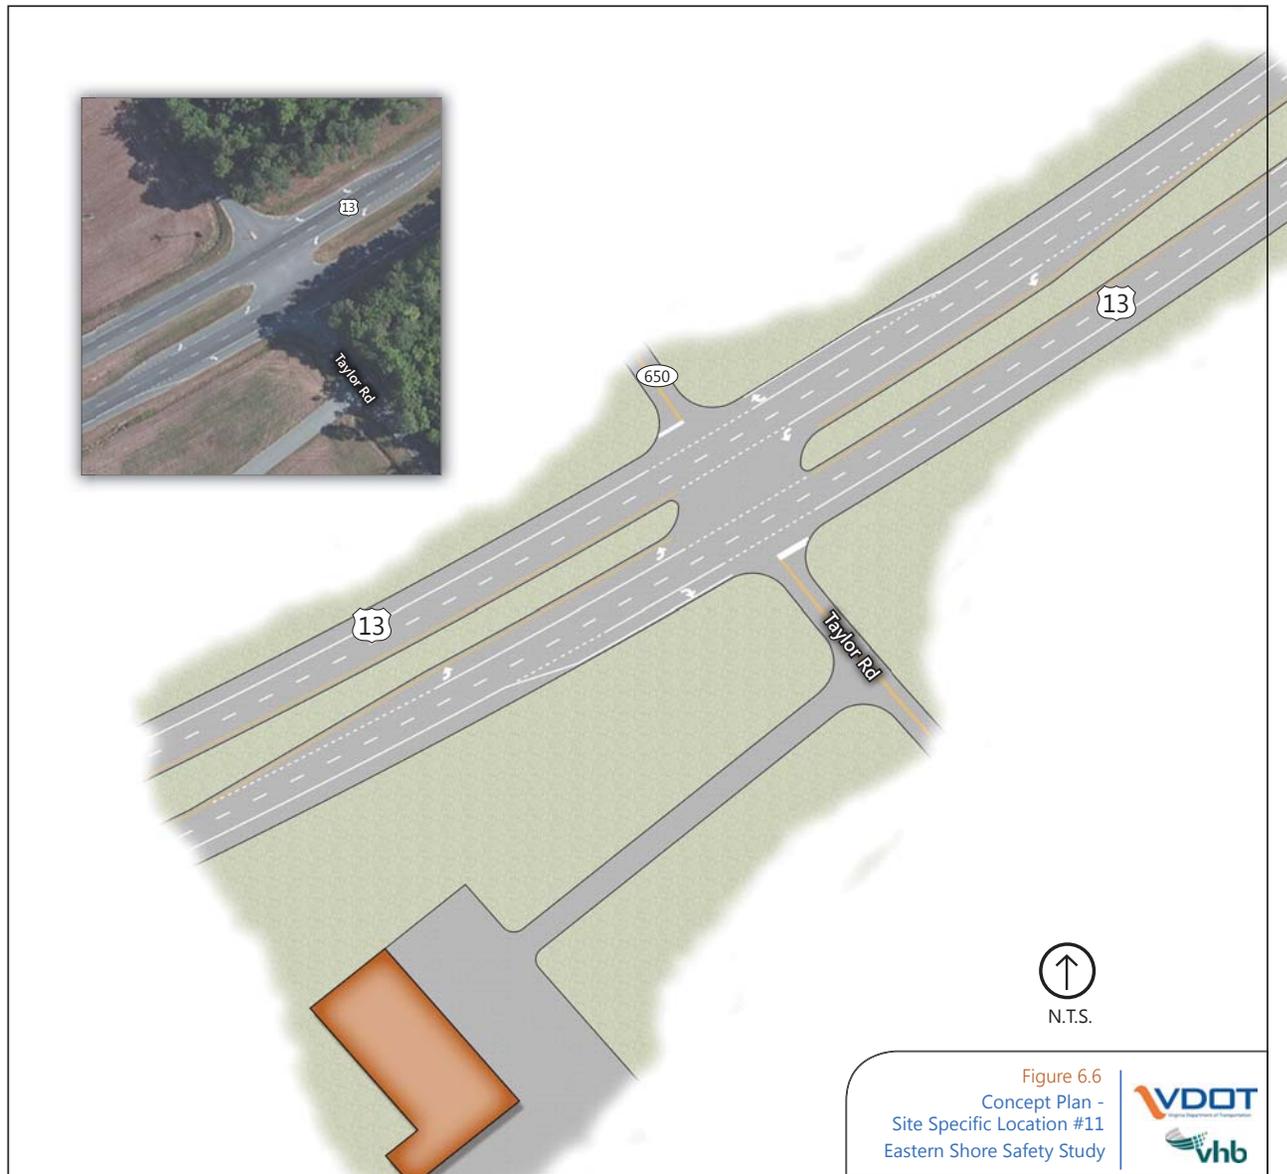
Figure 6.6
Concept Plan -
Site Specific Location #11
Eastern Shore Safety Study

- ◆ No intersection warning.
- ◆ Lack of intersection expectancy due to lack of intersection warning along with horizontal curvature and trees reducing intersection sight distance in the southbound direction.
- ◆ Observed high travel speeds.
- ◆ Street and stop sign placement is not MUTCD compliant.

- ▶ Install 12-inch street name signs to conform with MUTCD recommendations and revise placement to ensure they are visible from U.S. Route 13. Add stop signs on the right side of the street on Taylor Road, and add intersection warning signs on U.S. Route 13.

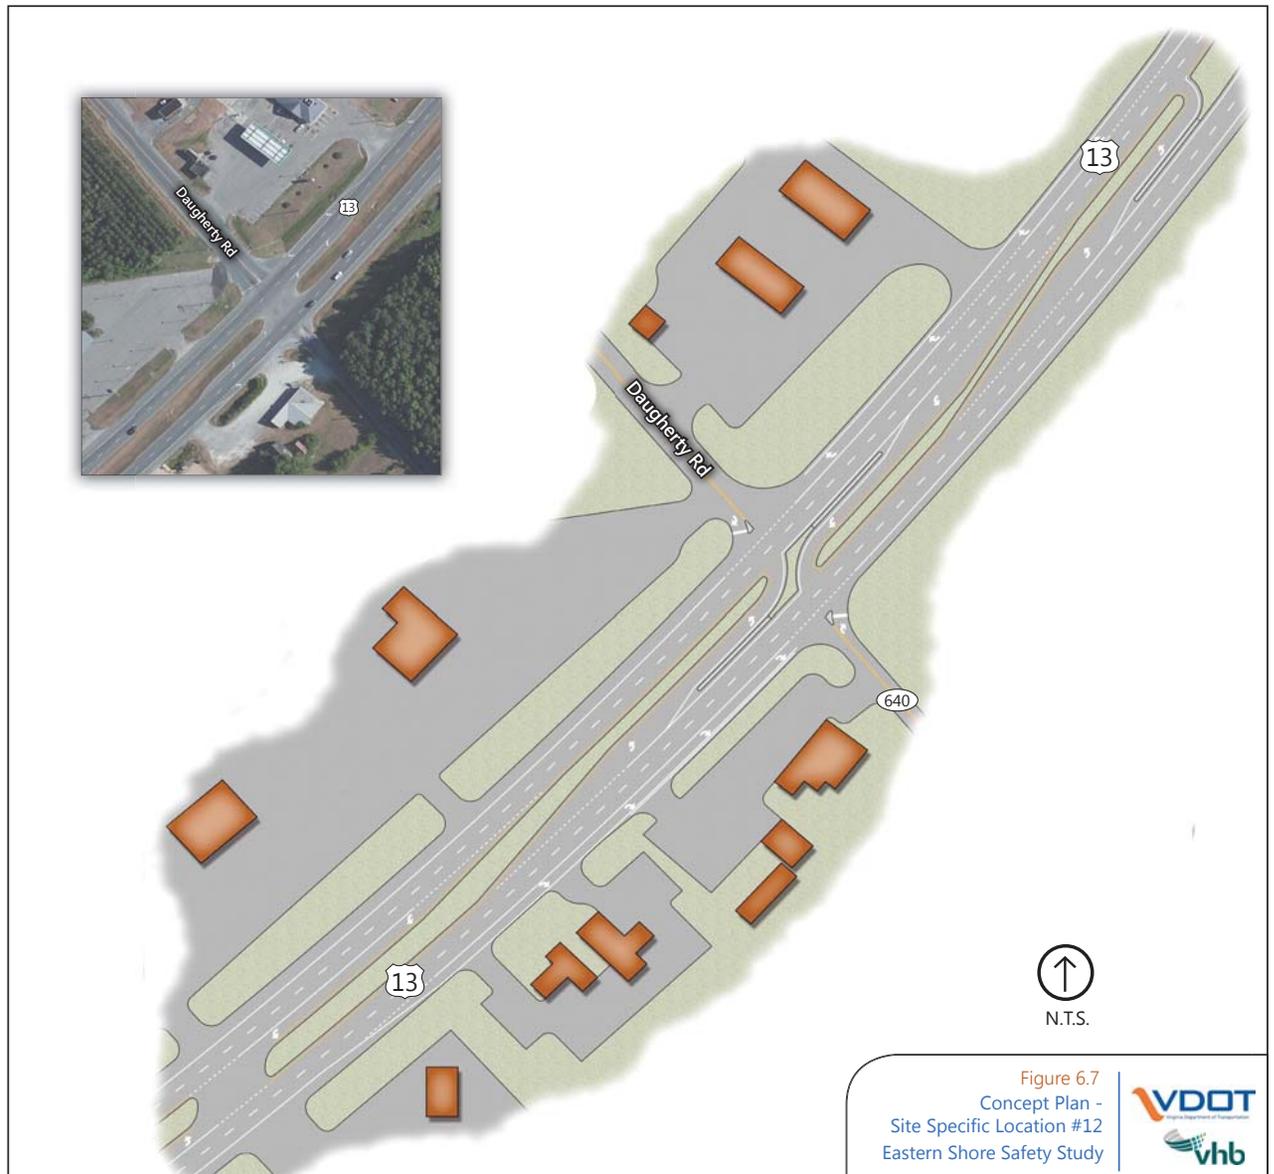
Figure 6.7
Concept Plan -
Site Specific Location #12
Eastern Shore Safety Study

- ◆ Insufficient turn lane and taper lengths.
- ◆ Horizontal curvature reduces intersection sight distance for southbound vehicles.
- ◆ Observed high travel speeds.
- ◆ Lack of median crossover delineation.
- ◆ Access management of adjacent properties, particularly those properties on the southwestern and southeastern corners. These properties have multiple consecutive entrances on U.S. Route 13 and Daugherty Road. There are eight (8) driveway accesses south of the intersection: three (3) on U.S. Route 13 southbound and five (5) on U.S. Route 13 northbound, and one north of the intersection on the southbound approach.

- ▶ Install a Restricted Crossing U-Turn (RCUT) intersection by modifying median access so that vehicles can only turn right from Daugherty Road with an available subsequent u-turn opportunity. Access for emergency responders that currently use this intersection can use an alternative route to the north to avoid the u-turn. Response time should be confirmed as a part of advancement of this recommendation.
- ▶ Implement access management measures on the properties adjacent to the intersection to consolidate access points onto U.S. Route 13.
- ▶ Lengthen substandard turn lanes to provide 200 feet of storage and 200 feet of taper for an overall minimum length of 400 feet.

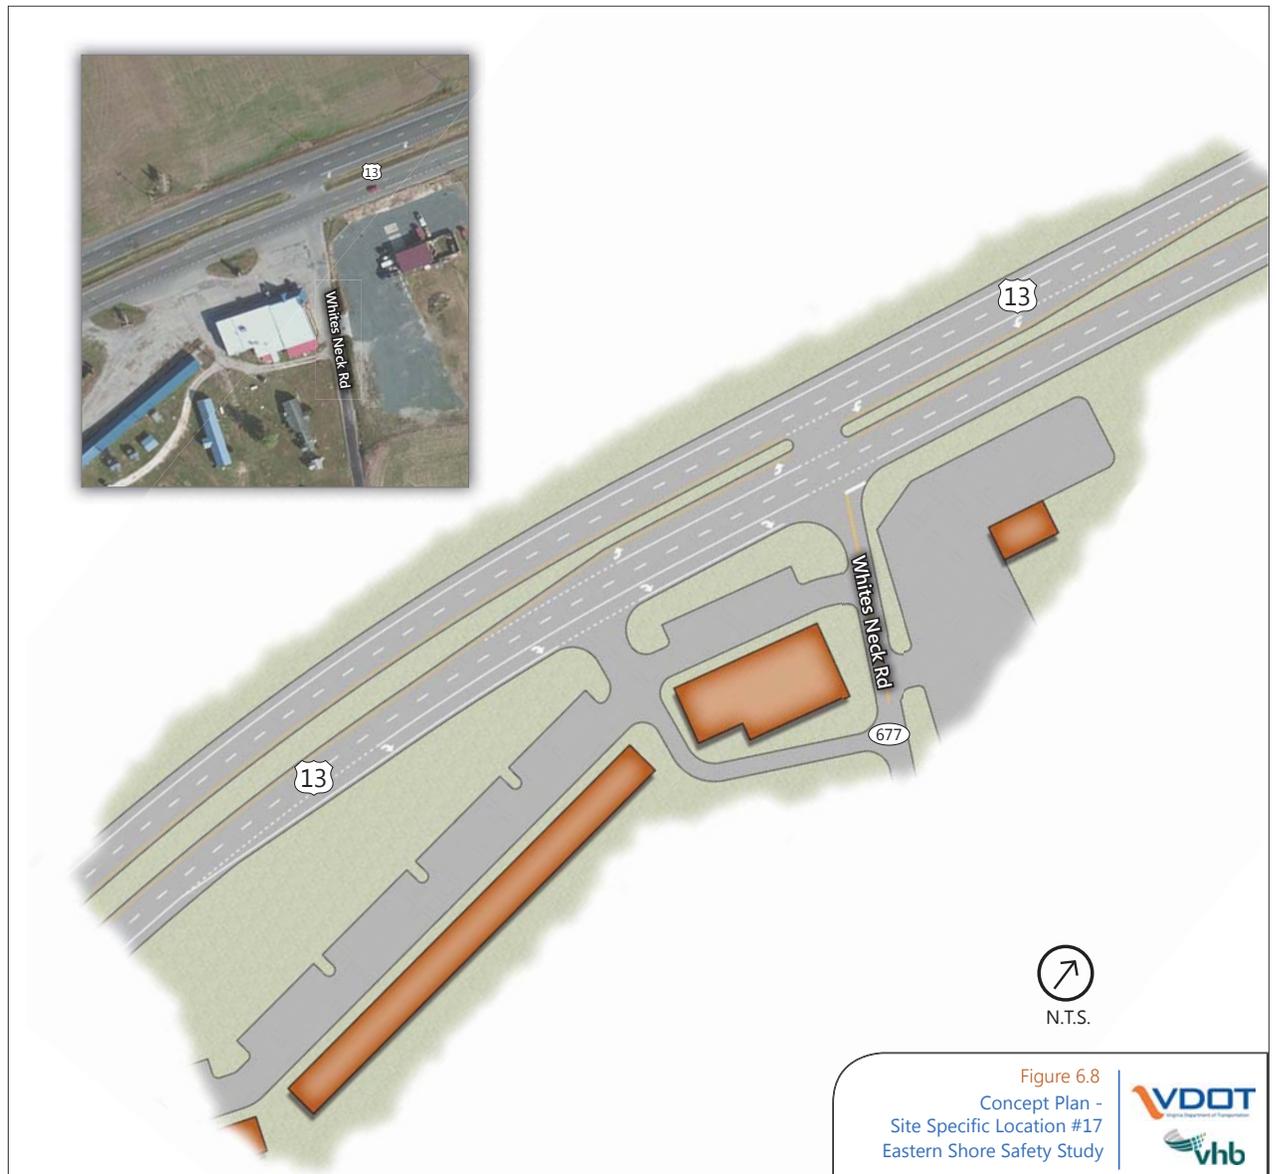
Figure 6.8
 Concept Plan -
 Site Specific Location #17
 Eastern Shore Safety Study

- ◆ Nighttime crashes.
- ◆ High speeds.
- ◆ Intersection expectancy and high speeds on U.S. Route 13.
- ◆ Access management at Whites Neck Road.
- ◆ Roadside conditions and ability for drivers to recover.

- ▶ Provide additional positive guidance through post mounted delineators and wider 6-inch pavement markings.
- ▶ Incorporate safety edge to provide an additional method for vehicles to recover from roadway departure crashes.
- ▶ Schedule mowing operations to be conducted regularly and at intervals that ensure grass does not obscure roadside hazards and signs.
- ▶ Place roadside object marker signs at appropriate height, so that they are visible to drivers.
- ▶ Review ditches to see if the depth and slope can be reduced. If not, widen shoulder and add guardrail or pipe ditch to eliminate hazard within clear zone.
- ▶ Conduct targeted speed enforcement, particularly during the nighttime when most of the crashes occurred.
- ▶ Install intersection warning signs for both Johnson Wharton Lane and Whites Neck Road.

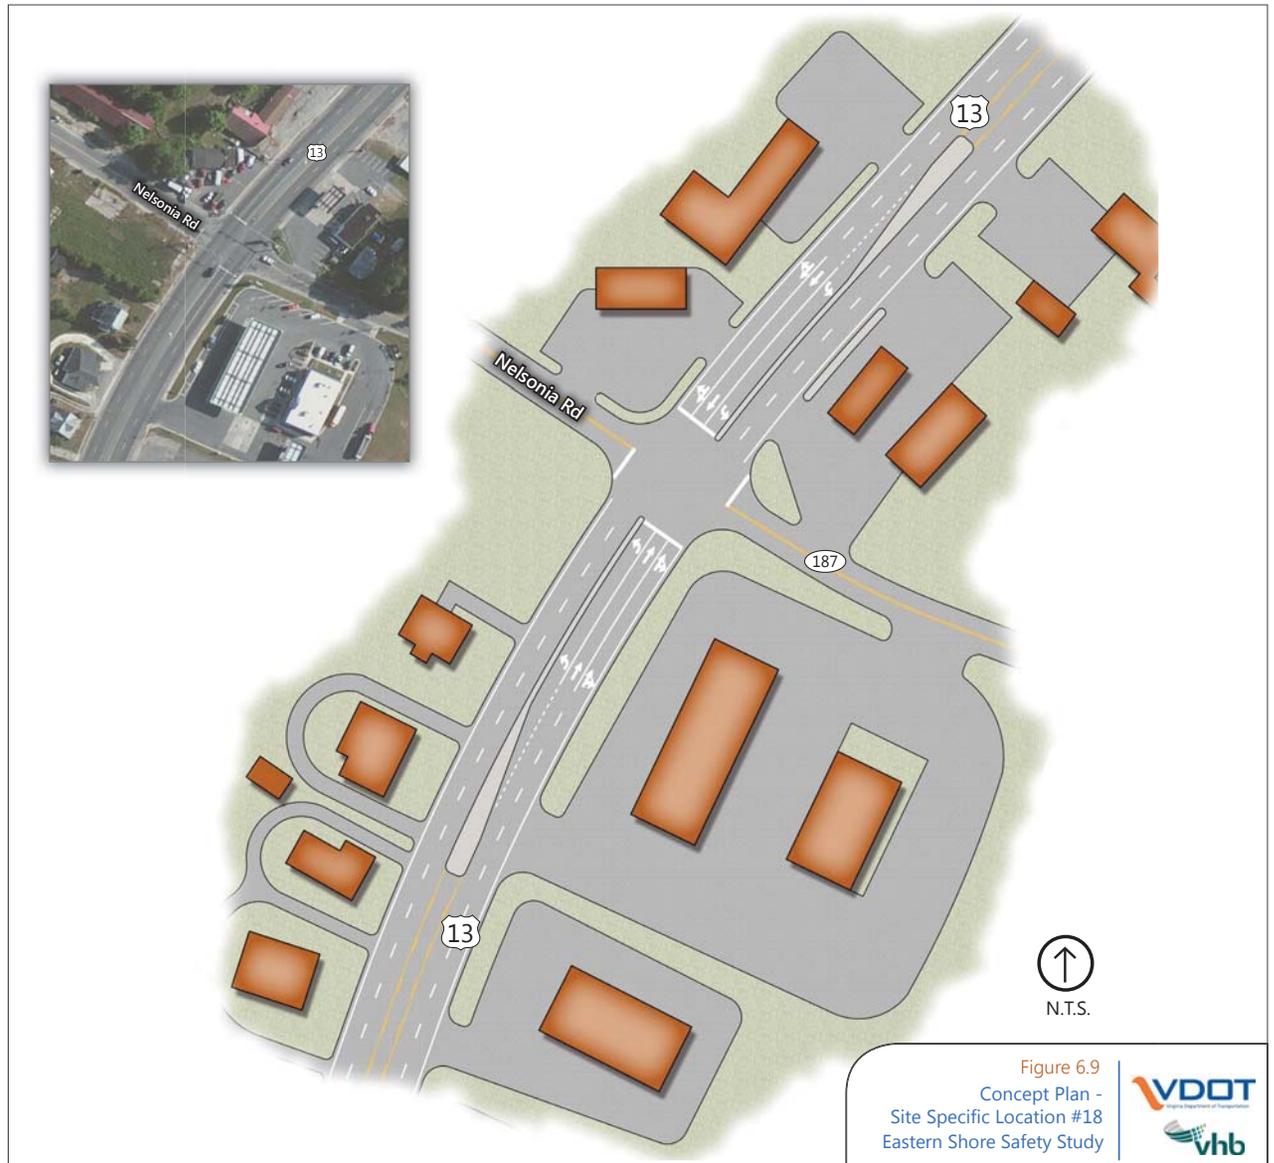
Figure 6.9
Concept Plan -
Site Specific Location #18
Eastern Shore Safety Study

There are fixed objects such as poles and mailboxes close to the roadway. Curb and sidewalk are present at the intersection but no crosswalks or pedestrian signal enhancements. During field review, pedestrians were observed walking on the shoulder.

The hillside at Royal Farms limits sight distance for the westbound intersection approach. Street signs were less visible to drivers as they were post mounted rather than mast arm mounted. Drivers were observed cutting through the Sunoco parking lot on the northeastern corner of the intersection to avoid the traffic signal. Heavy truck traffic and high vehicle speeds were also observed on U.S. Route 13. It was also noted that many westbound approach drivers turning north onto U.S. Route 13 look left before entering the roadway on their green signal indicating hesitation regarding drivers obeying the traffic signal. Northbound trucks traveling at high speeds may not see the signal as they come around curve to the intersection.

- ▶ Restrict right turn on red for westbound approach.
- ▶ Conduct targeted speeding and signal enforcement in the vicinity of the intersection.
- ▶ Install intersection warning signs and next signal ahead warning signs in both the north and southbound directions and replace post mounted with mast arm mounted street name signs.
- ▶ Install retroreflective tape on backplates or install retroreflective backplates to enhance day and nighttime signal conspicuity.
- ▶ Investigate pedestrian activity to determine if sidewalks should be extended and crossing measures installed at the intersection.
