# Battling Segregation Using Pave IR System

# What is Thermal Segregation

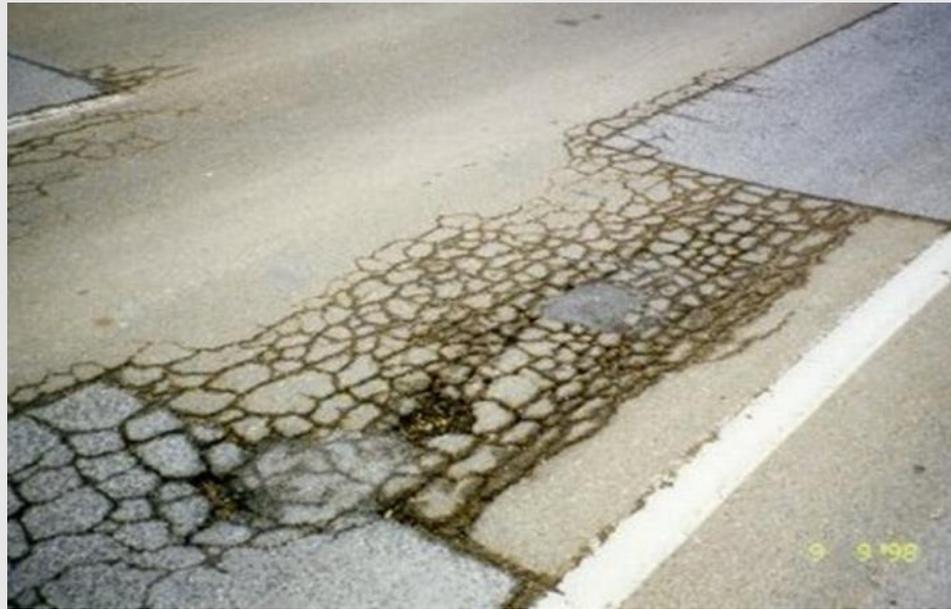
- Thermal segregation is defined as temperature differences in the hot mix asphalt (HMA) mat as it is placed and is a potential cause of premature failure in asphalt roads. It can cause a significant reduction in pavement life due to low density from cold spots in the HMA mat.

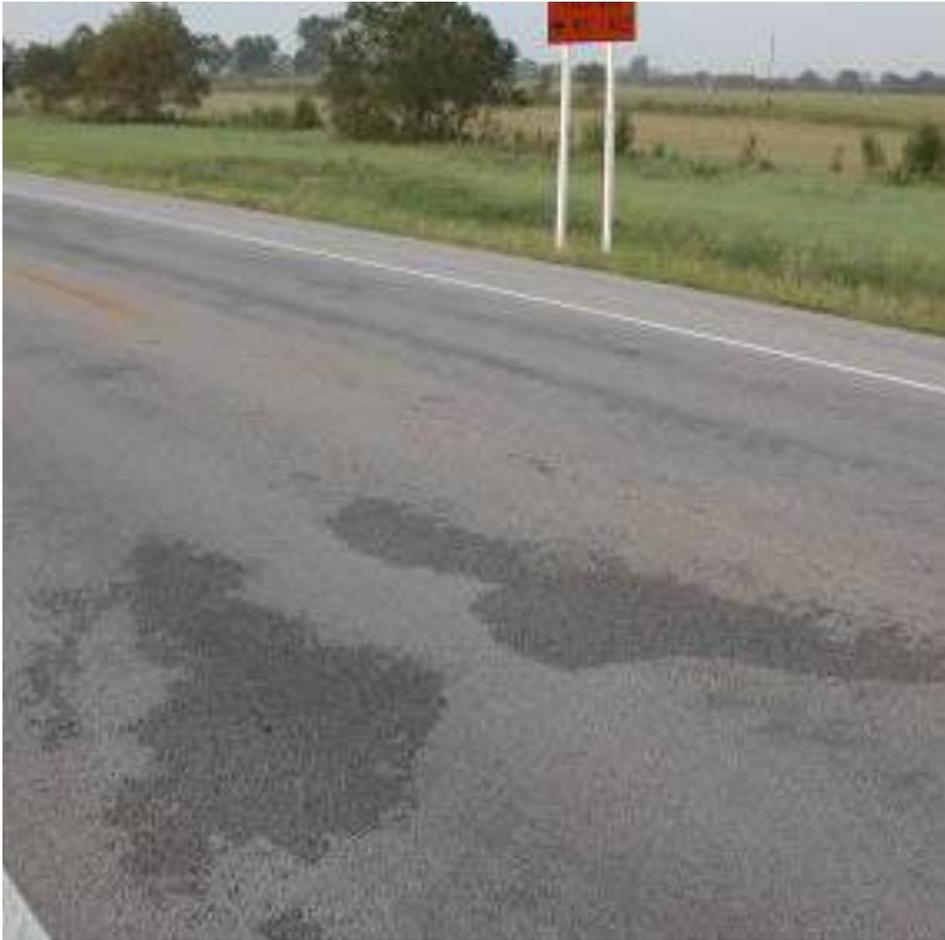
# SYMPTOMS OF THERMAL SEGREGATION

- **Localized spots of coarse texture**
  - May hold water after rain event
- **Premature failure due to fatigue cracking, raveling, and moisture damage**
- **Increased roughness**
- **Same as insufficient compaction**

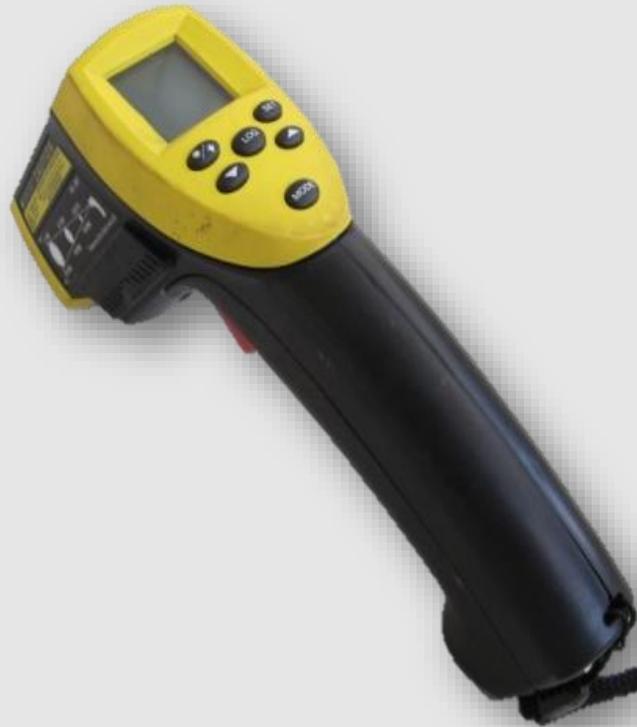
## Handheld Infrared Thermometers 1<sup>st</sup> Generation of Thermal Detection

**Handheld Infrared Thermometers are not allowed for temperature profiles in the 2014 Specification**

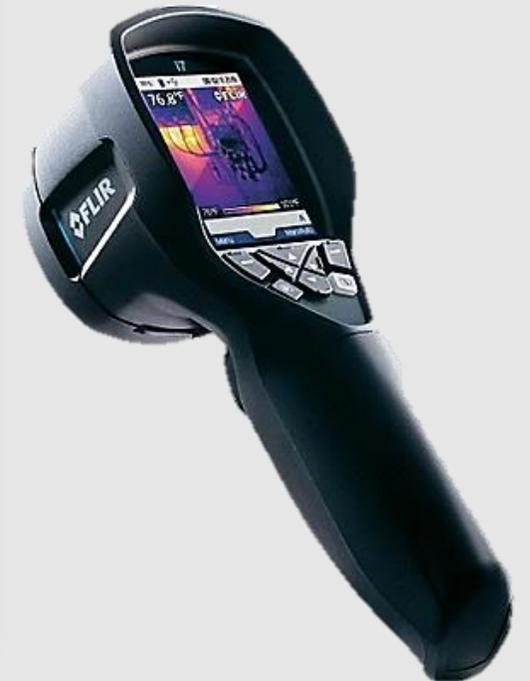
## Thermal Camera

- Thermal camera requirements are outlined in Tex-244-F, “Thermal Profile of Hot Mix Asphalt”
  - Minimum resolution of 19,200 pixels
    - Older cameras may not meet this requirement
- TxDOT Selected
  - Camera is FLIR E6
  - Handheld (not mounted, portable)
  - Thermal image is displayed in real time
  - Pull the trigger to take thermal images
  - A digital image is also taken

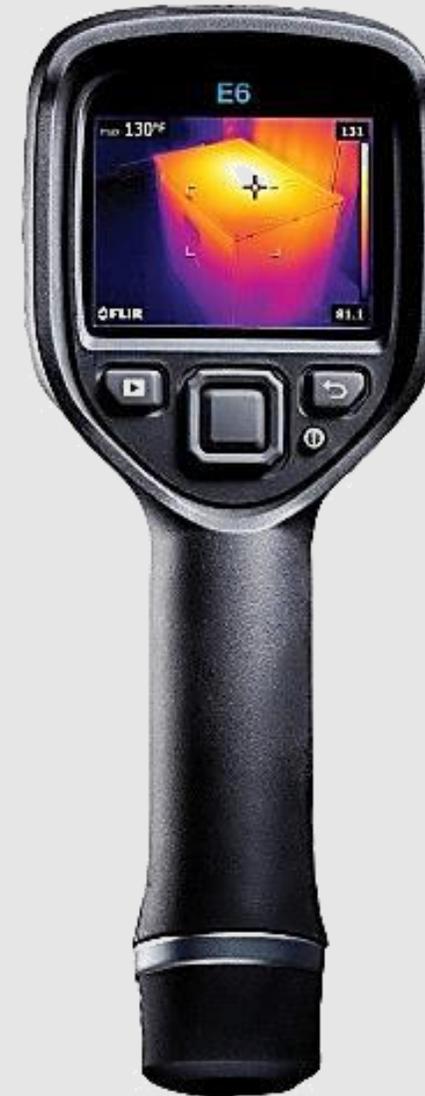
## ■ Camera Settings

- Emissivity = 1.00
- Reflected Temperature = 68°F
- Distance = 10 feet
- Language = English
- Temperature Unit = °F
- Distance Unit = Feet
- Set Correct Date and Time
- Color = Rainbow
- Image Mode = Thermal MSX

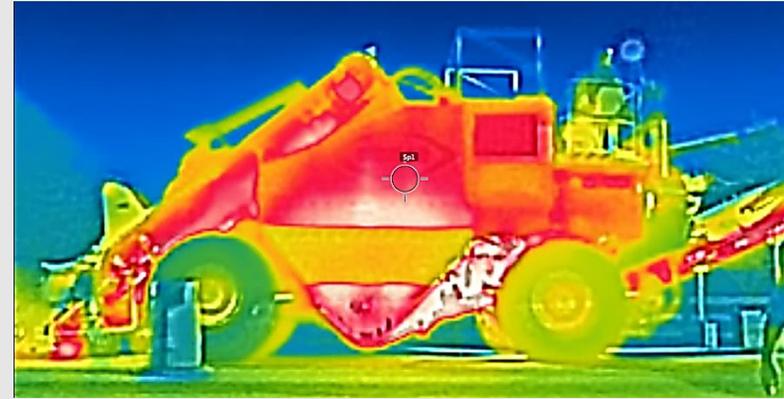
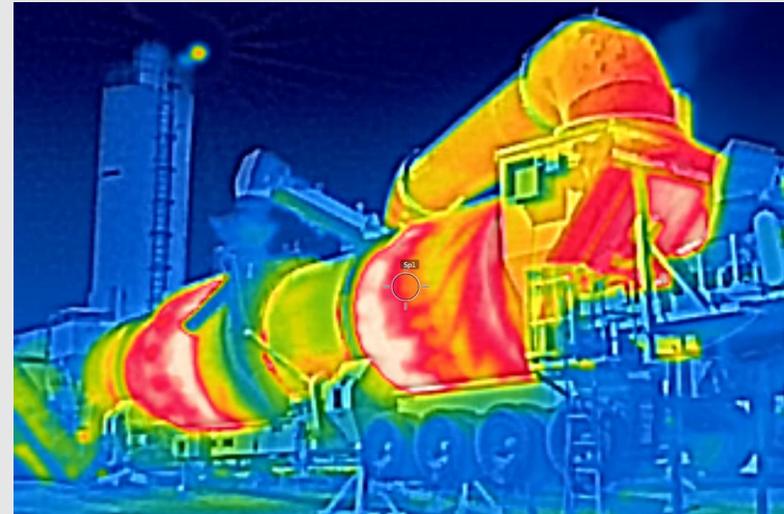
# Thermal Camera Guidelines

- Take several thermal images for each thermal profile
  - Recommendation is 2 to 3 photos for the first 20 feet (max. baseline)
  - 13 to 15 photos for the remaining 130 feet
- Take corrective action to eliminate recurring moderate thermal segregation
- Suspend operations and take immediate corrective action to eliminate severe thermal segregation unless otherwise directed
- Use the camera to mark areas of moderate and severe segregation, which can be followed up with a density profile

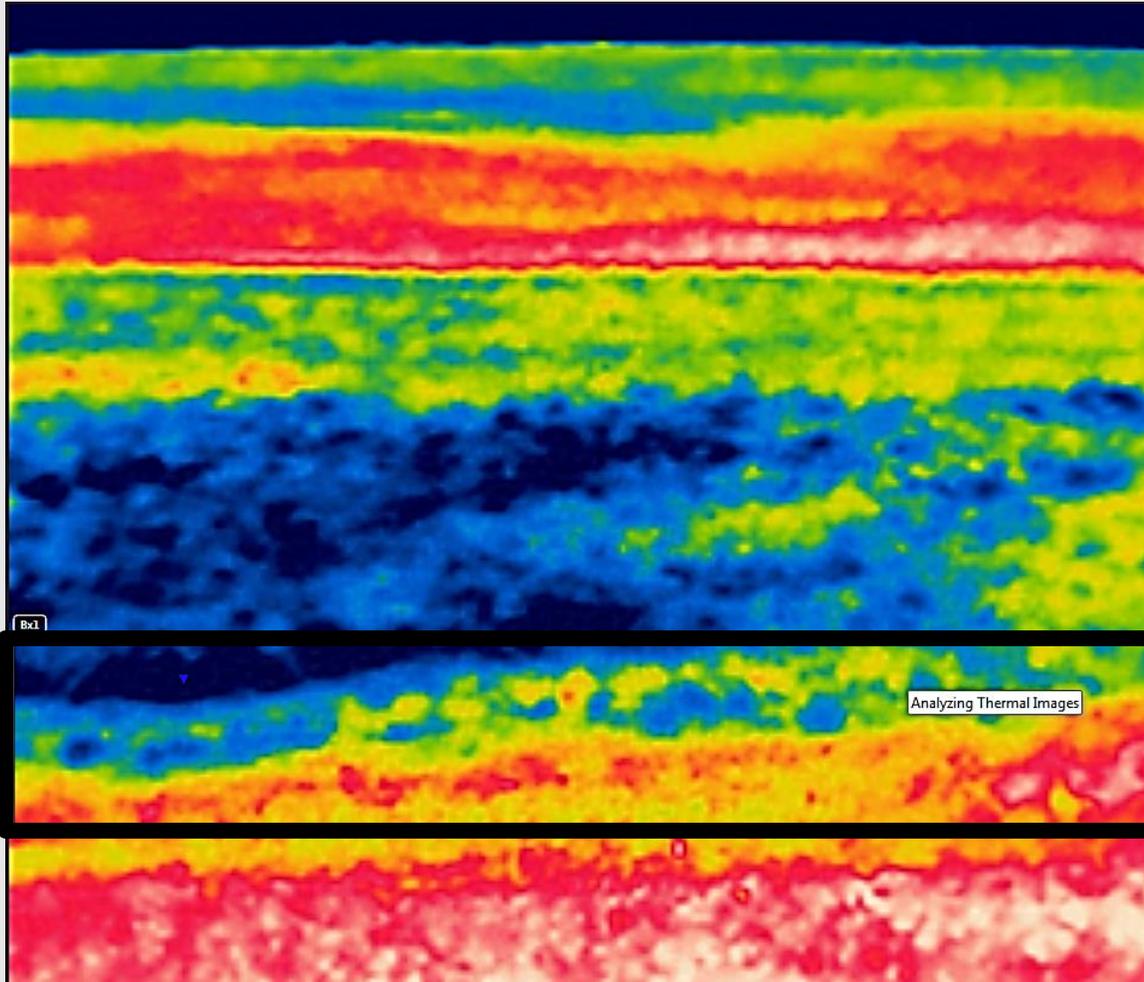
# Thermal Camera Examples of Thermal Segregation

| Measurements | | | °F |
| Bx1 | Max | 235.5 | |
| | Min | 187.9 | |
| | Average | 217.6 | |
| Dt1 | Bx1.Max - Bx1.Min | 47.7 | ⚙️ ✕ |

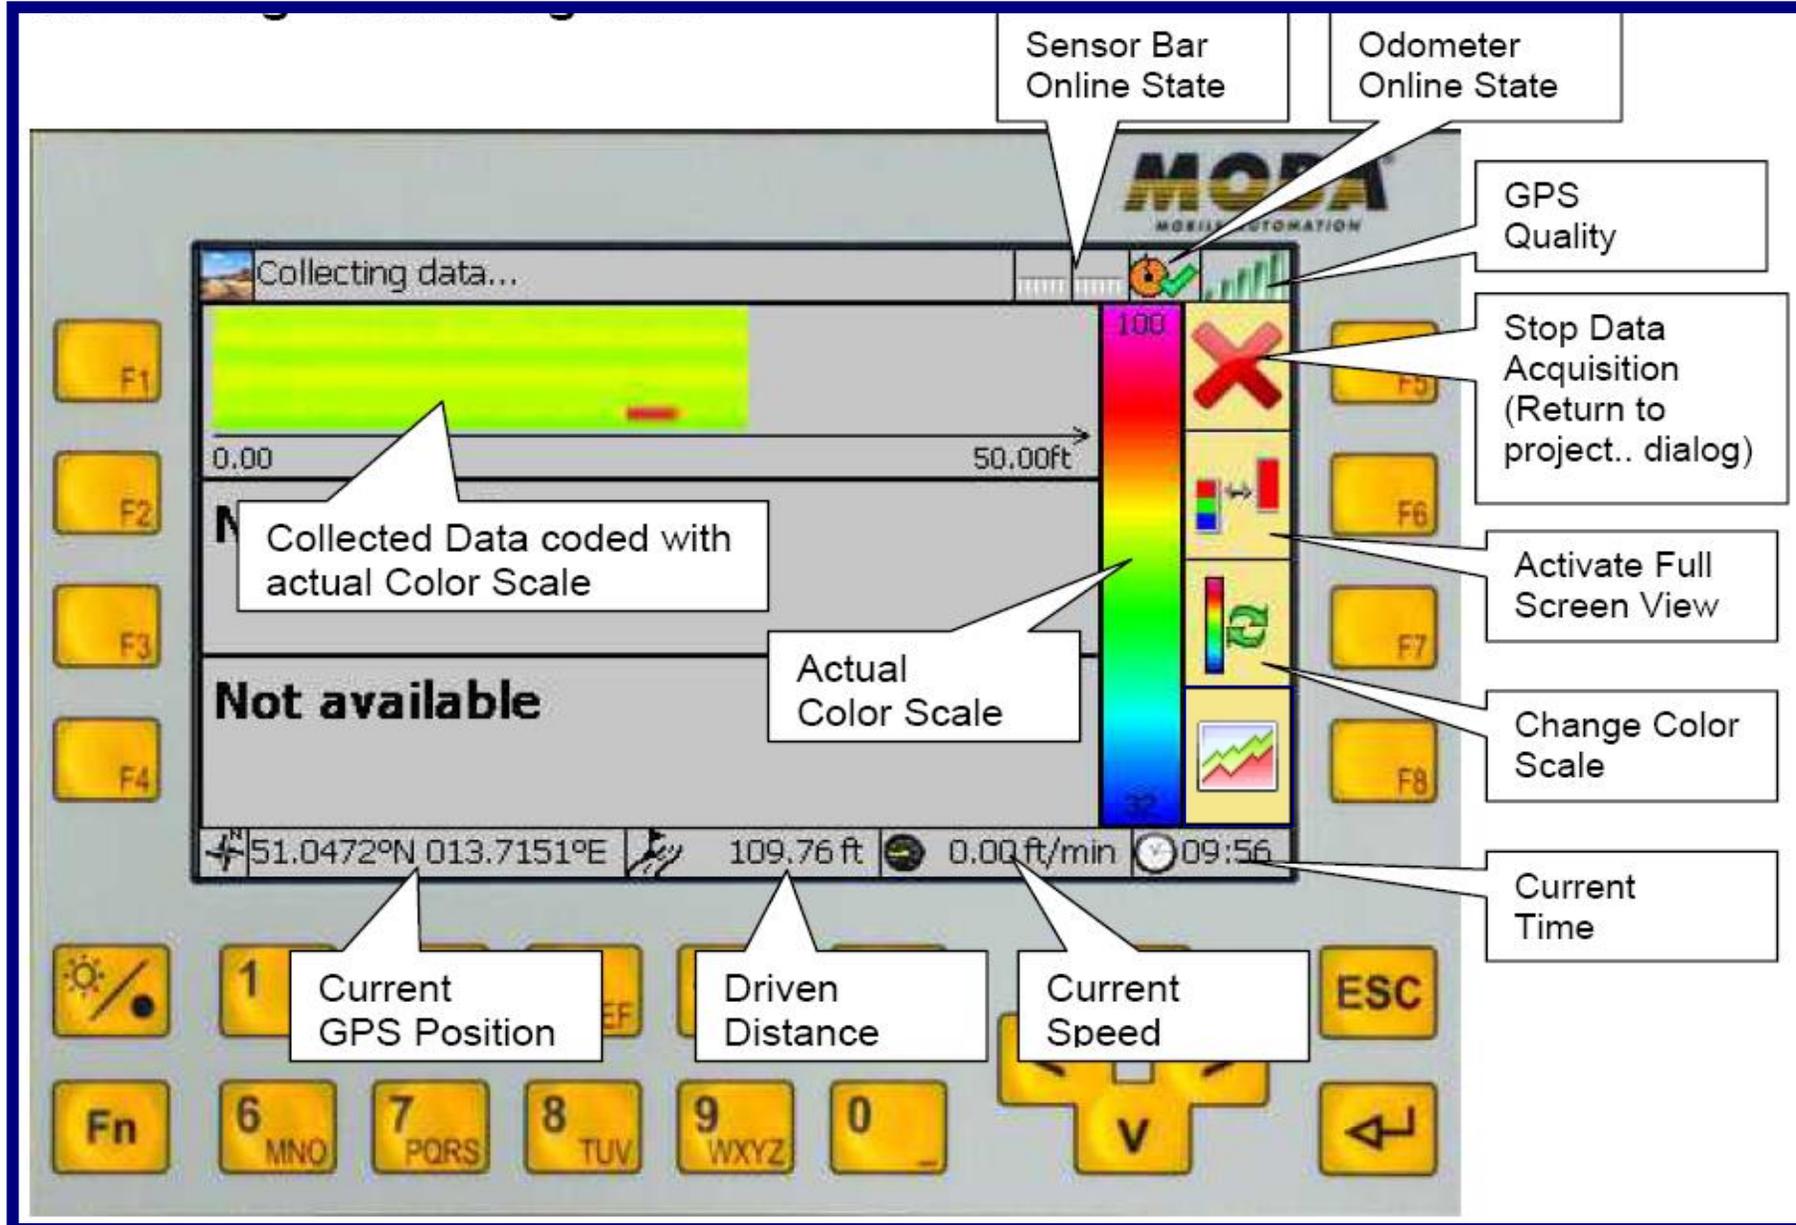
# DATA COLLECTION SCREEN

The screenshot displays the MOBA (Mobile Automation) interface for data collection. The main display area shows a color-coded data collection strip from 0.00 to 50.00ft. A vertical color scale legend is visible on the right side of the strip, ranging from blue at the bottom to red at the top, with '100' at the top. The text 'Not available' is displayed in the lower-left area of the data strip.

- Sensor Bar Online State**: Callout pointing to the top status bar.
- Odometer Online State**: Callout pointing to the top status bar.
- GPS Quality**: Callout pointing to a small icon in the top right.

- Stop Data Acquisition (Return to project.. dialog)**: Callout pointing to a red 'X' button on the right side.
- Activate Full Screen View**: Callout pointing to a button with a double-headed arrow icon.

- Change Color Scale**: Callout pointing to a button with a color scale icon.
- Current Time**: Callout pointing to the time '09:56' in the bottom status bar.

- Current GPS Position**: Callout pointing to the coordinates '51.0472°N 013.7151°E'.
- Driven Distance**: Callout pointing to the value '109.76 ft'.
- Current Speed**: Callout pointing to the value '0.00 ft/min'.

- Collected Data coded with actual Color Scale**: Callout pointing to the data strip.
- Actual Color Scale**: Callout pointing to the vertical color scale legend.

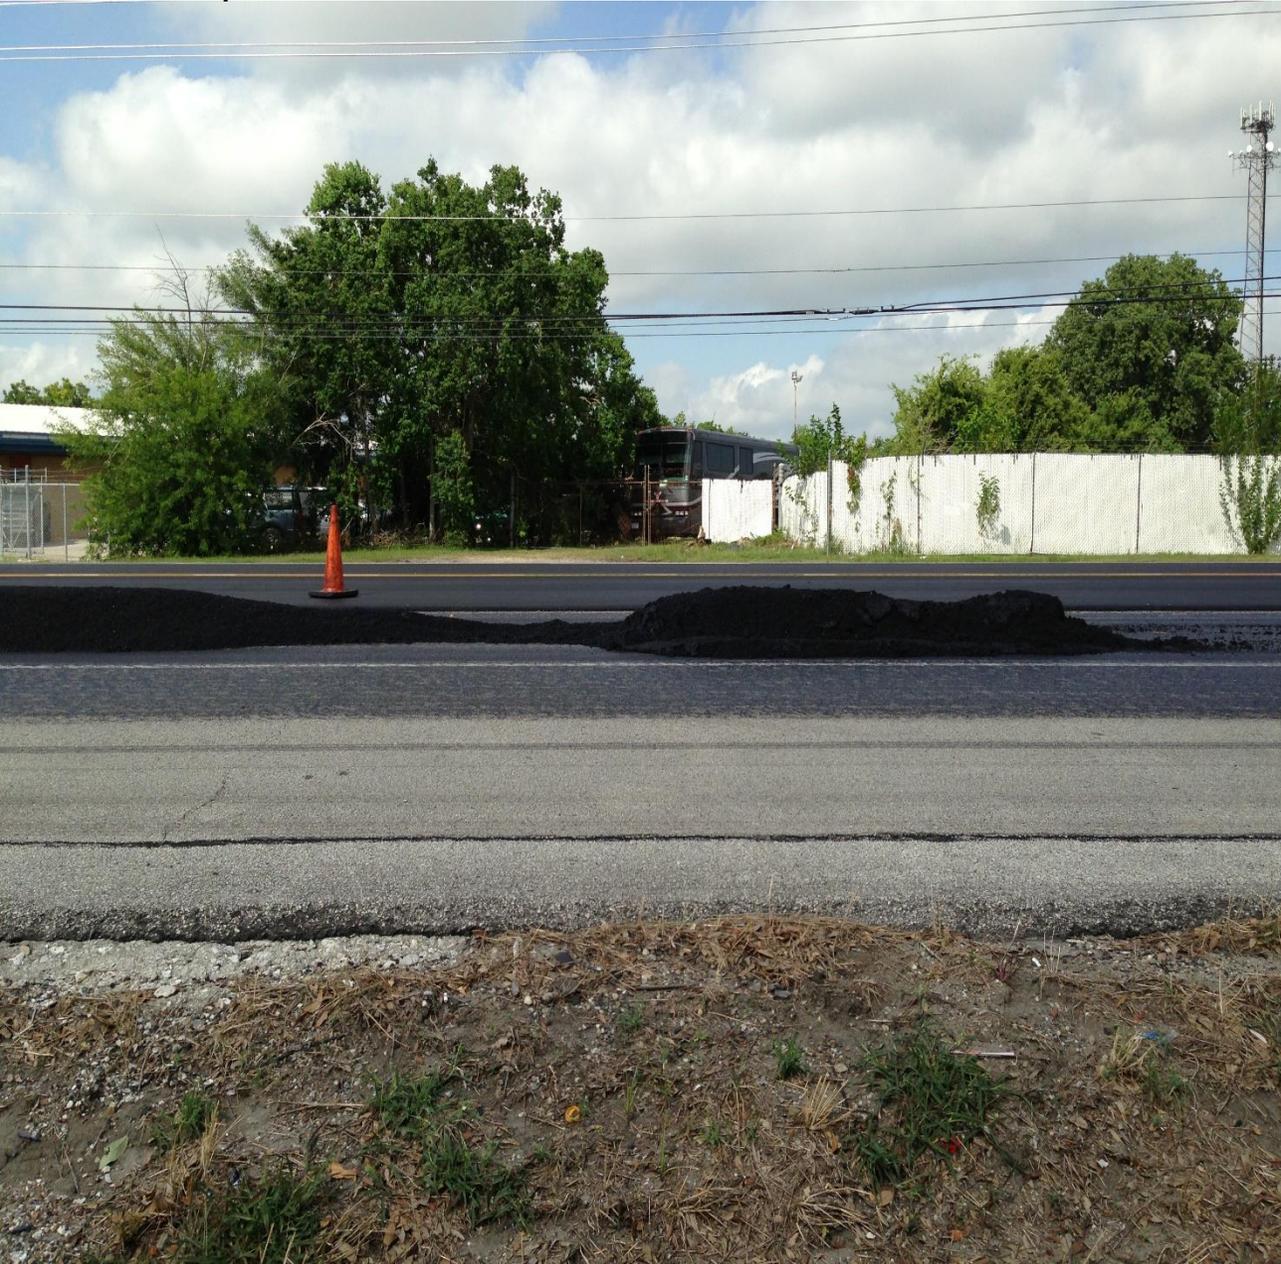
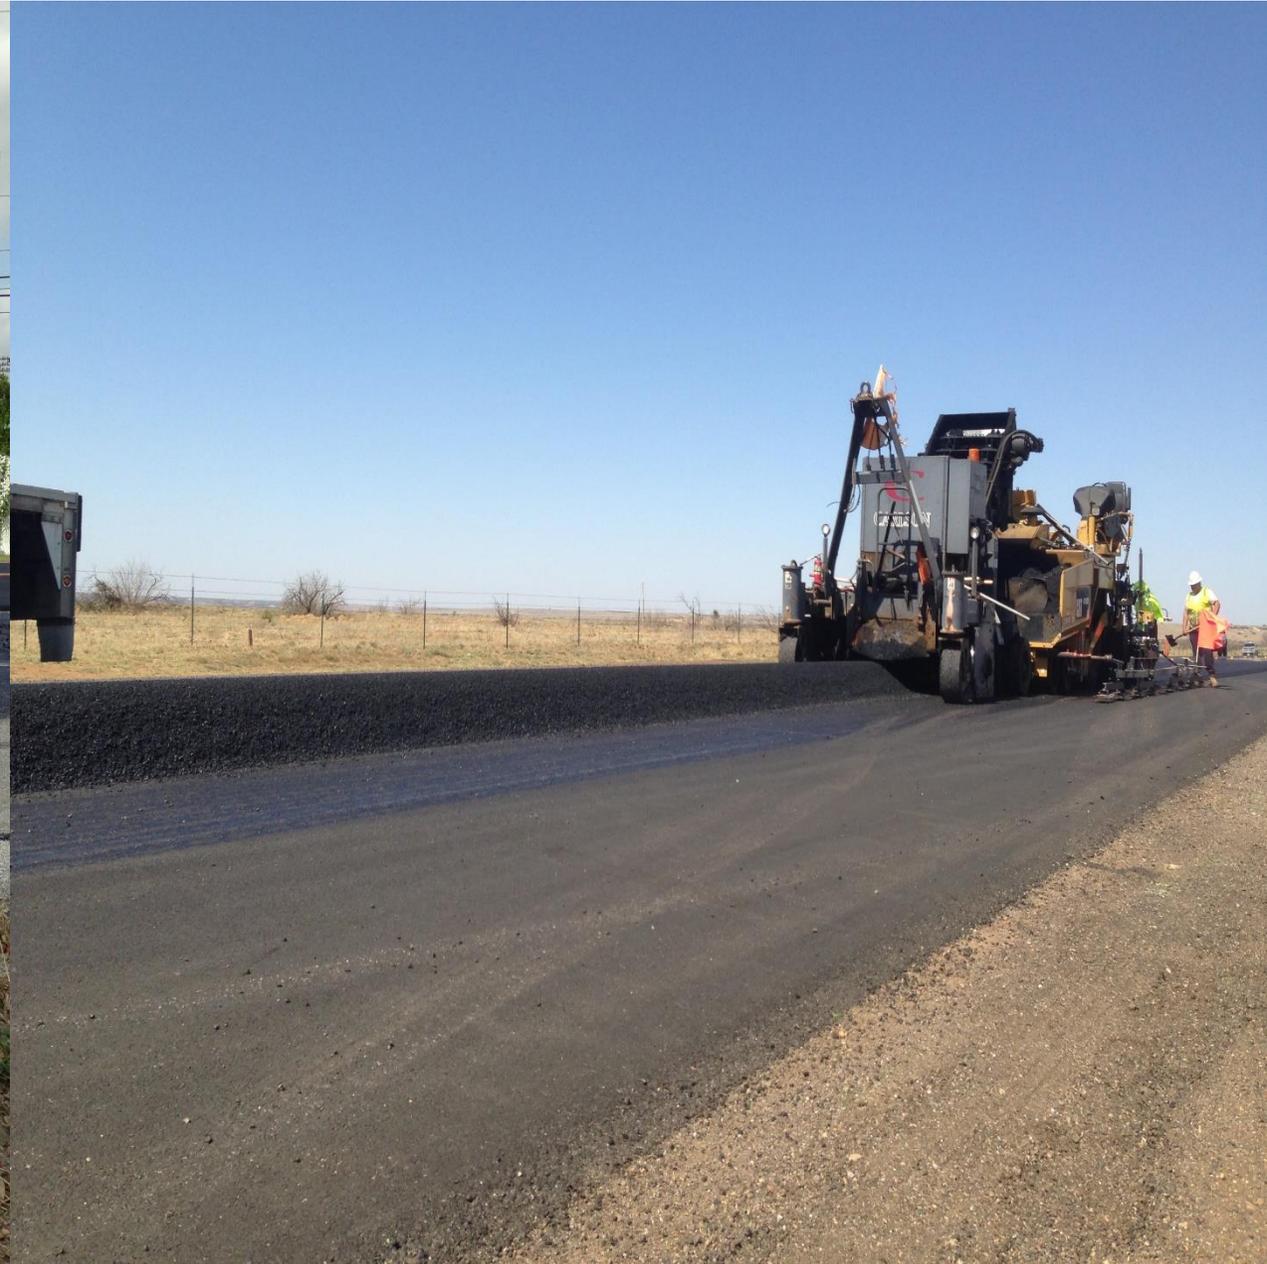
# End of load segregation

*Dump men are important! Can't stress this enough*

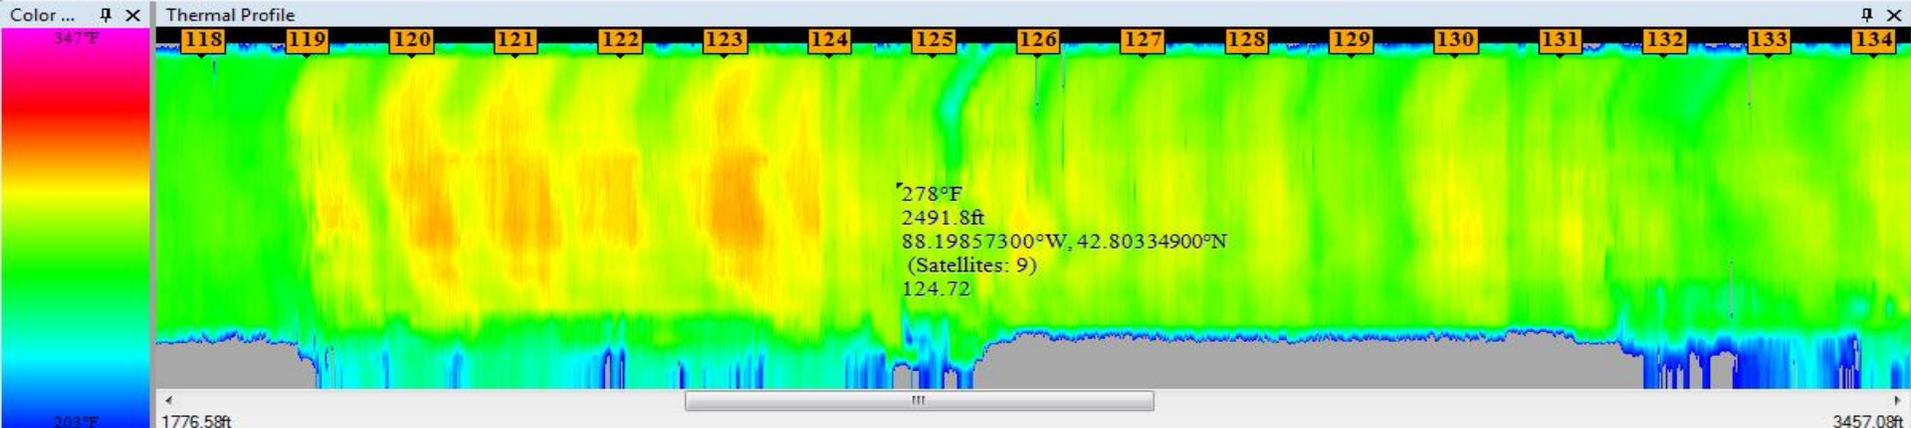
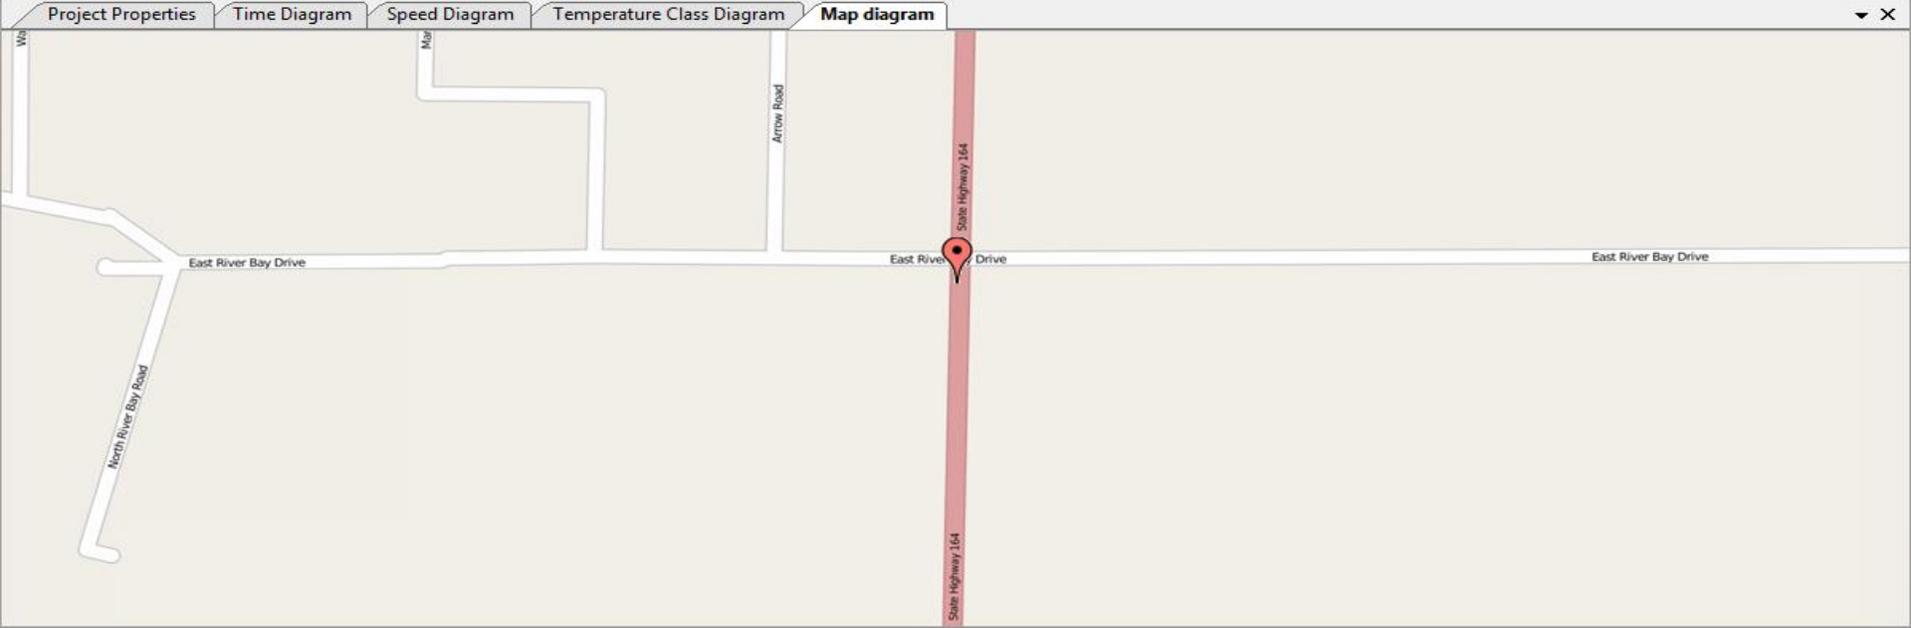
278°F  
2491.8ft  
88.19857300°W, 42.80334900°N  
(Satellites: 9)  
124.72

- Actions
  - Interpolation: **Linear**
  - Sample Spots of Interest: **Enabled**
  - Stations: **Show**
  - Tooltip: **Visible**
- Profile View
  - Ignored Sensors: **None**
  - Length: **1680.49ft**
  - Start: **1776.58ft**
  - Units: **Feet**
  - Zoom: **27.8%**

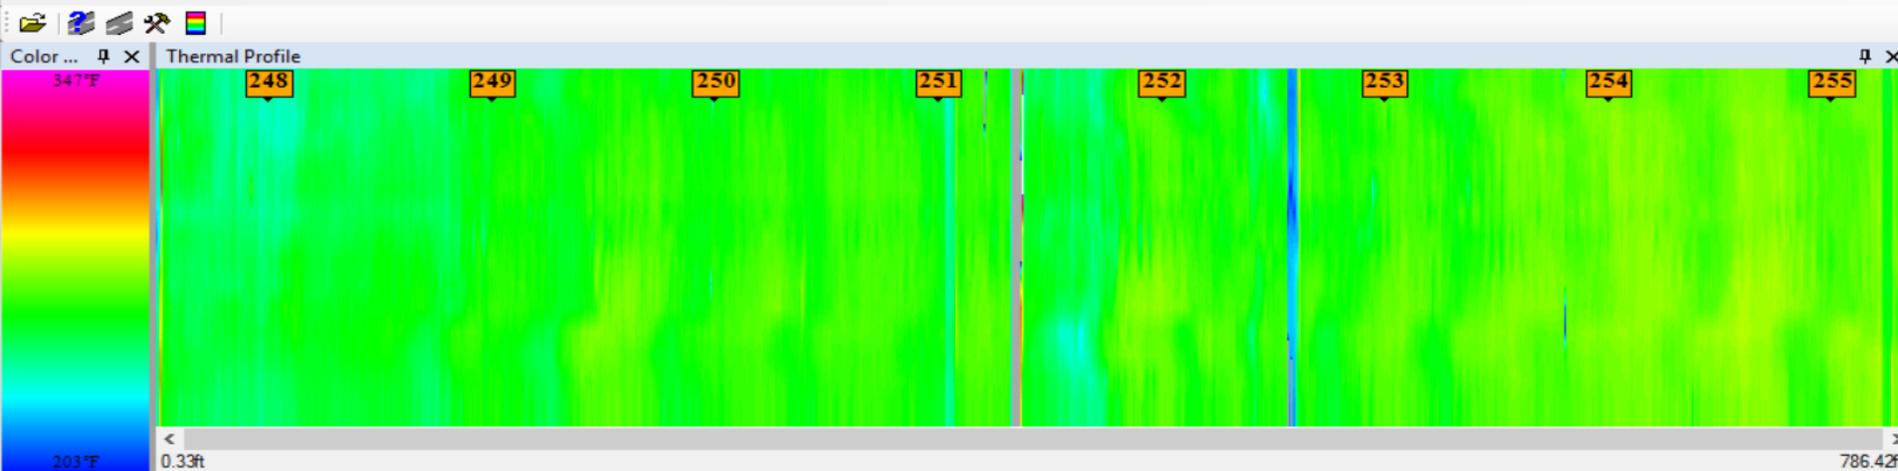
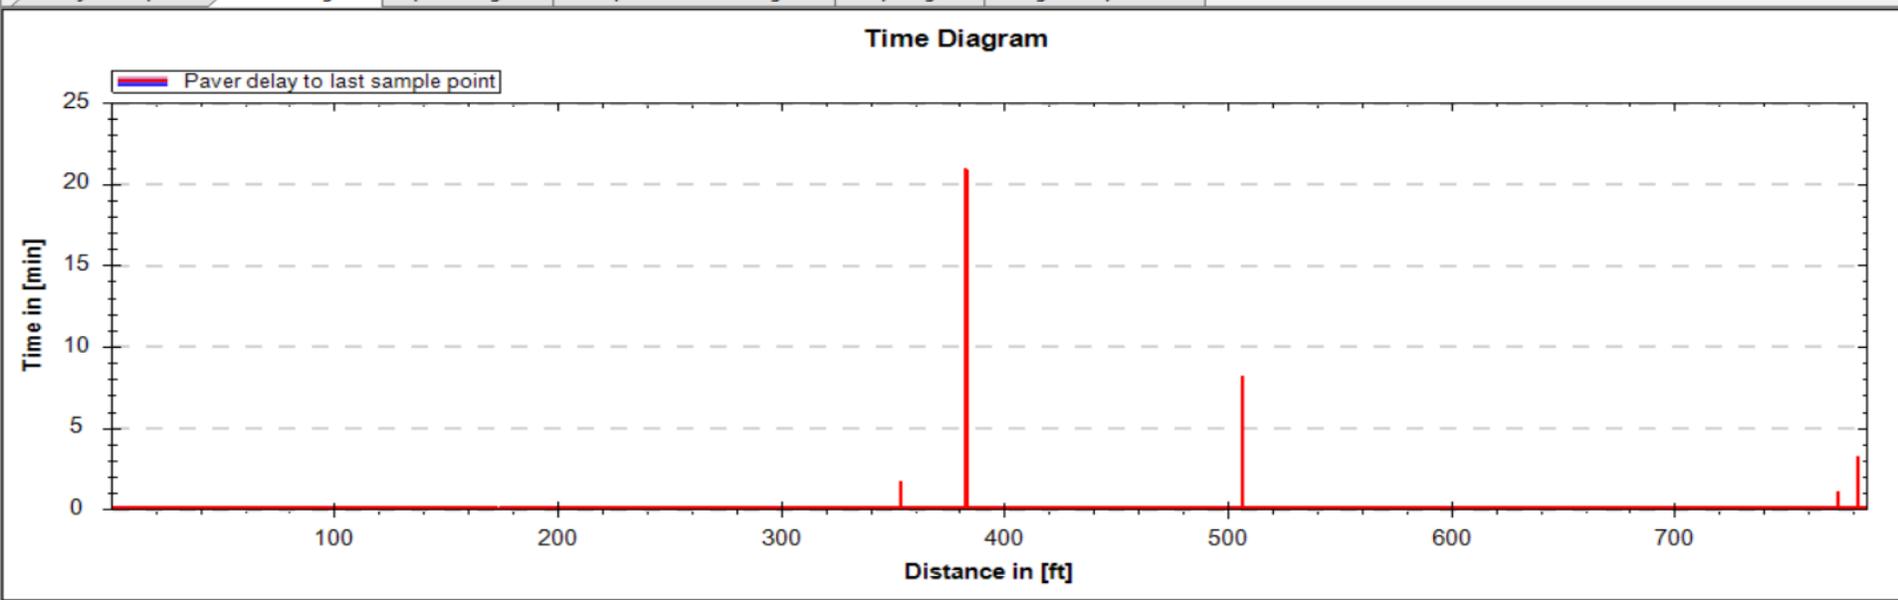
- Actions
  - Interpolation: **Linear**
  - Sample Spots of Interest: Enabled
  - Stations: **Show**
  - Tooltip: Visible
- Profile View
  - Ignored Sensors
  - Length: **786.09ft**
  - Start: **0.33ft**
  - Units: **Feet**
  - Zoom: **100.0%**

Ignored Sensors  
Enter the sensor IDs you don't want to be displayed. ID 1 is the outer left sensor. Examples: "1:2;11:12", "1-3;10-12"
