Braddock Road/Pleasant Valley Road Alternatives Analysis

Fairfax County, Virginia

June 2013

KITTELSON & ASSOCIATES, INC.
TRANSPORTATION ENGINEERING/PLANNING

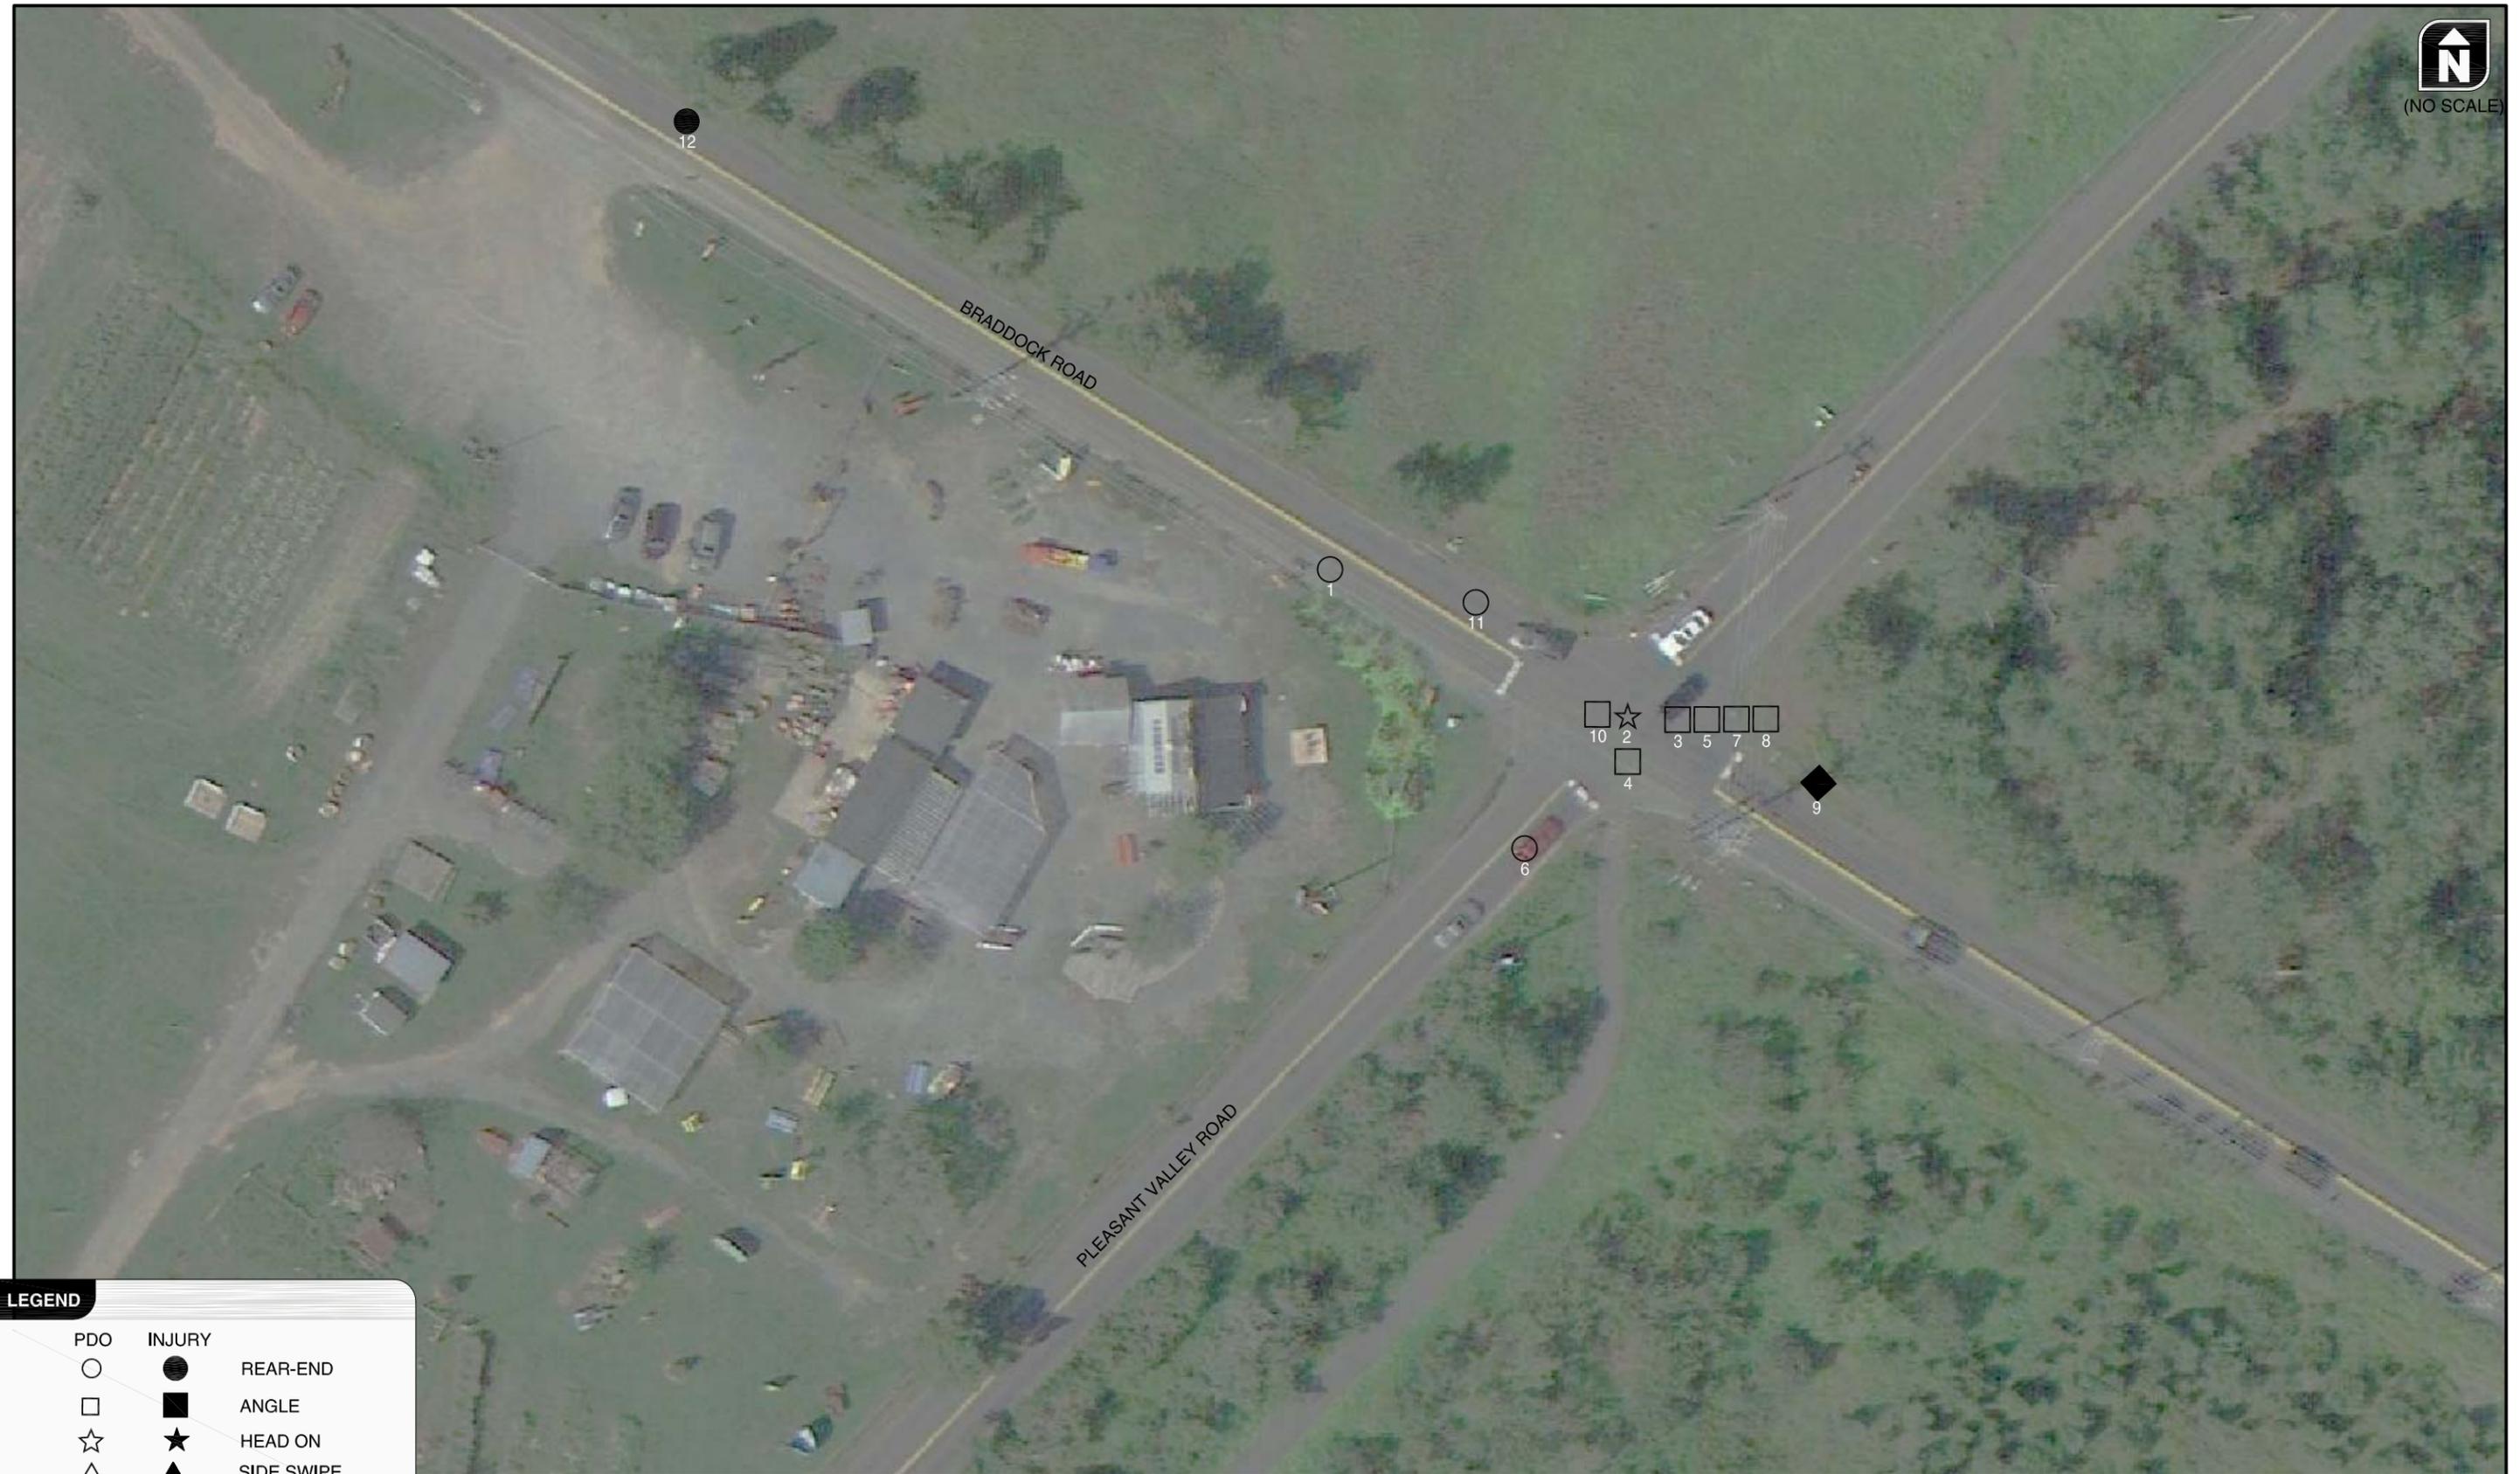
PDO	INJURY	
○	●	REAR-END
□	■	ANGLE
☆	★	HEAD ON
△	▲	SIDE SWIPE
◇	◆	FIXED OBJECT
###		CRASH INDEX NUMBER

- Four angle crashes occurred when vehicles traveling westbound on Braddock Road ran a stop sign and collided with vehicles traveling northbound on Pleasant Valley Road.
- Two angle crashes occurred when vehicles traveling straight through the intersection collided with vehicles making a left-turn movement.
- Two rear-end, property damage only crashes occurred leading up to the intersection: one in the eastbound direction 100 feet west of the study intersection and one in the northbound direction (distance from the intersection unknown).

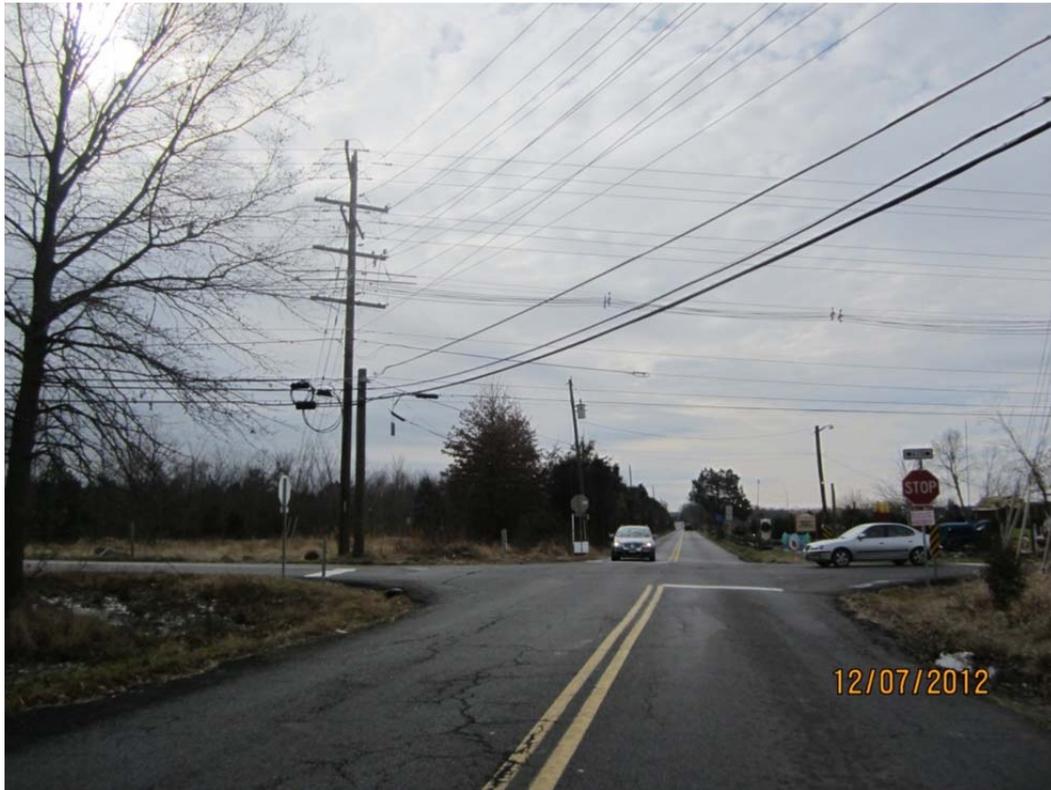
Figure 6 and **Figure 7** show the layout and magnitude of utility poles in the immediate vicinity of the intersection.

Figure 6 Southbound View of Utility Poles

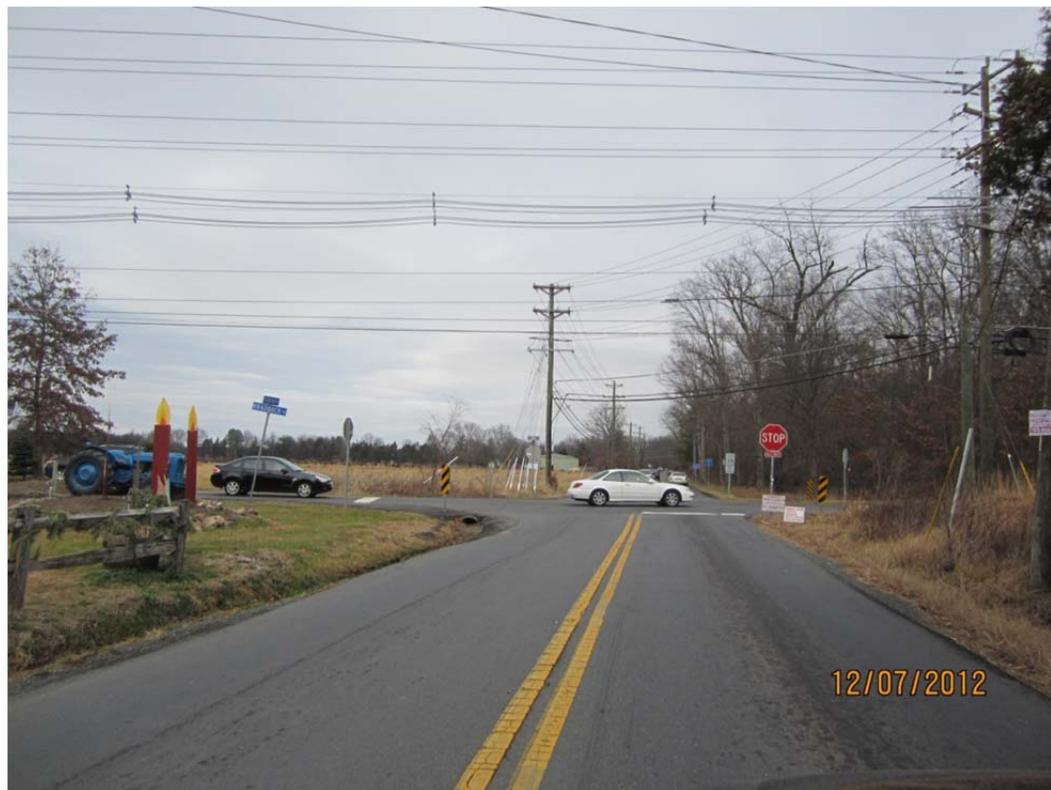
Figure 7 Northbound View of Utility Poles

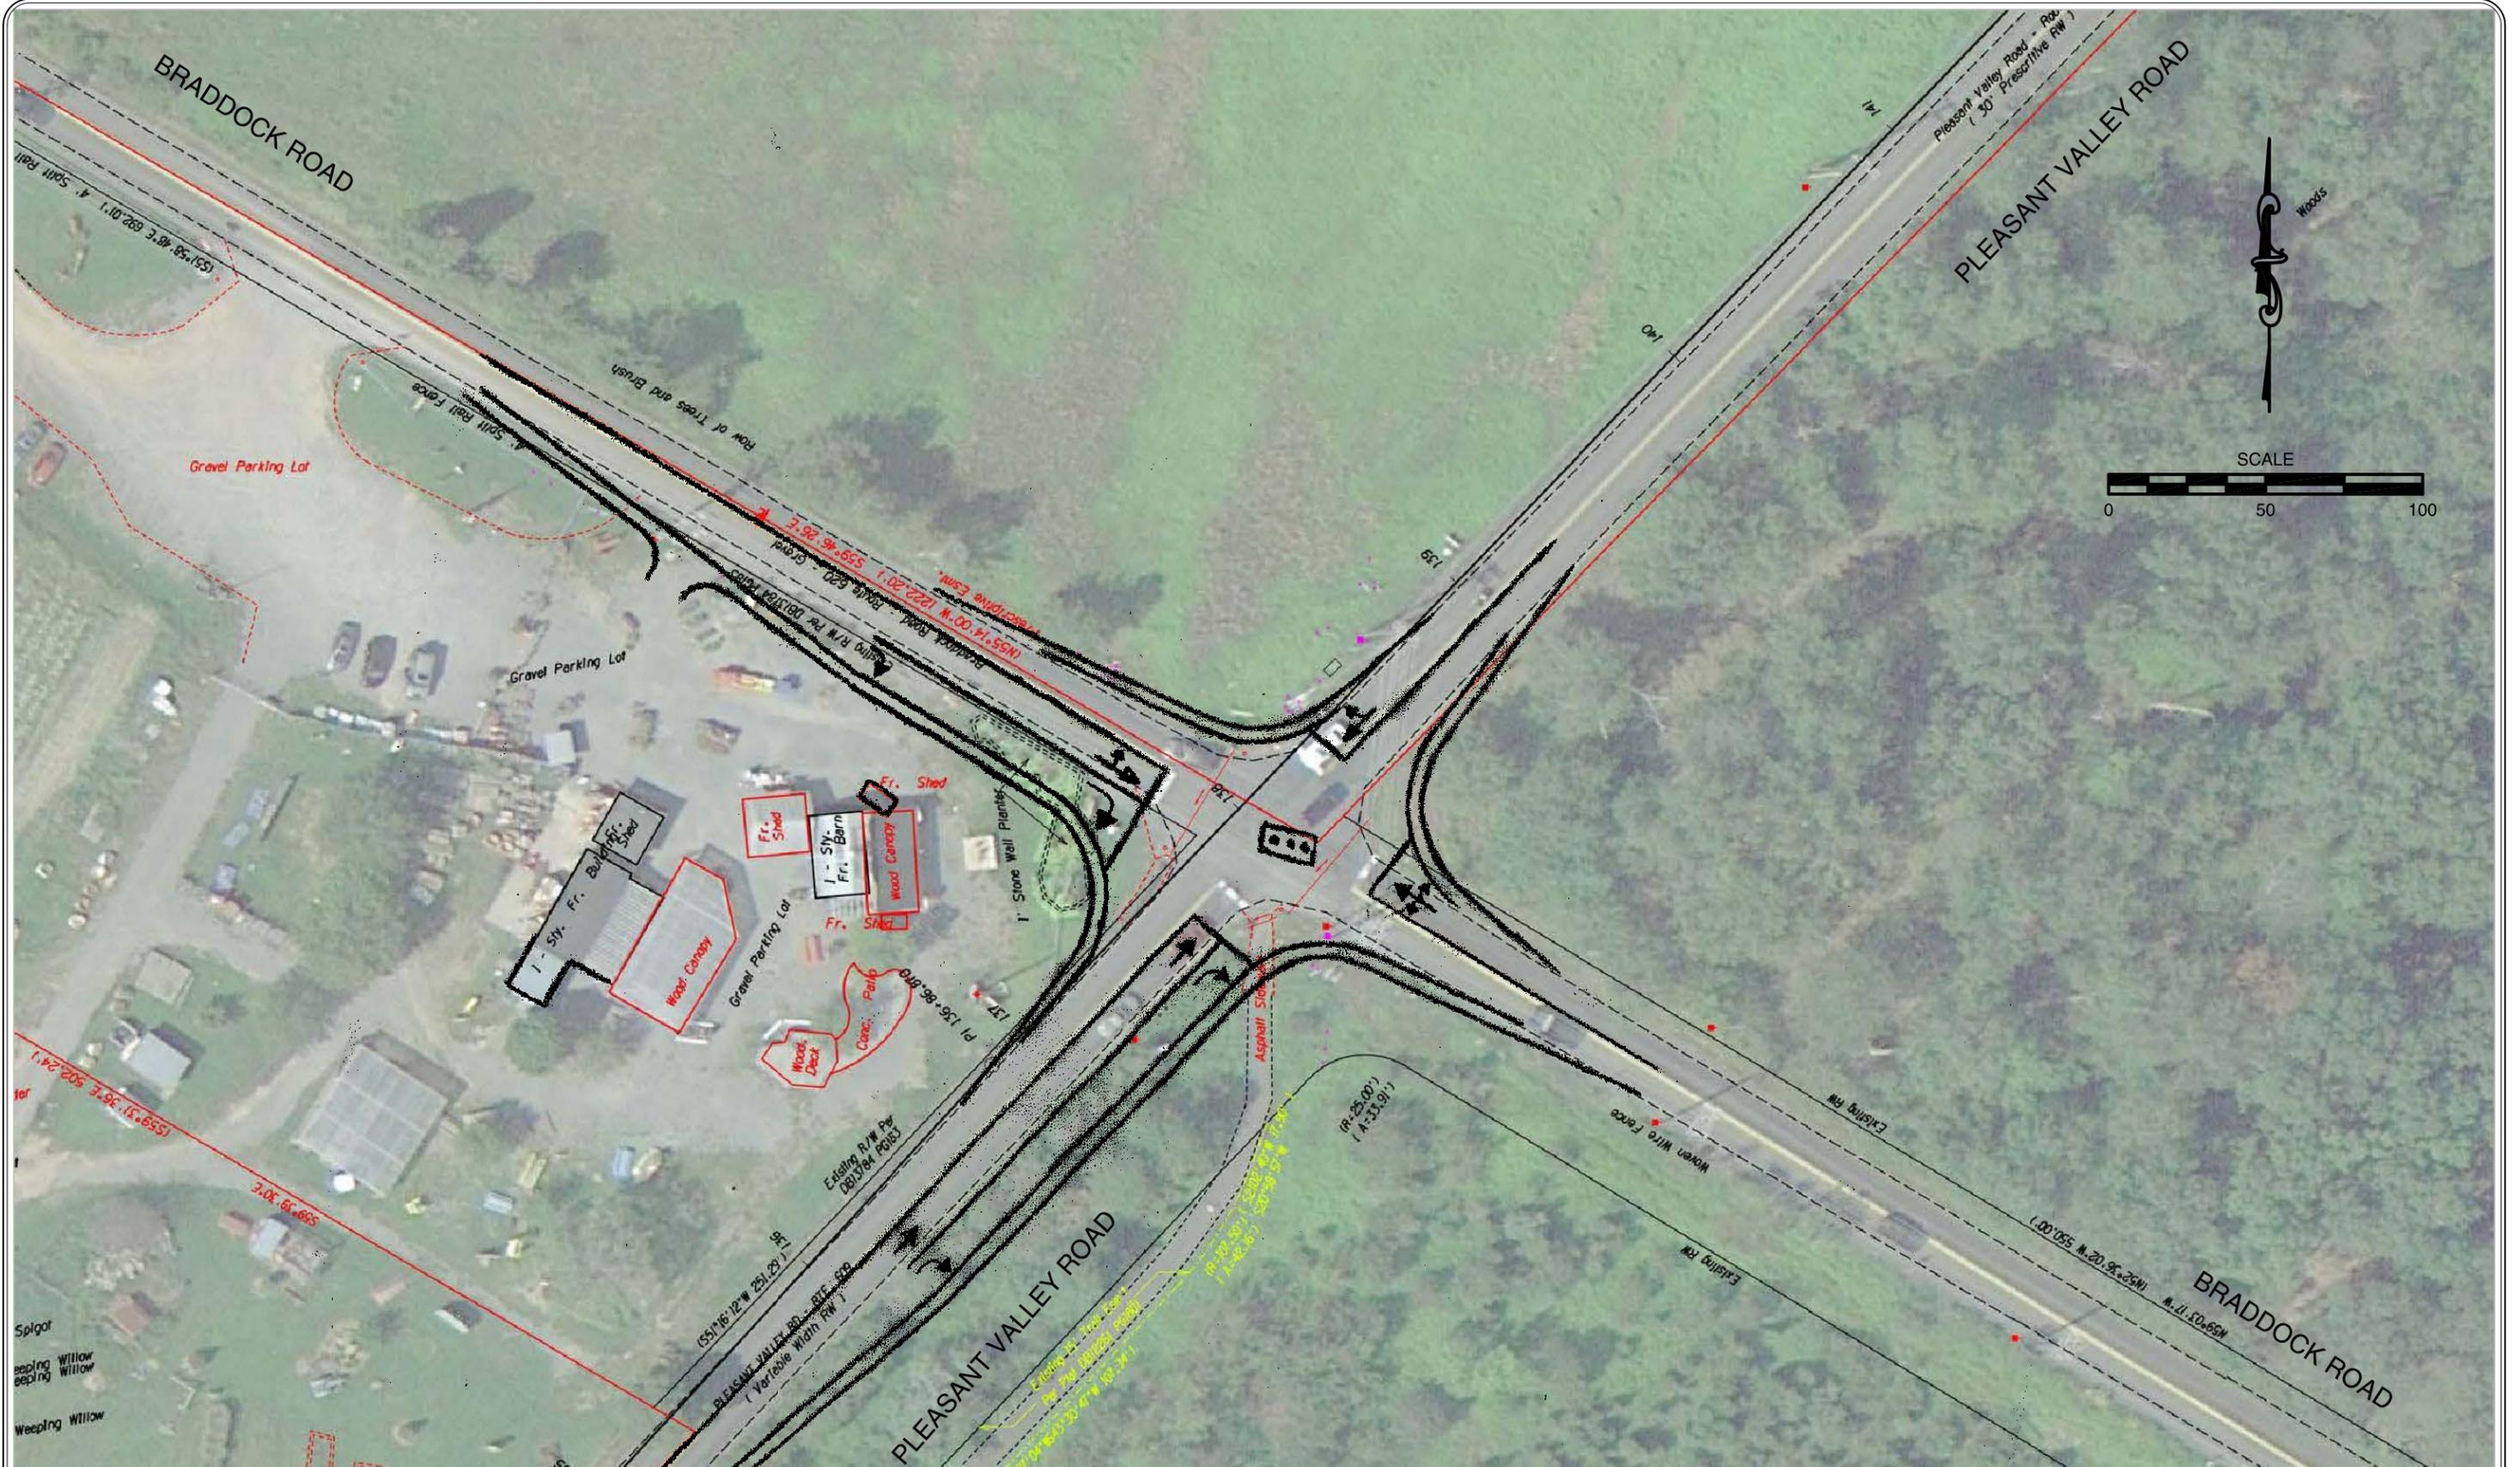
TRAFFIC SIGNAL WITH AUXILIARY TURN LANES (NB & SB LEFT-TURNS RESTRICTED) ALTERNATIVE BRADDOCK ROAD/PLEASANT VALLEY ROAD FAIRFAX COUNTY, VIRGINIA

The traffic signal with restricted northbound and southbound left-turn movements operates at LOS A and LOS B during the weekday a.m. and p.m. peak hours with v/c ratios of 0.55 and 0.62, respectively. **Table 8** shows the 95th percentile queues for this alternative.
