# **SMA 2003 - Virginia's Implementation Effort and Results**

**Materials Division**

**August 2004**

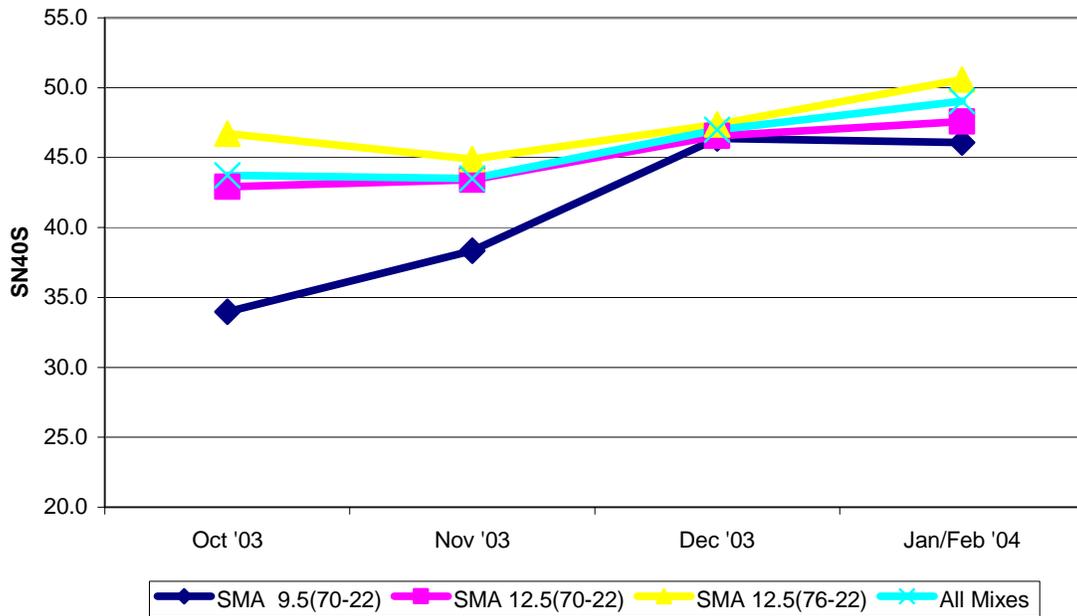
**Figure 1 – Friction (SN40S) Change with Accumulated Traffic/Weather.**

Figure 1 shows the average skid number for each mix type and month tested. As can be seen from the graph, the skid numbers for the PG70-22 surface mixes have essentially leveled off since December, while the PG76-22 mixes continued to show modest increases.

The most significant increases in skid number have occurred in the colder months, between November 2003 and February 2004. However, a steady increase in skid number has occurred during each month of testing.

Overall, the friction numbers are good and have continued to increase with time. The initial low readings on a few sites were conducted shortly after paving and have continued to increase as the traffic has begun to wear off the initial film thickness and expose more of the aggregate texture.

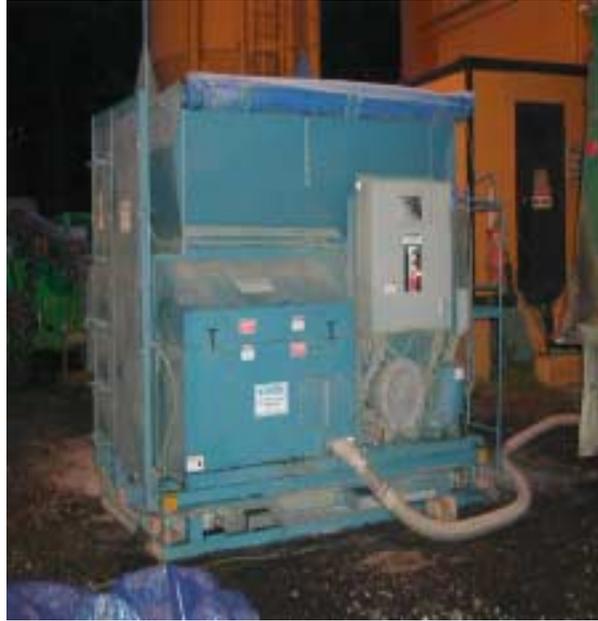
**Picture 1 – Fiber Machine**

The high liquid asphalt content of SMA mixtures typically requires the use of a fiber additive to increase the film thickness. Adding fiber at the plant presents a unique challenge. It requires the use of a “fiber dispersion” machine that is interlocked into the plant control system. Essentially, when the fiber machine either runs out of fiber material or breaks, the plant is shutdown automatically. This past year, there were two distinct problems noted. One problem was equipment breakdown, which can be expected but will result in lost production. The other problem encountered was clogging of the feed line for the fibers. The cause was typically the result of a “kinked” line, which would not allow flow of the fibers. In order to reduce the possibility of this happening, it is recommended that the amount of bends in the line be minimized. In addition, a clear piece of tube can be strategically placed in the line to assure visually that the fibers are flowing freely. On night paving, one Contractor placed a light behind the line, which allowed the plant operator to view the fiber flow.

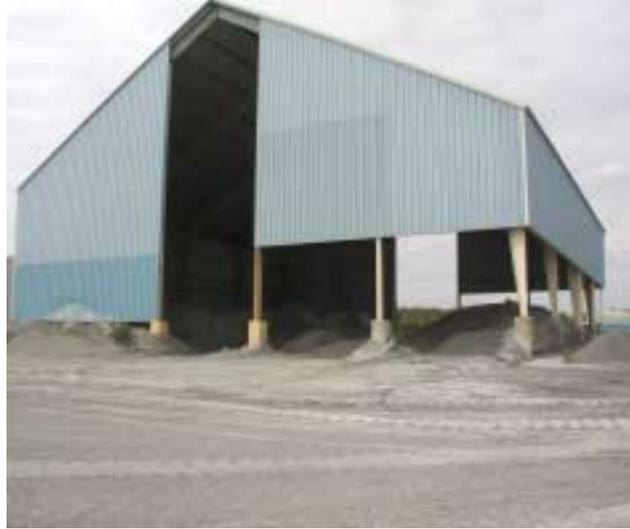
**Picture 2 – Storage Facility to Protect Mineral Filler**

Mineral filler is used in conjunction with the binder to form an asphalt mastic/mortar. The material is a very fine graded material that has a tendency to retain moisture. Therefore, it is very important to store this material in a manner to reduce the chance of moisture infiltration. Typically, Contractors have used tarps to cover the mineral filler stockpile. Although the tarps work when covering the stockpiles, there have been occasions when during production, a rainstorm has occurred before the stockpile could be covered. Once the material becomes wet, it is very difficult and in some cases impossible to dry it to a point where it will not be detrimental to the mix. What some contractors are doing now is utilizing sheds to store the mineral filler.

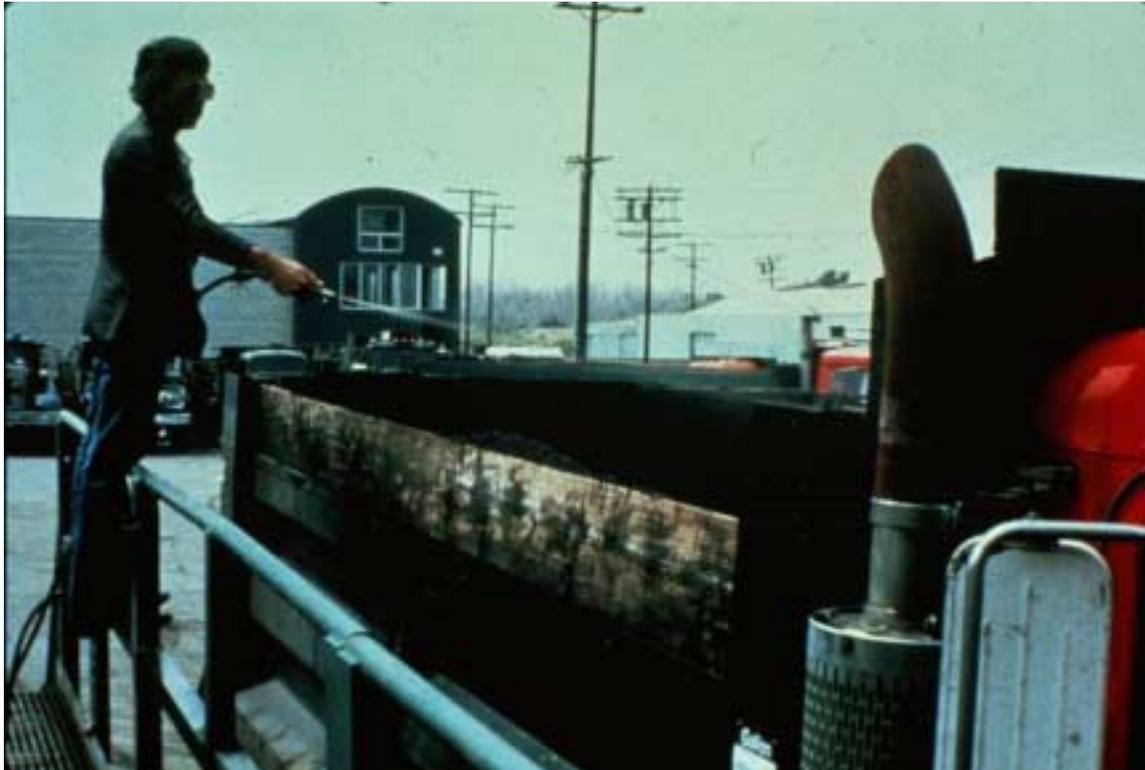
**Picture 4 – Application of Release Agent**

As with conventional HMA mixes, a release agent is required to coat the haul-truck bed in order to assure the mixture will not stick to it. The “sticky” nature of SMA mixtures makes this practice even more important. In spite of these requirements, there were cases in which the release agent or its application was not completely successful and drivers were required to spend

excessive amounts of time cleaning truck beds. Unfortunately, there were reported cases of drivers resorting to diesel fuel as the release agent, which is not an acceptable practice, whether it is for SMA or conventional mixes. Consequently, it is recommended that producers not load a truck that has used diesel fuel as the release agent. If the truck is already loaded, then the material should be placed in the RAP pile. If approved release agents are not functioning adequately, then No. 10 screenings can be used to dust the truck bed in order to aid in the release of the SMA.

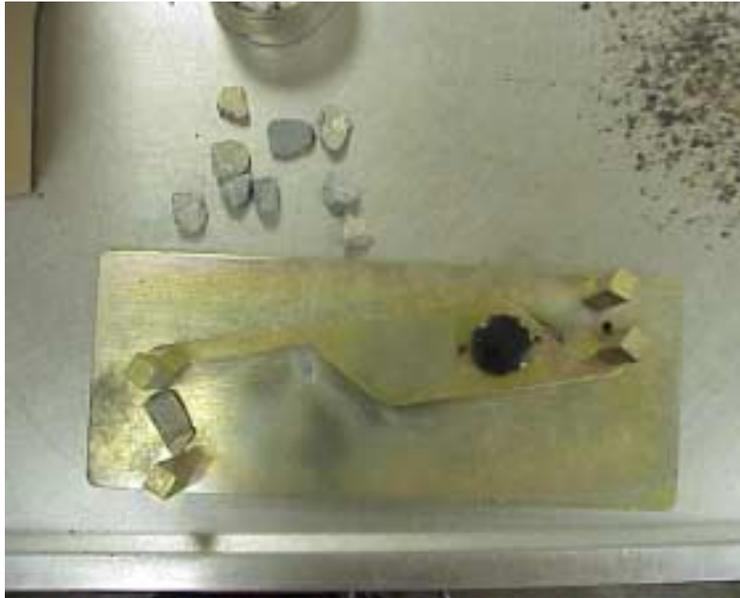
**Picture 5 – F&E Testing Device**

During the 2003 paving season, the growing pains associated with expanded SMA application were not strictly limited to the asphalt producers. Before and during the season, the flat and elongated criteria presented challenges for some coarse aggregate producers. In order to meet the SMA criteria, modifications to existing processes and in some cases, additional equipment was required. Modifications included changing/adjusting stone screens and reprocessing previously crushed stone. Additional equipment consisted of new crushers – vertical impact and cone.

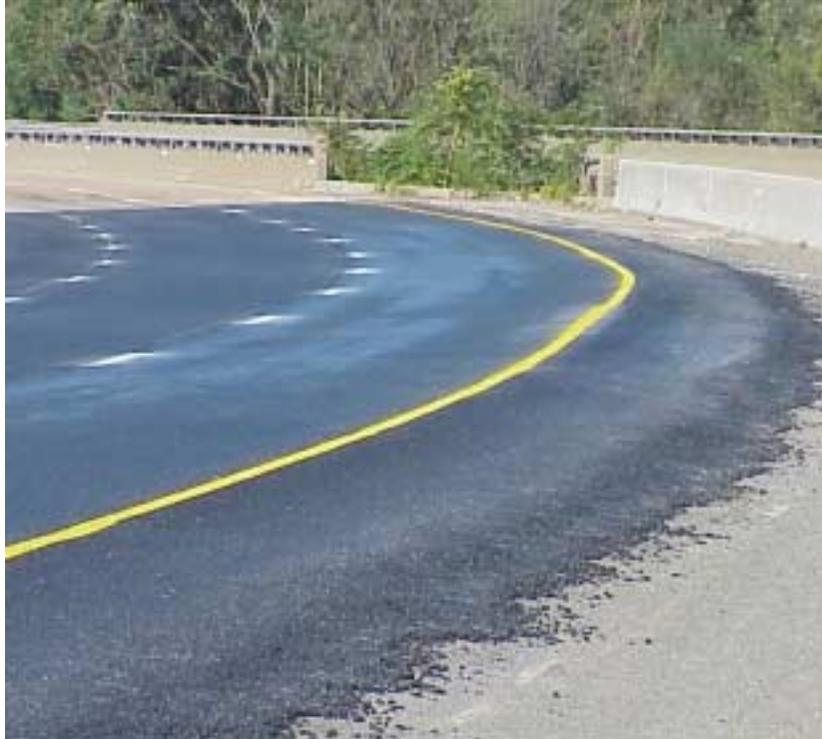
**Picture 6 – Flushing Pavement – Failure to “Waste” First Loads**

A recommended practice when starting to produce SMA is to discard the first loads of material in order to allow the plant to “settle.” The number of loads that were discarded ranged from three to six before shipping material to the road. The picture below illustrates the flushing/segregation that can result if the first loads are not discarded.

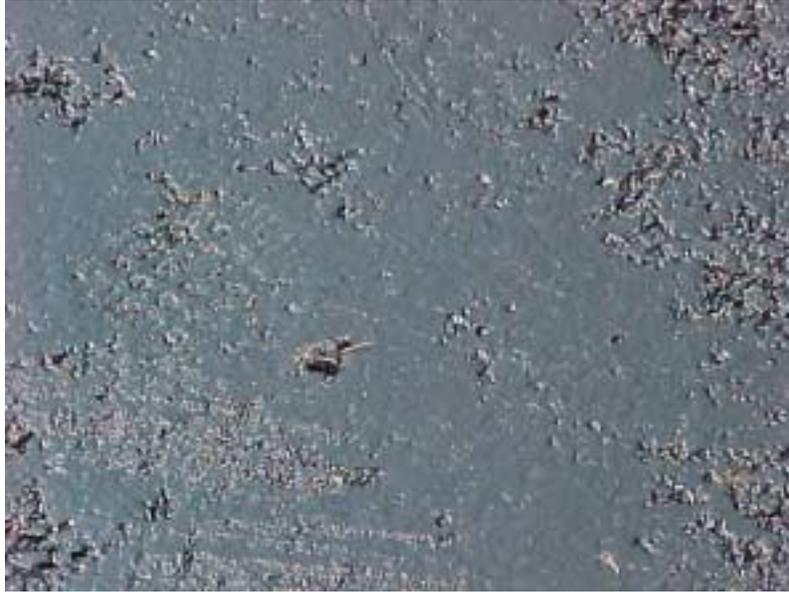
**Picture 7 – Close-Up of Flushing – Excessive Moisture in Mineral Filler**

As mentioned before, it is important to keep the mineral filler dry. If the mineral filler becomes wet and is introduced into the mixture, the moisture present will become part of the finished mixture. The result will be flushed areas of various extents, and a consequential loss in supplied friction.

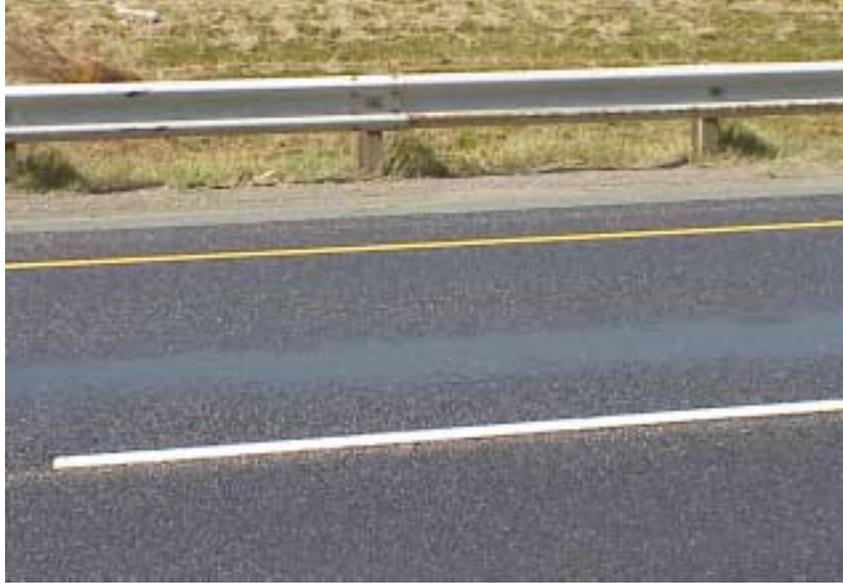
**Picture 8 – Flushing Isolated In Wheelpath After Placement**

There was an instance this past season in which the fat spots were large, repeated, and confined to the right wheel path. Follow-up investigation failed to yield any conclusive results as to the cause of the flushing. Speculation was that a build-up of excess fines and asphalt might have been distributed consistently to the right side of the paver. A hydraulic leak of the paver or MTV was also a possibility. Some areas were severe enough to require correction to improve friction values. In this instance, pavement-marking eradicators were used to remove the excessive fine material from the surface.

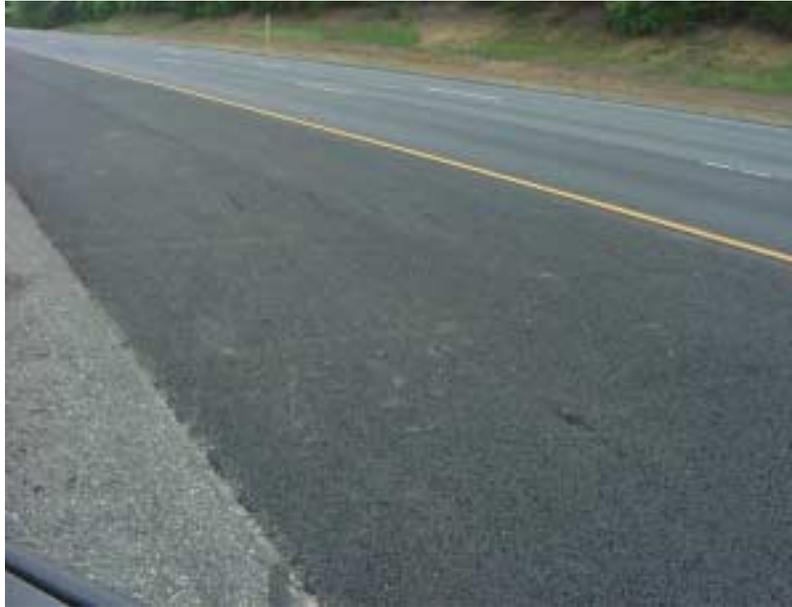
**Picture 10 – Roller Pick-Up**

Roller pick-up with SMA can easily happen due to the “sticky” asphalt mastic and high mix temperature at time of placement. Therefore, it is essential to have a properly operating spray bar on the roller and to ensure that there is adequate water supply. Some contractors have indicated that they have added powdered soap to the water to prevent the mixture from sticking to the roller. Even in doing so, there have been cases of roller pick-up on SMA. In these situations, it is

important to stop the roller, clean it, and check the water supply. Continuing on without cleaning will result in additional pickup and a marred surface.

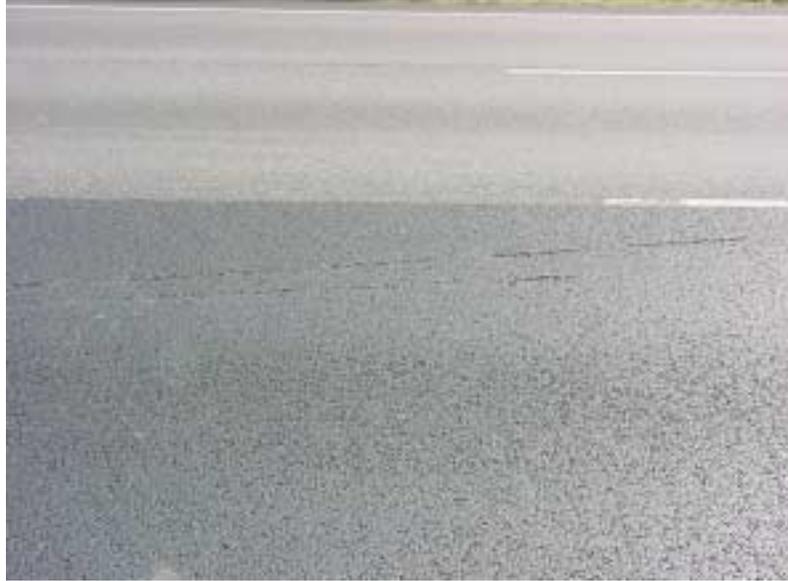
**Picture 11 – Roller Marks in Mat**

When compacting an SMA, aggregate interlock should take place within the first two to three passes of the roller. There should be virtually no visible “roll down” beyond these passes. If on subsequent passes, a continued “roll down” is observed, an investigation of the mix should be performed immediately because the aggregate is not interlocking. If after final rolling of the mat is performed and roller marks are still present, then an investigation of lab results should be done to ensure that the stone-on-stone contact was achieved (i.e., is  $VCA_{mix}$  less than  $VCA_{drc}$ ?).

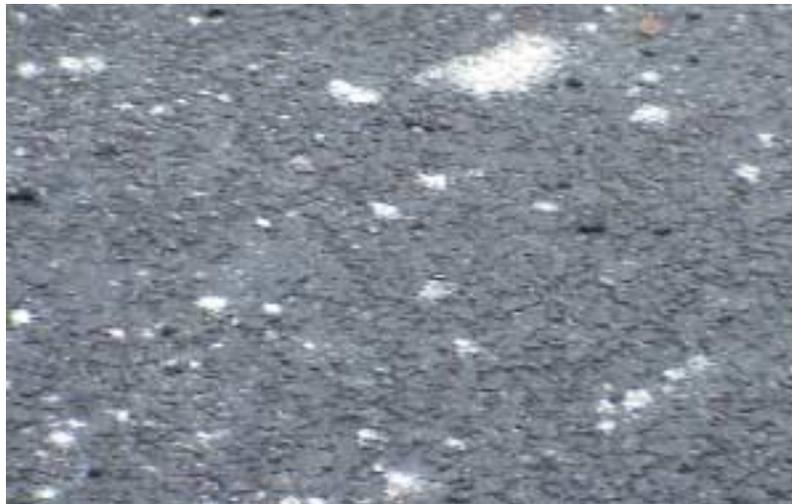
**Picture 12 – Fractured Aggregate – Surface**

Currently, specifications allow for no more than three vibratory passes in the high frequency, low amplitude mode. During the 2003 season, the standard number of vibratory passes observed consistently was two. There were some cases where the roller was set in the high frequency, high amplitude setting to try to achieve density. In these cases, the result was fractured aggregate. If the fracturing of the aggregate penetrates beyond the surface, then the load carrying capability of the mix has been compromised. Fractured aggregate on the surface could lead to popouts.
