**Post-tensioned Gout Update (Design,
Specifications, Material & Construction)**
Virginia Concrete Conference March 8, 2013

Michael Sprinkel, P.E.

Claude Napier, P. E.

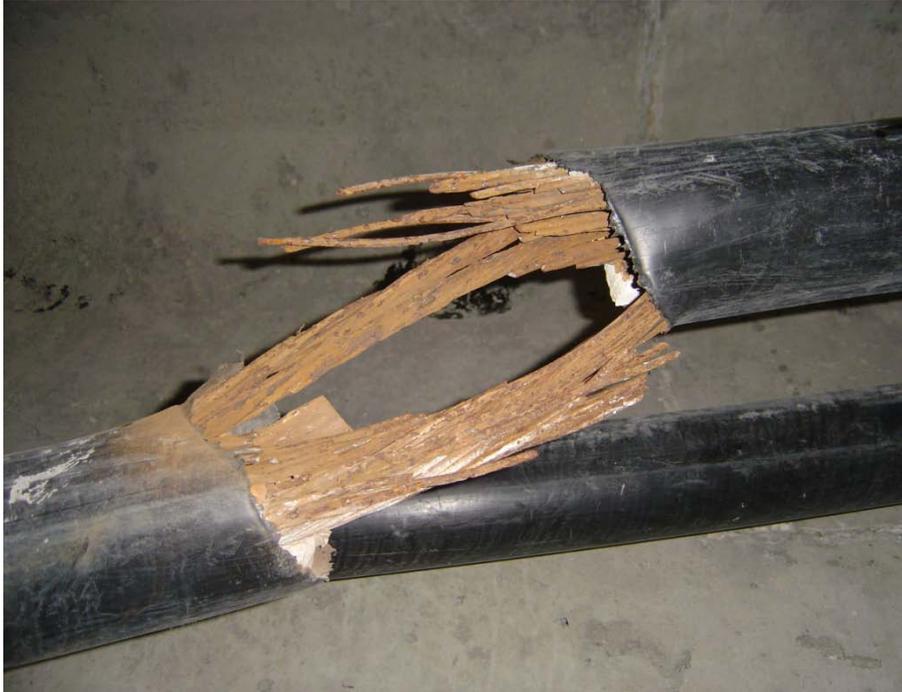
Photo – PT Tendon Failure, May 22, 2007

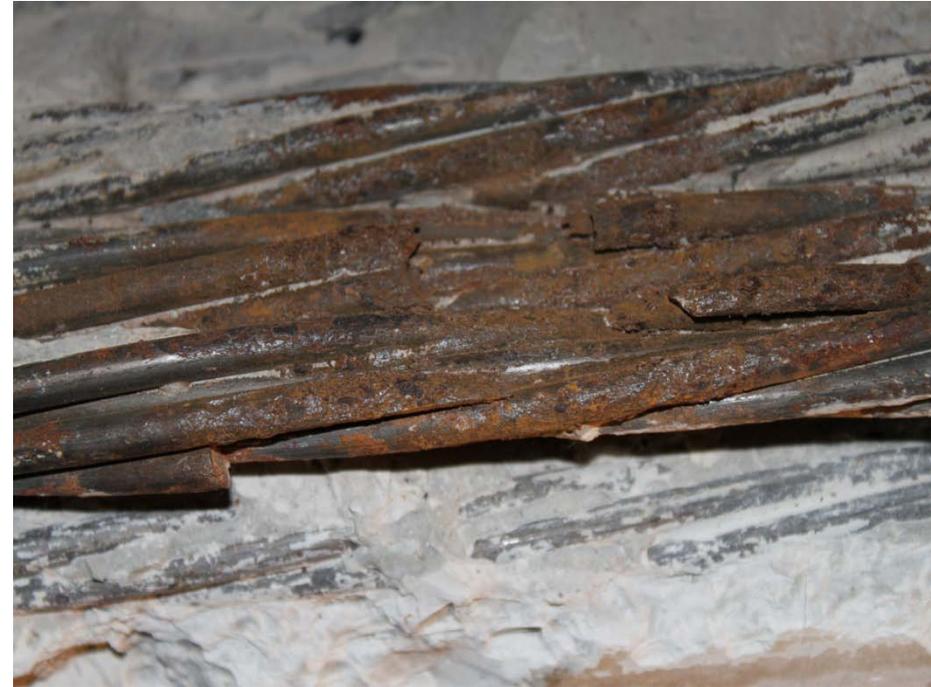
Photo – 3 Broken Wires on Tendon, November 28, 2012

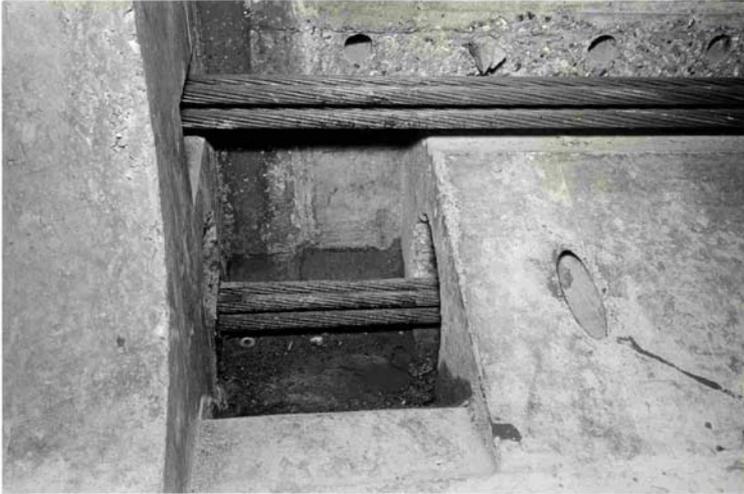
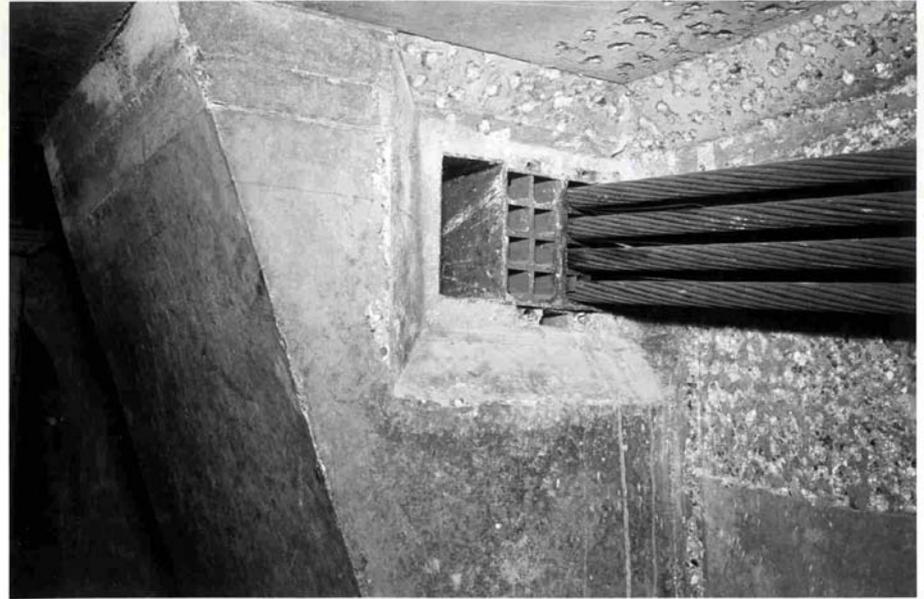
BELOW: SUPERSTRUCTURE - Unit Mk. 18A in span AB. East end of South 10" duct in inner compartment. One group of cables reeved and stressed. Saddle type S5/A in cantilever unit Mk. 19A for lower group of cables only. Slip strips visible through saddle.
Photo: Munsell No. 2/49/5 - 26.1.61

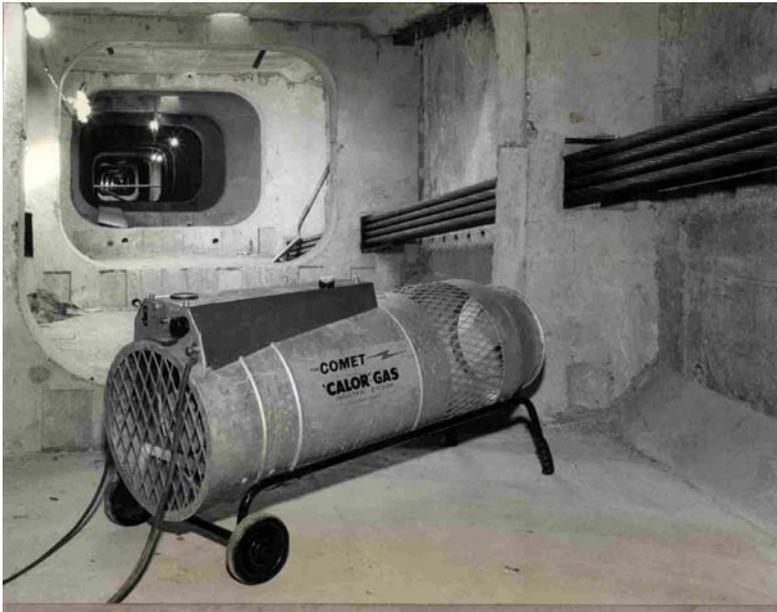
ABOVE: SUPERSTRUCTURE - Unit Mk. 28, centre compartment. First of three groups reeved and stressed.
Photo: Munsell No. 2/48/5 - 26.1.61

ABOVE: SUPERSTRUCTURE - Interior of spine beam showing stressed cables and heater used during jointing in cold weather. Photo: W.J. Longland.

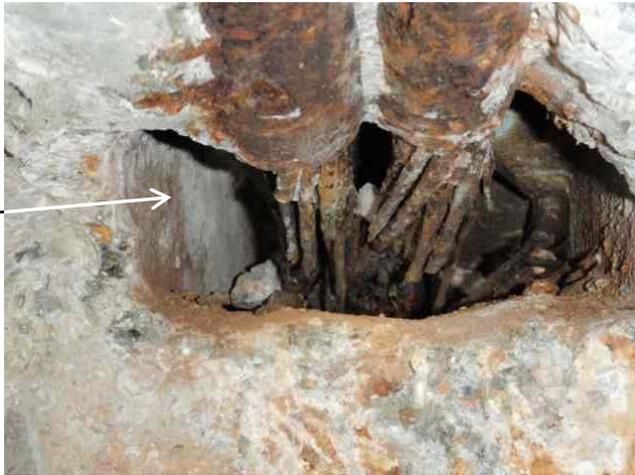
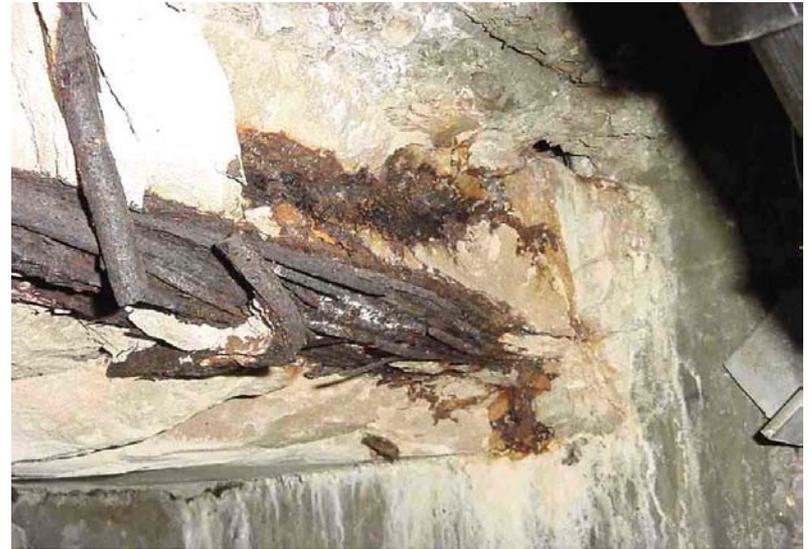
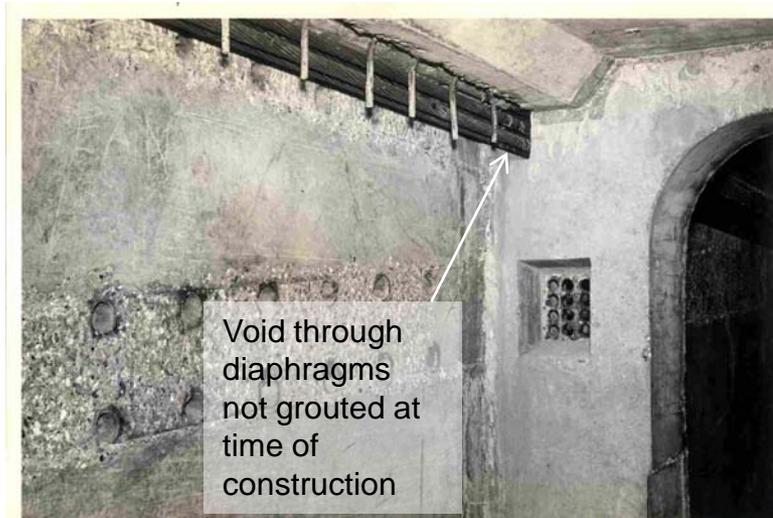
Tendons before encasing in grout boxes

Corrosion concentrated at un-grouted voids through diaphragms

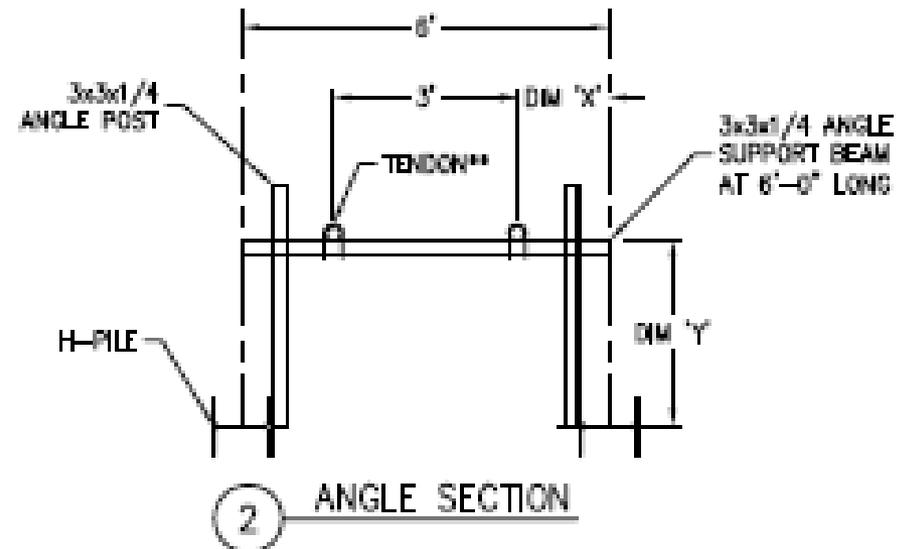
** TENDONS ARE TO BE TIED DOWN TO SUPPORTING BEAMS WITH STANDARD REBAR TIE WIRE

Tendon Mock up longitudinal sections

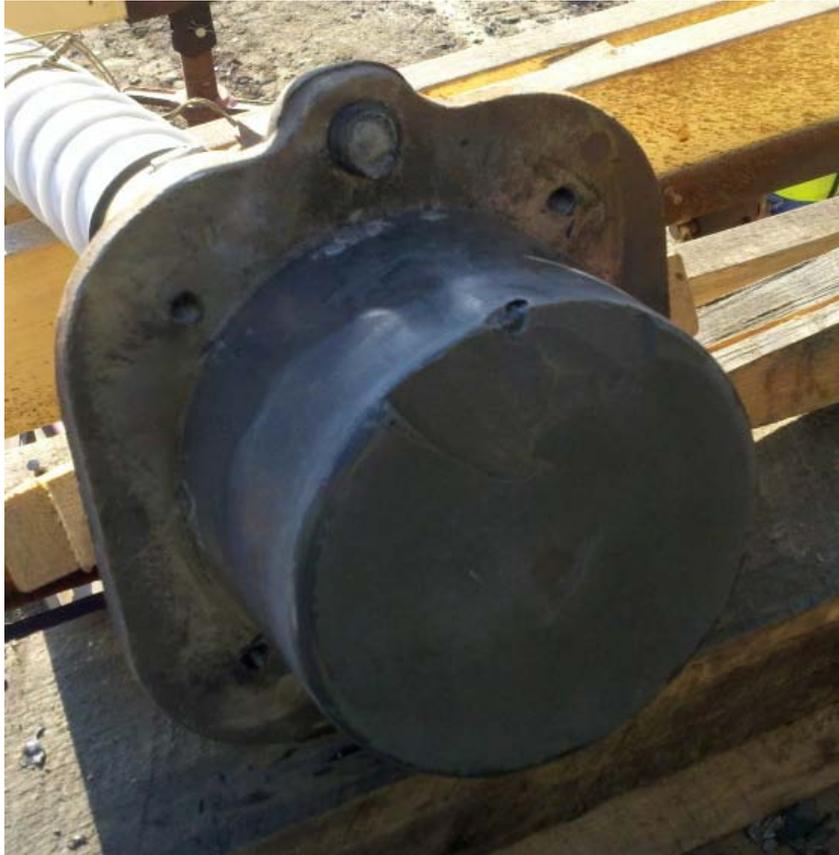
Grout 1 no void or soft grout

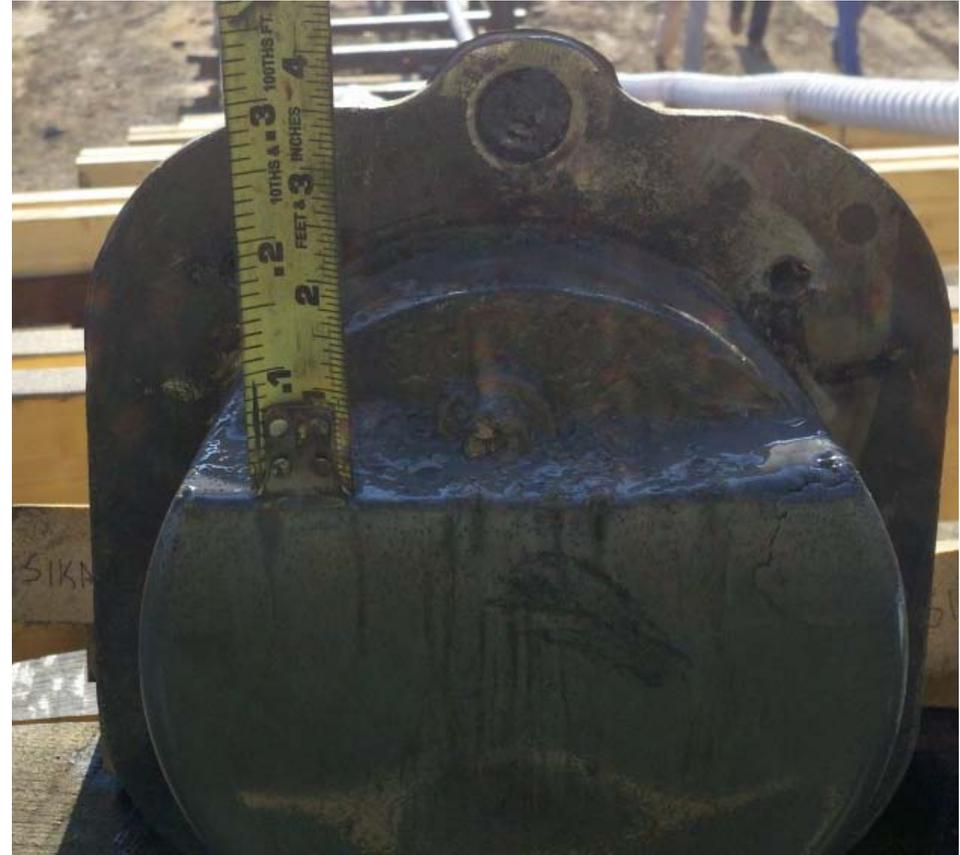
Grout 2 void and soft grout

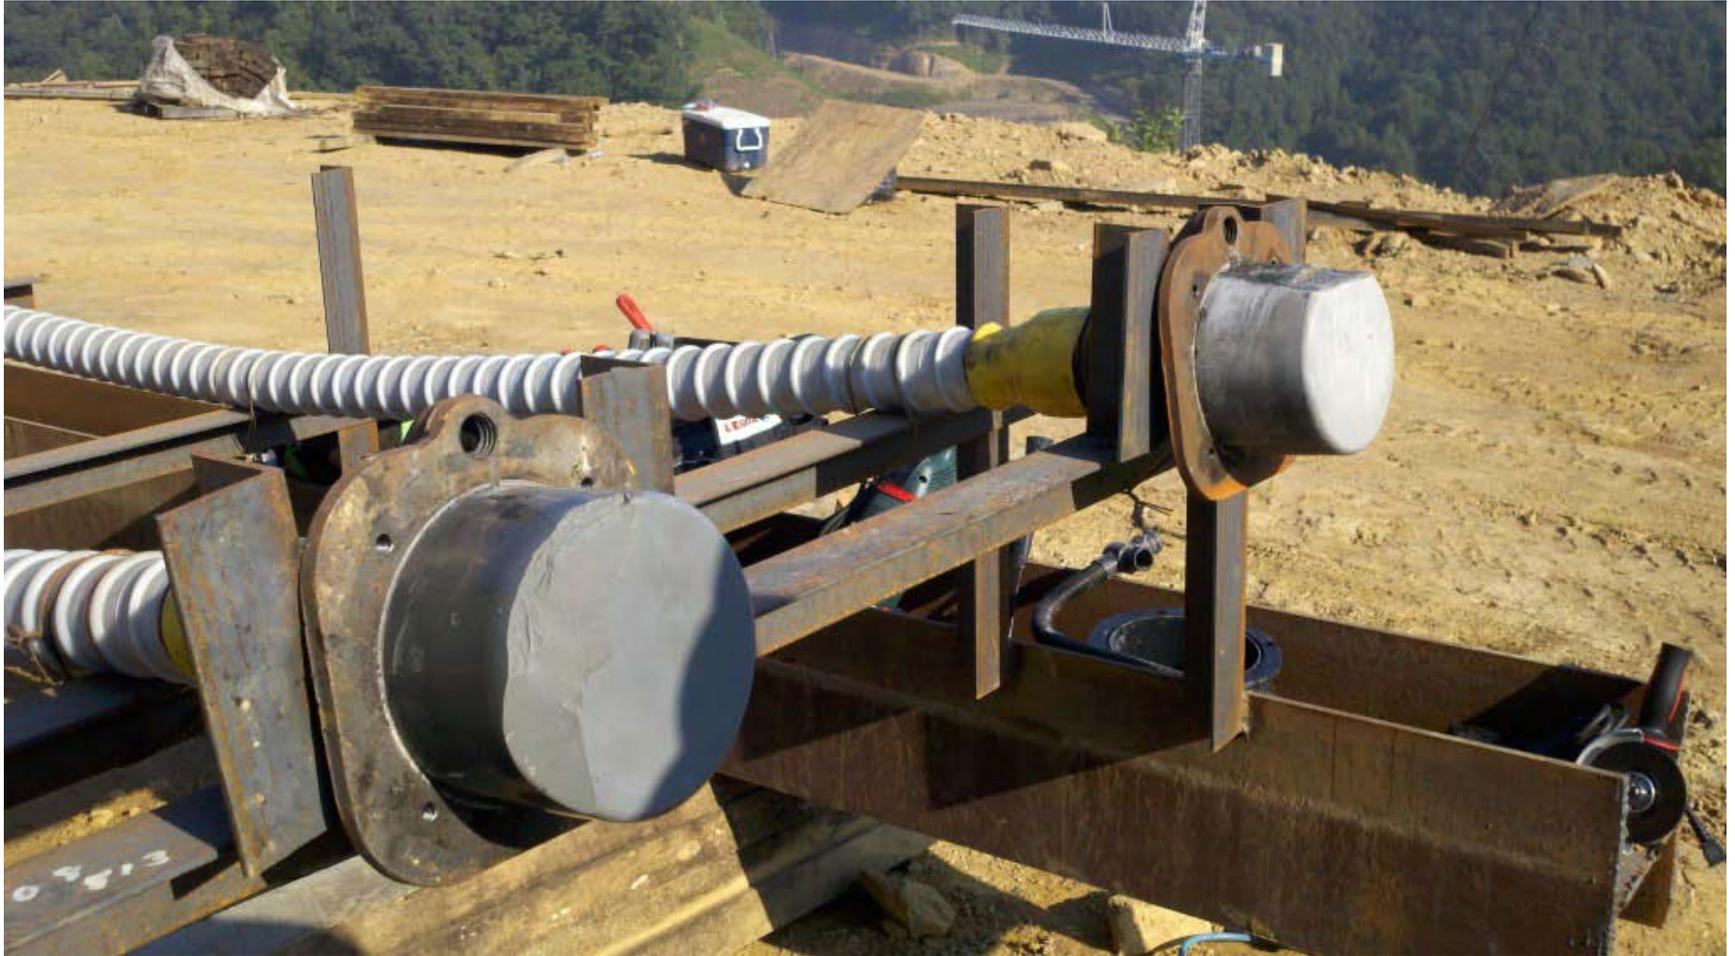
US 460 Tendon Mock up inlet end caps

grout 1 no void or soft grout, grout 2 void and soft grout

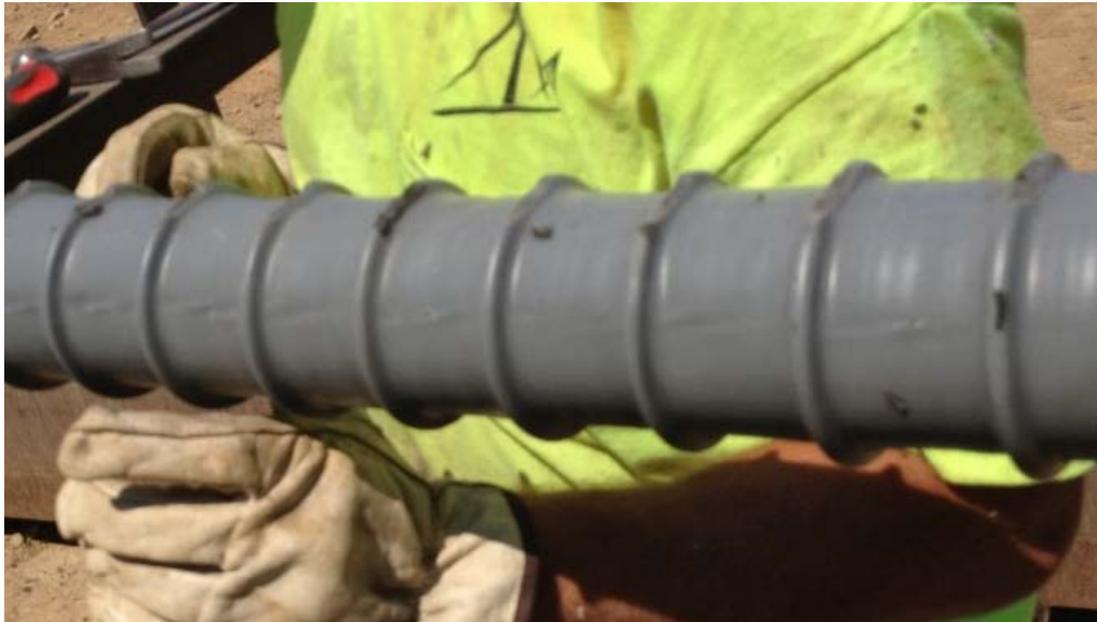
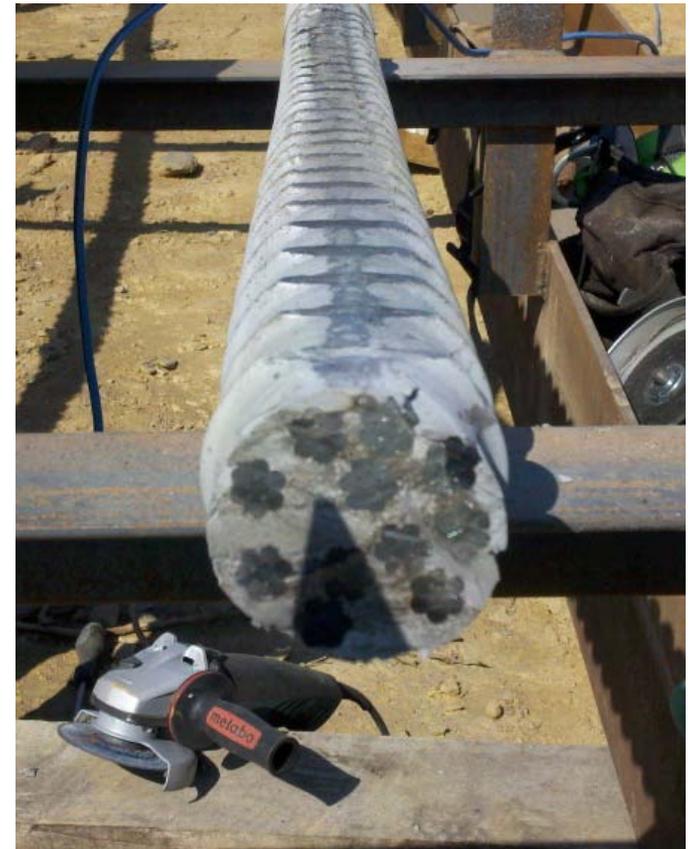
US 460 Tendon Mock up

grout 1 provides filled tendon
grout 2 leaves void on top

- 2012: Mockup for US 460 segmental bridge identifies voids, segregation and soft grout in tendon grouted with an approved HPG.

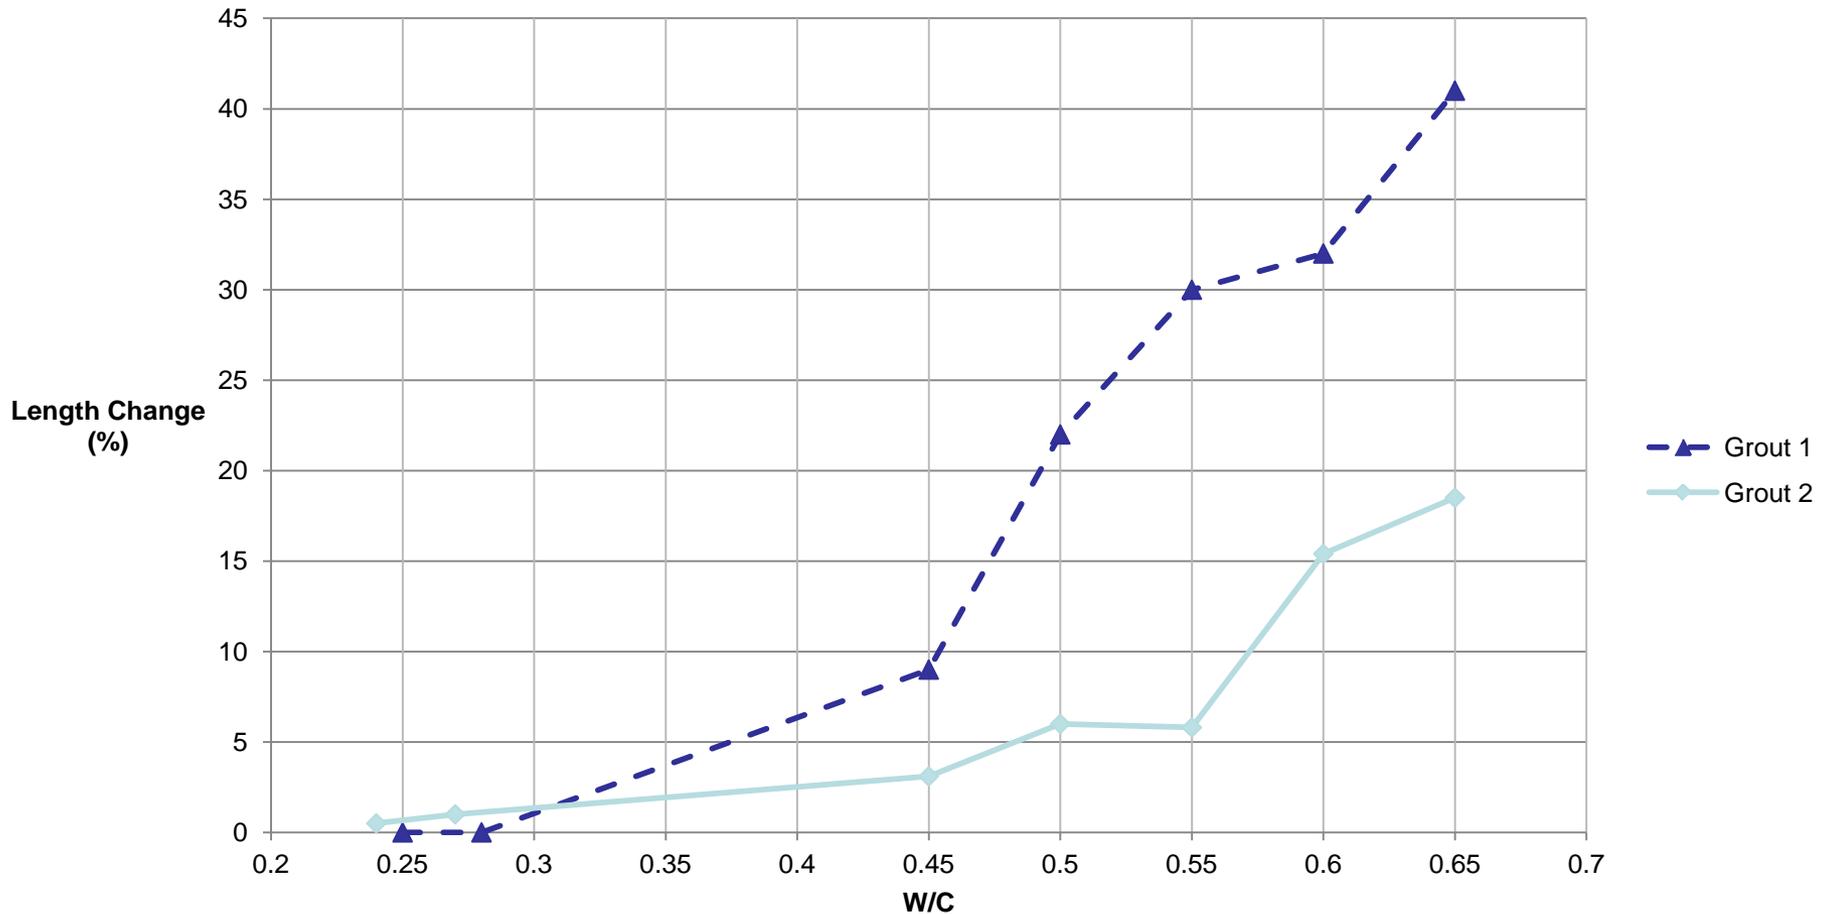
Length Change Tests @ VCTIR

Length Changes from 4x8-in cylinders

- Tests were conducted to determine the effect of grout water content on the segregation, length change and compressive strength of 2 HPG.

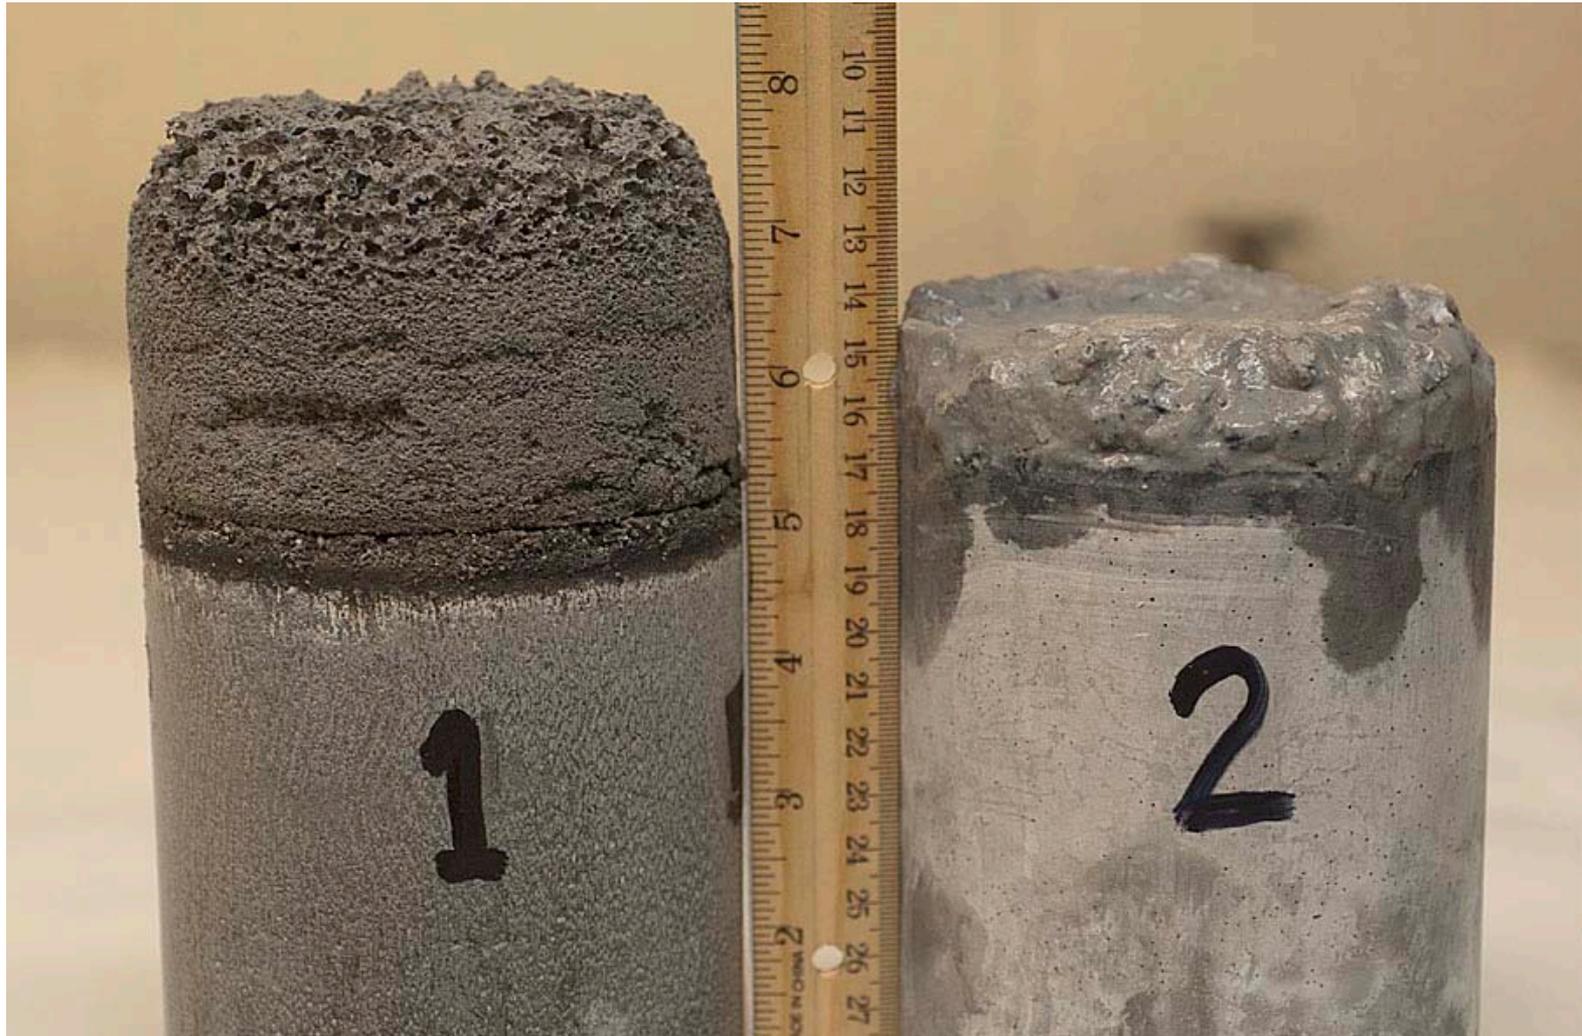
Length Change Tests with $w/b = 0.65$

Both HPG are badly segregated

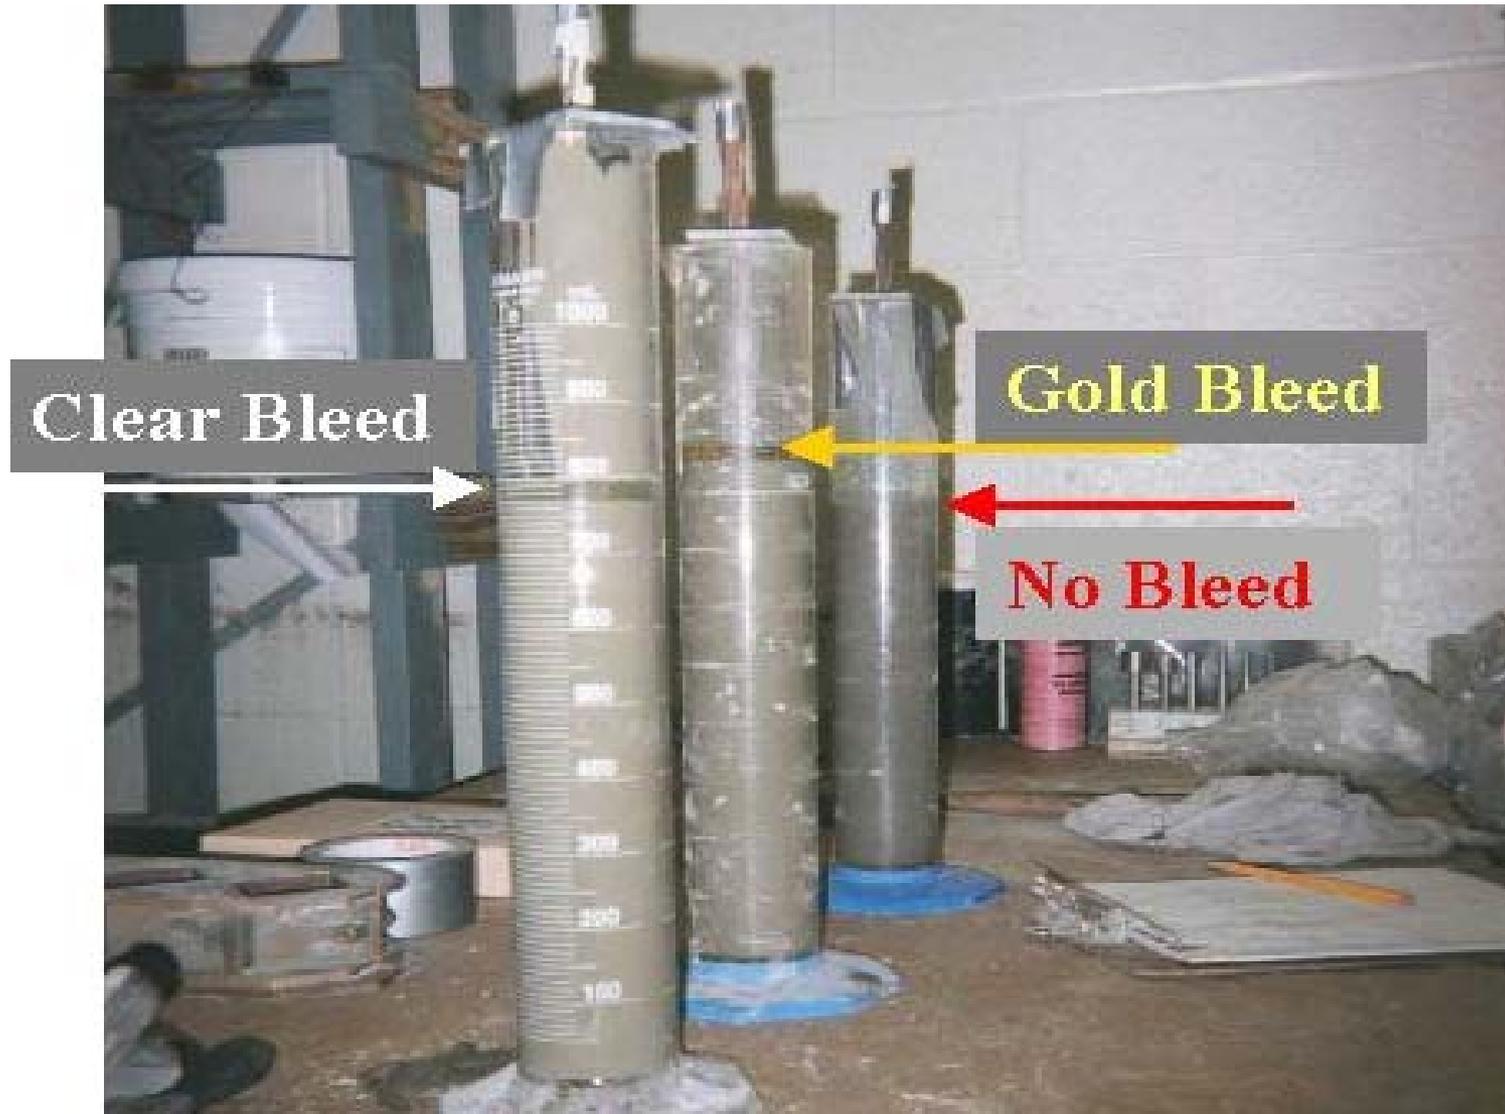
Wick Induced Bleed Test

cement and water, aluminum powder, high performance prepackaged grout (R. Gulyas)

- Prior to 1995 grouts bleed and segregate.
- Bleed water evaporates and leaves a void.
- Strands in the voids are not protected by grout.
- Bleeding was approximately 4 percent in a properly batched grout ($w/c \leq 0.42$) prior to 1995.
- In a typical 150 ft long tendon 6 ft of void at the high points adjacent to the anchor plates in draped tendons is expected.

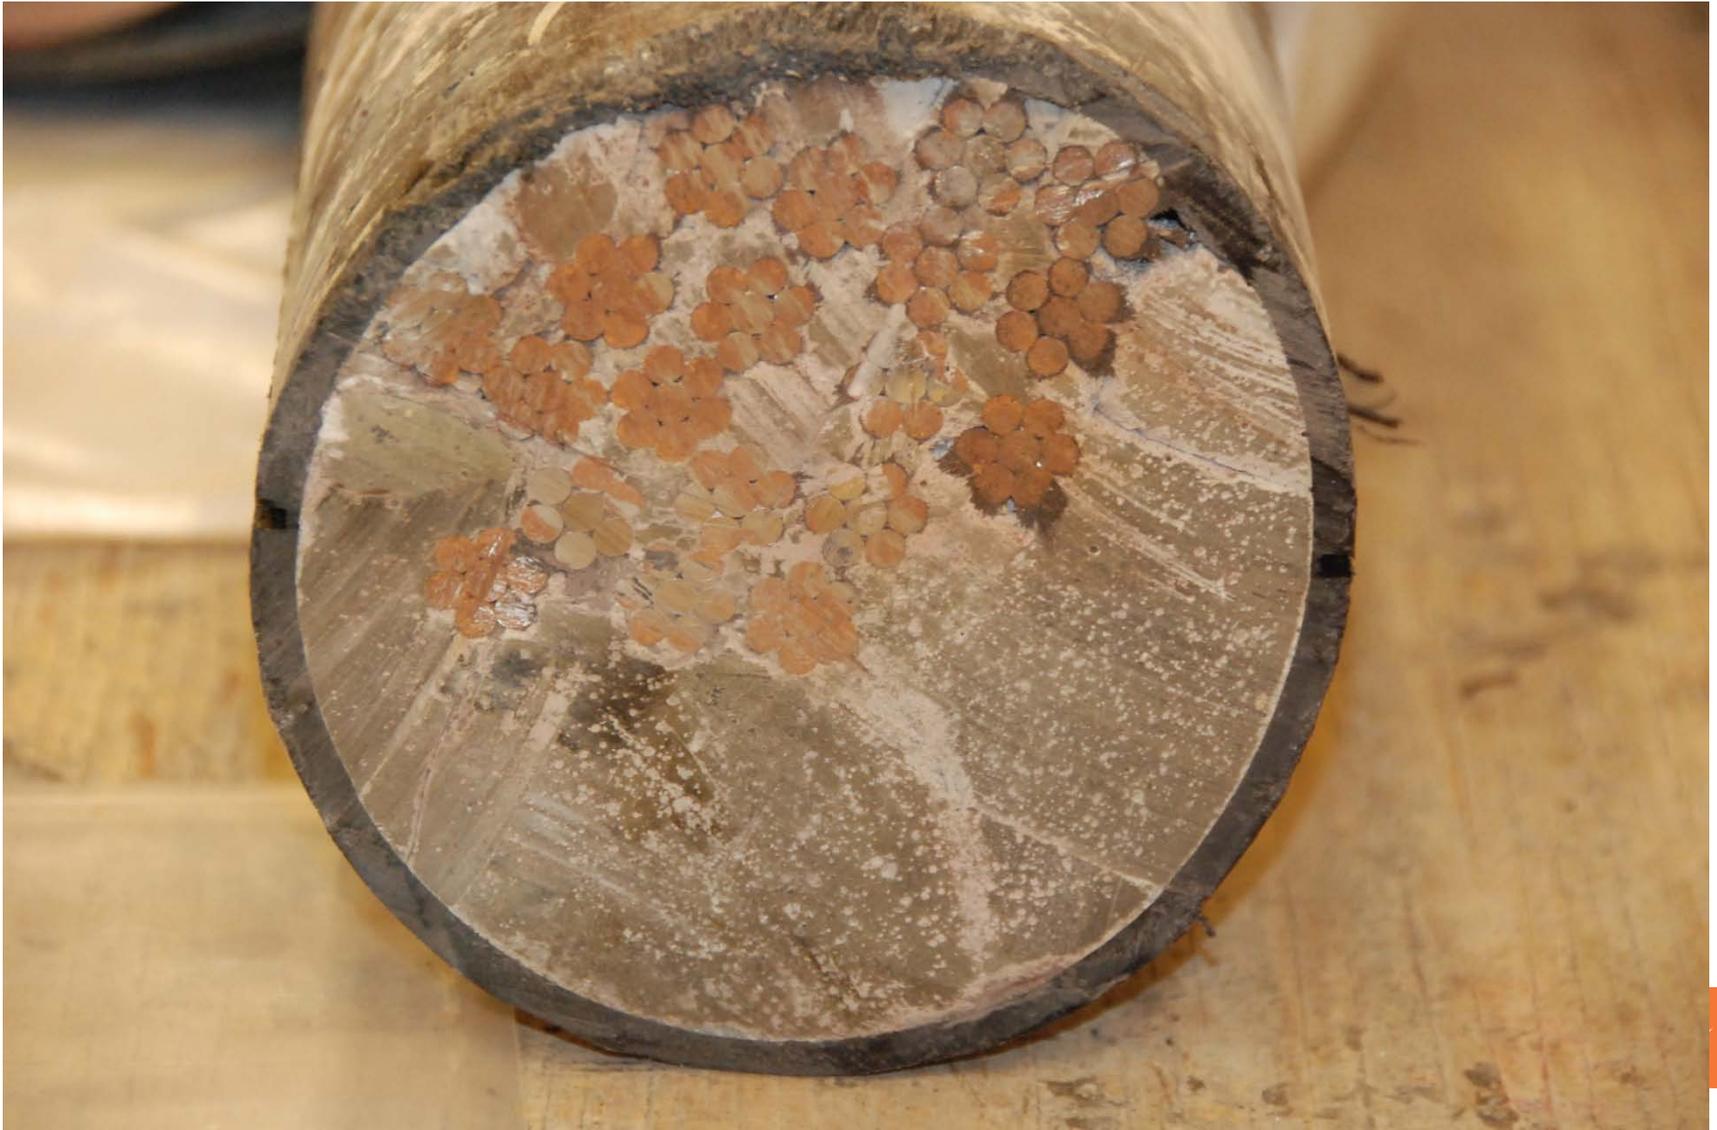
Design problem: Typical grouted draped tendon indicating it is not possible to surround upper strands with grout
