# US 460/US 19 CORRIDOR STUDY

US 460 from US 460 BUS to US 19;  
US 460/US 19 from US 460 to Route 637

Final Report

December 2018

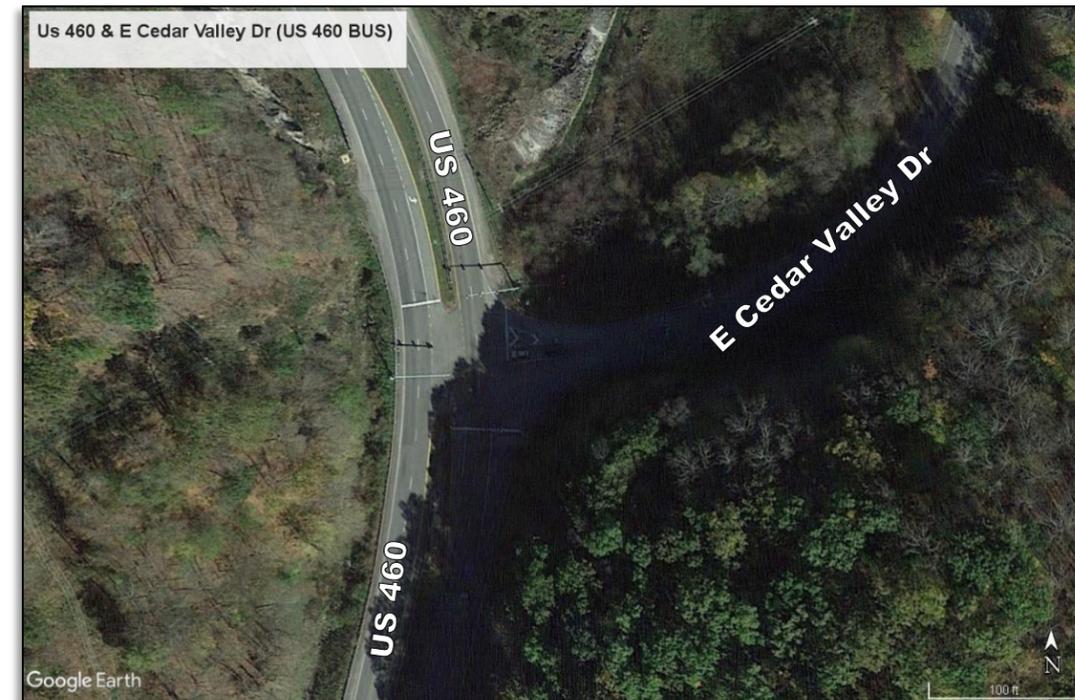
Figure 2: US 460 at E Cedar Valley Drive

E Cedar Valley Drive is classified as Minor Arterial per *VDOT Functional Classification*. The intersection of US 460 at E Cedar Valley Drive is a 3-leg T-signalized intersection. The posted speed limit for E Cedar Valley Drive is 35 miles per hour. The northbound approach of US 460 has two through lanes and one right-turn lane. The southbound approach has one left-turn lane and two through lanes. The westbound approach of E Cedar Valley Drive has one left-turn lane and one right-turn lane. The signal operations include protected left turns for the southbound approach. Pedestrian facilities (crosswalks, pedestrian signals) are not currently present at this intersection. **Figure 2** shows an aerial of the intersection.

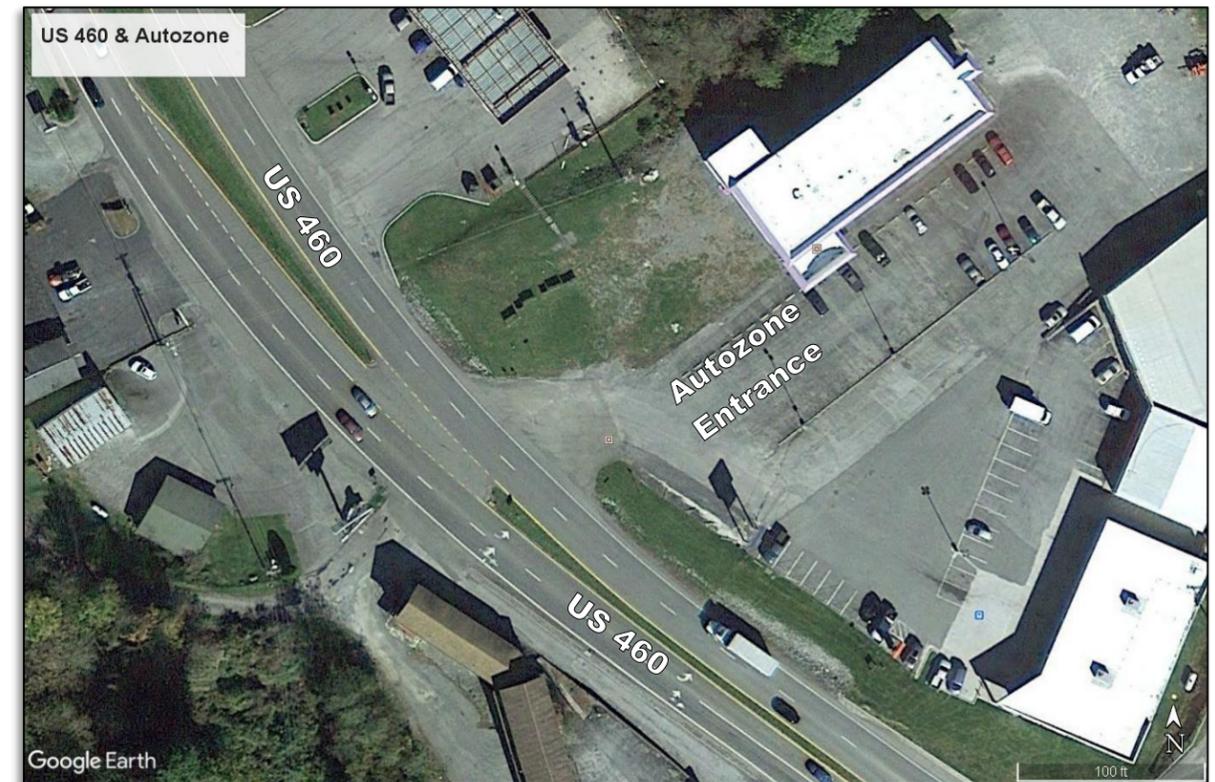
Figure 6: US 460 at Autozone Entrance

The intersection of US 460 at Autozone Entrance is currently a 3-leg unsignalized T-intersection at a median opening along US 460. The northbound and southbound approaches of US 460 are free-flow, while the westbound Autozone Entrance is stop-controlled. The northbound approach of US 460 has one through lane and one shared thru-right lane. The southbound approach has a shared U-turn-left-thru lane and two through lanes. The westbound approach of the Autozone Entrance has one shared left-right lane. No pedestrian facilities (crosswalks, pedestrian signals) are currently present at this intersection. **Figure 6** shows an aerial of the intersection.

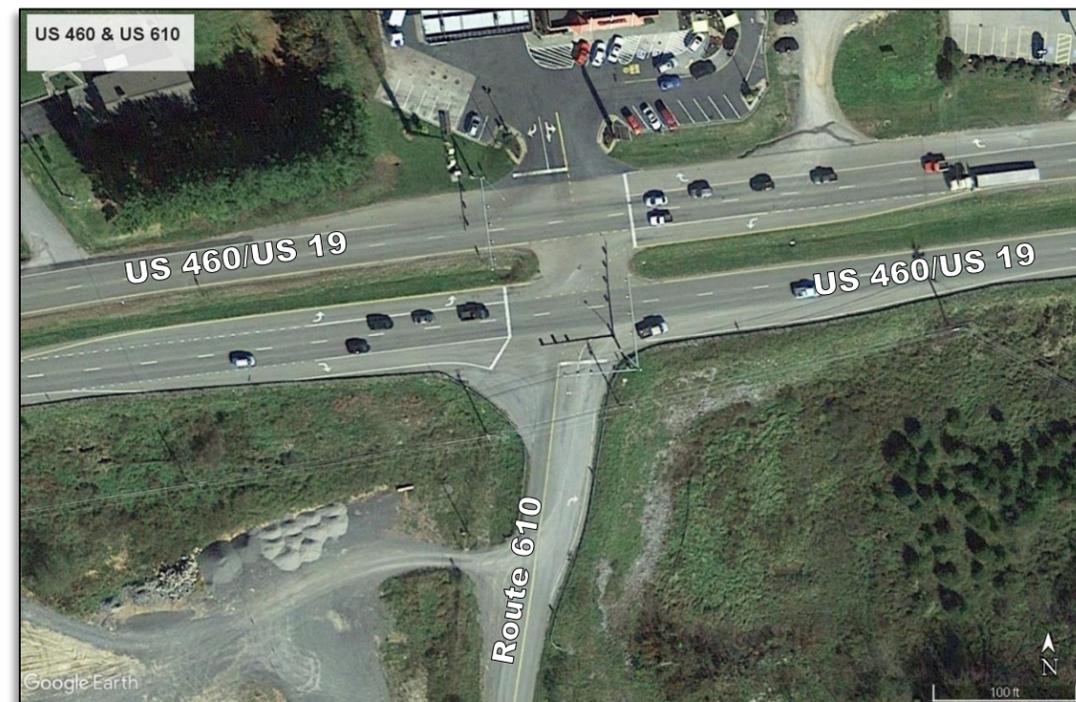
Figure 8: US 460/US 19 at Route 610

The intersection of US 460/US 19 at Route 610 is currently a 4-leg signalized intersection. The posted speed limit for Route 610 is 35 miles per hour. The northbound approach of Route 610 has one free-flowing right-turn lane with a receiving lane along east leg. The southbound approach, which primarily serves McDonald's restaurant has one shared left-thru lane and one right-turn lane. The eastbound approach of US 460/US 19 has one left-turn lane, two through lanes, and one right-turn lane. The westbound approach has one left-turn lane, two through lanes, and one right-turn lane. The signal operations include eastbound and westbound protected left-turn movements. Pedestrian facilities (crosswalks, pedestrian signals) are not provided for this intersection. **Figure 8** shows an aerial of the intersection.

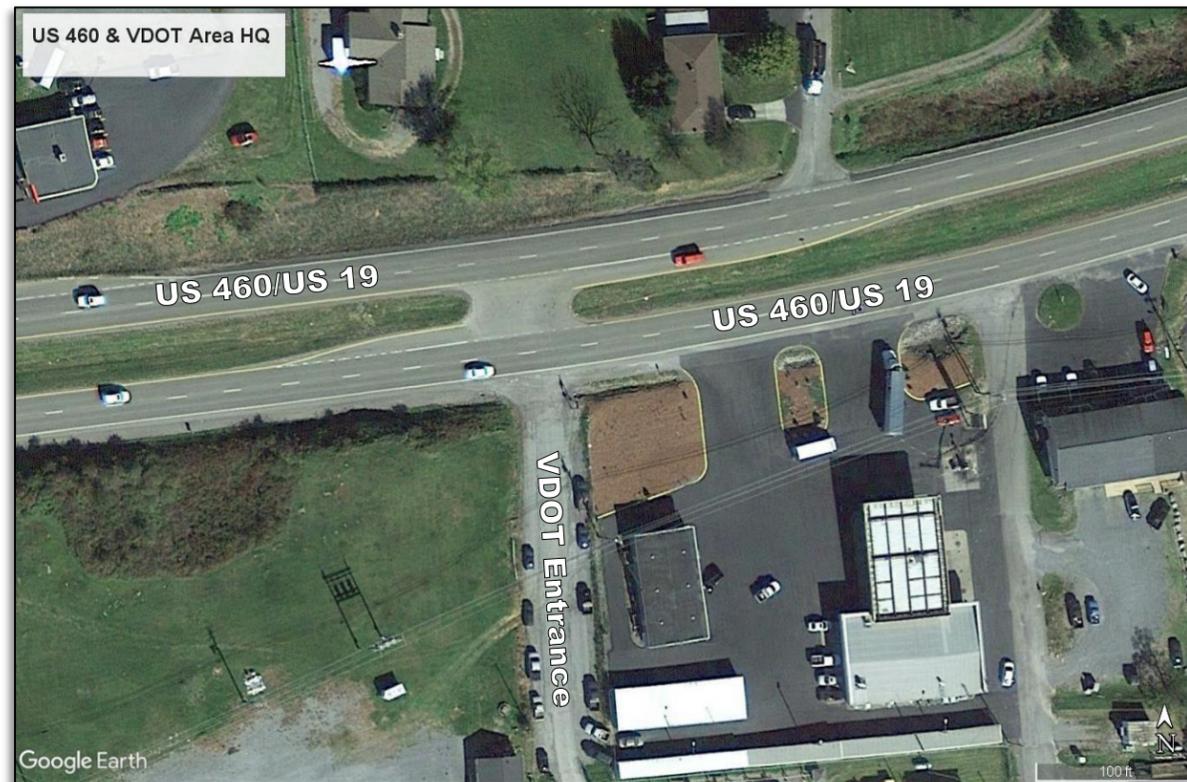
Figure 9: US 460/US 19 at VDOT Area HQ Entrance

The intersection of US 460/US 19 at VDOT Area HQ Entrance is currently a 3-leg unsignalized intersection at a median opening along US 460/US 19. The eastbound and westbound directions are free-flow. The northbound approach of the VDOT Area HQ Entrance is a shared left-right lane. The eastbound approach of US 460/US 19 has a left-turn lane, a through lane, and a shared thru-right lane. The westbound approach has one left-turn lane and two through lanes. Pedestrian facilities (crosswalks, pedestrian signals) are not currently provided at this intersection. **Figure 9** shows an aerial of the intersection.

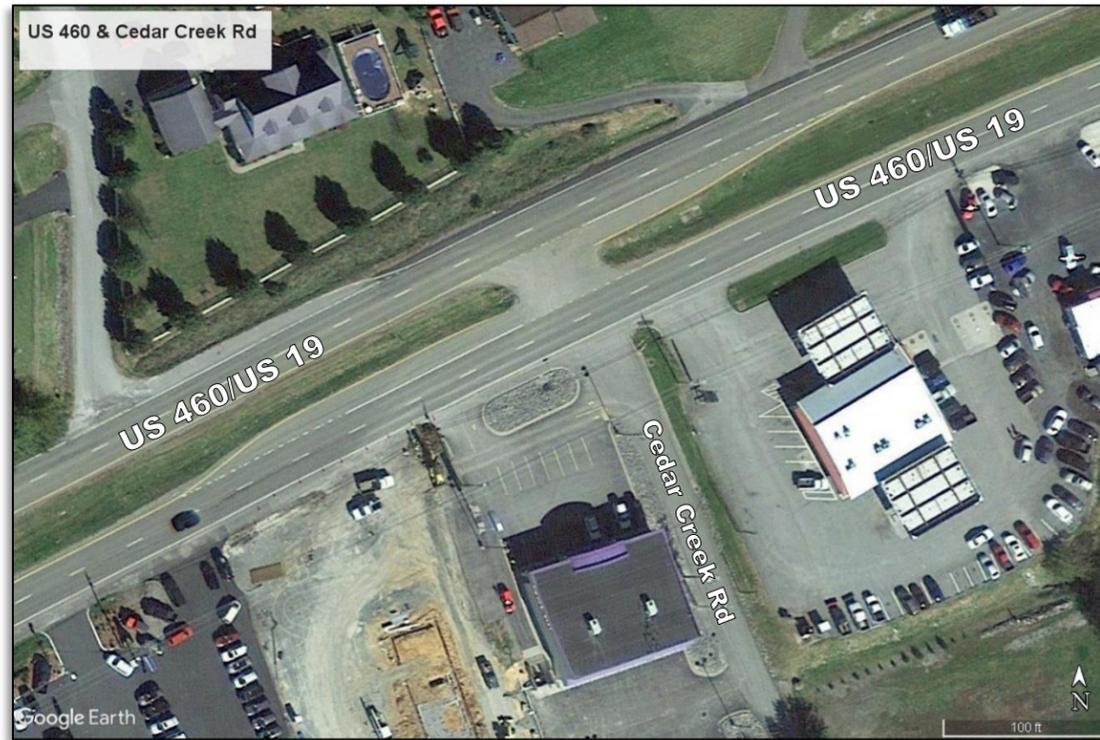
Figure 11: US 460/US 19 at Cedar Creek Road

The intersection of US 460/US 19 at Cedar Creek Road is currently a 3-leg unsignalized intersection with a median opening along US 460/US 19. There is no posted speed limit along Cedar Creek Road. The northbound approach of Cedar Creek Road has one shared left-right lane. The eastbound approach of US 460/US 19 has one U-turn lane, one through lane, and one shared thru-right lane. The westbound approach has one left-turn lane and two through lanes. Pedestrian facilities (crosswalks, pedestrian signals) are currently not provided for this intersection. **Figure 11** shows an aerial of the intersection.

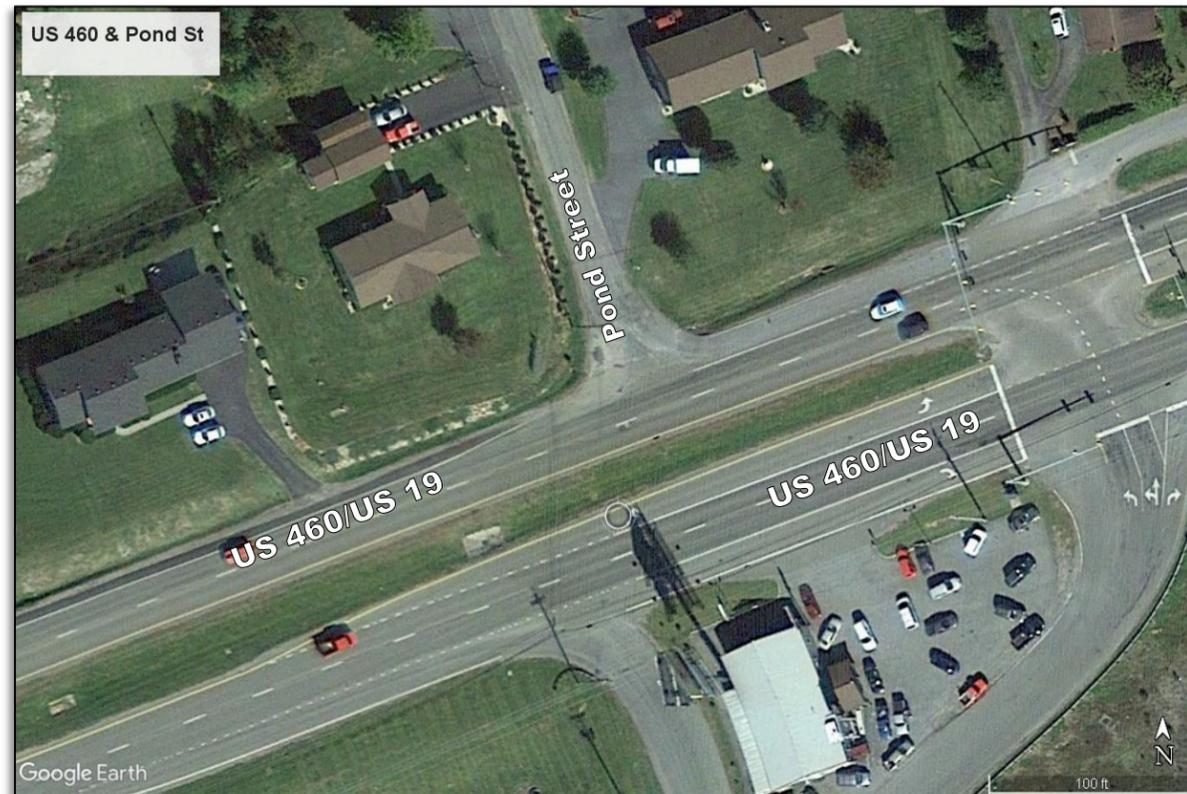
Figure 13: US 460/US 19 at Pond Street

The intersection of US 460/US 19 at Pond Street is currently a 2-leg right in/right out unsignalized intersection. There is no posted speed limit along Pond Street. The southbound approach of Pond Street is a right in/right out stop controlled entrance, while the westbound approach of US 460/US 19 is free-flow. The eastbound approach of US 460/US 19 has one shared thru-right lane and one through lane. Pedestrian facilities (crosswalks, pedestrian signals) are not currently provided at this intersection. **Figure 13** shows an aerial of the intersection.

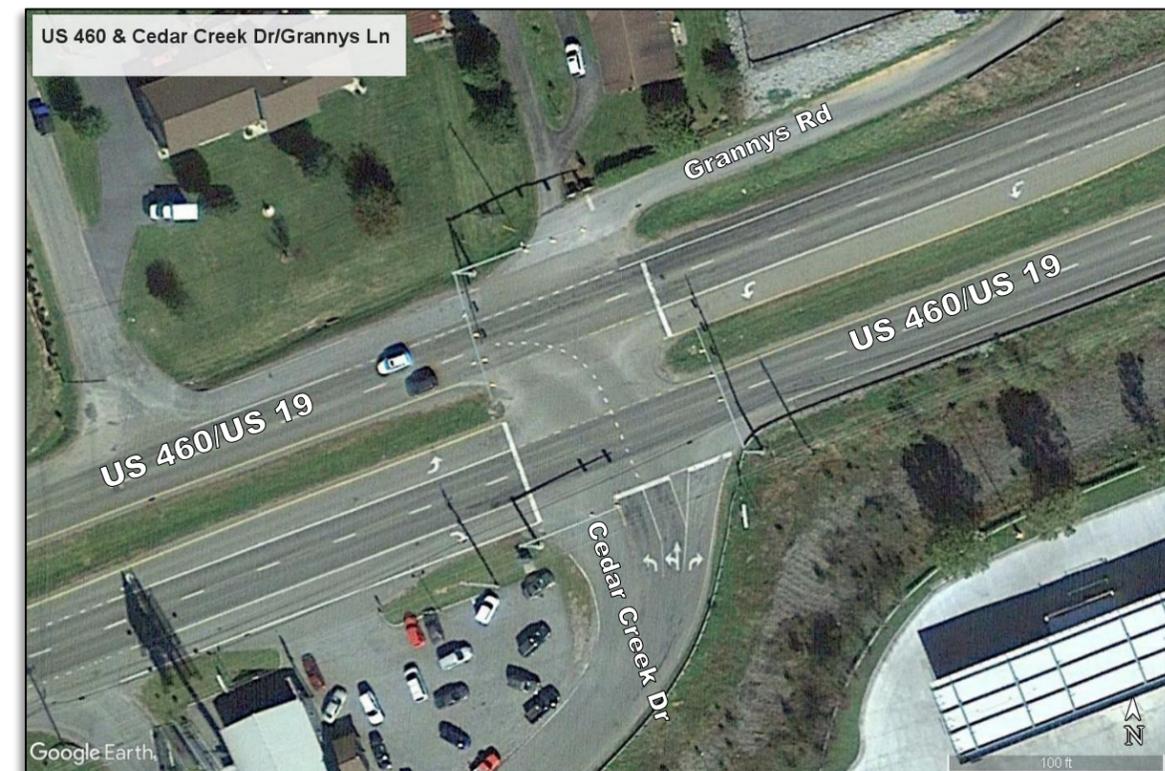
Figure 14: US 460/US 19 at Route 1249 (Cedar Creek Drive)

The intersection of US 460/US 19 at Route 1249 (Cedar Creek Drive) is currently a 4-leg signalized intersection. There is no posted speed limit along Route 1249. The northbound approach of Route 1249 has one left-turn lane, one shared left-thru lane, and one right-turn lane. The southbound approach of Granny's Road has one shared left-thru-right lane. The eastbound approach of US 460/US 19 has one left-turn lane, two through lanes, and one right-turn lane. The westbound approach has one left-turn lane, one through lane, and one shared thru-right lane. The signal operations include protected left-turns for eastbound and westbound approaches and permitted lefts for northbound and southbound approaches. Pedestrian facilities (crosswalks, pedestrian signals) are currently not provided at this intersection. **Figure 14** shows an aerial of the intersection.

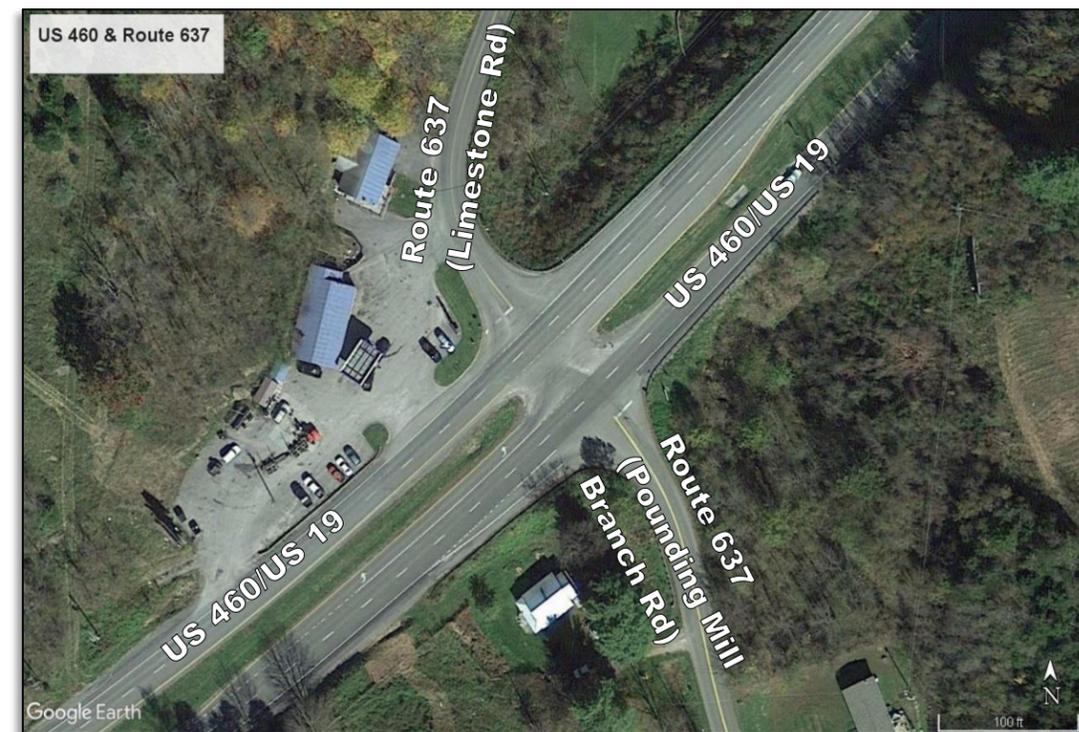
Figure 16: US 460/US 19 at Route 637 (Pounding Mill Branch Rd)

Route 637 (Pounding Mill Branch Rd) is classified as a Minor Collector per the *VDOT Functional Classification*. The intersection of US 460/US 19 at Route 637 is currently a 4-leg unsignalized intersection. The eastbound and westbound movements are free-flow. Route 637 is referred to as Pounding Mill Branch Rd south of US 460/US 19 and Limestone Rd north of US 460/US 19. The posted speed limit for northbound Pounding Mill Branch Rd is 40 miles per hour and the speed limit for southbound Limestone Rd is 35 miles per hour. The northbound approach of Pounding Mill Branch Rd has one shared left-thru-right lane. The southbound approach has one shared left-thru-right lane. The eastbound approach of US 460/US 19 has one left-turn lane, two through lanes, and one right-turn lane. The westbound approach has one left-turn lane, one through lane, one shared thru-right lane. Pedestrian facilities (crosswalks, pedestrian signals) are currently not provided at this intersection. **Figure 16** shows an aerial of the intersection.

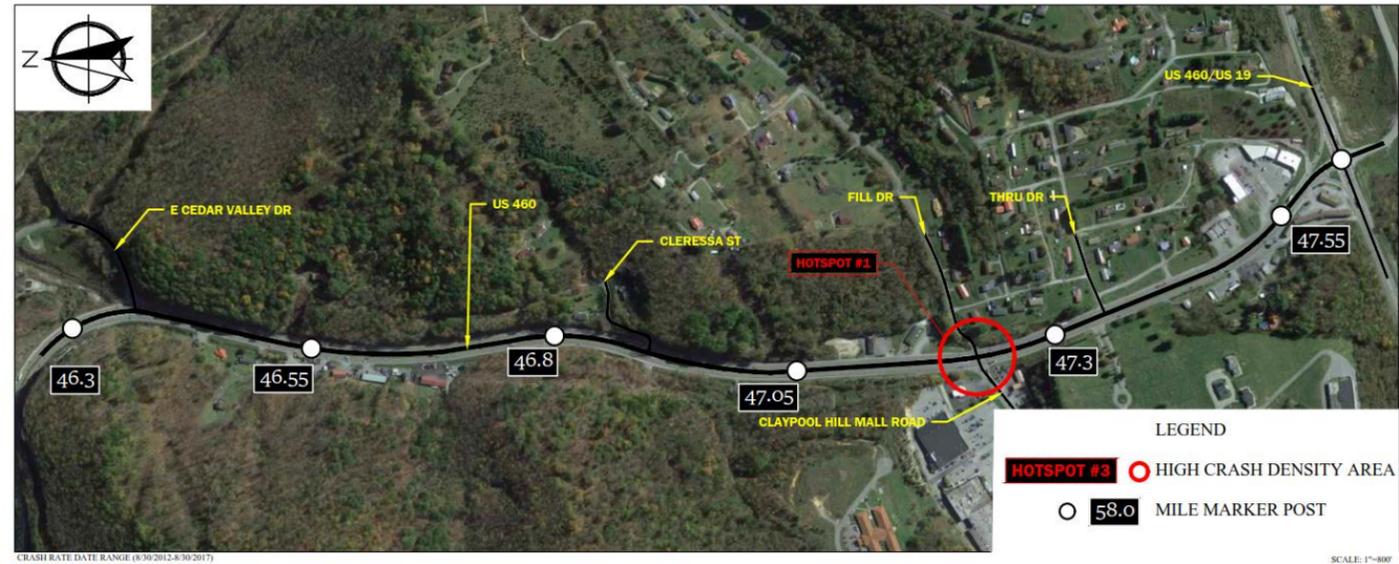
Figure 30. Crash Density Histograms per ¼-mile (US 460 Southbound).

Crash density histograms were developed in ¼-mile increments to provide a visual representation of crashes along the corridor based on crash type, crash severity, time-of-day, and roadway conditions. The histograms were separated into eastbound & westbound and southbound & northbound for US 460/US 19 and Route 460, respectively. Crash hot spots were identified along the corridor as locations with the highest crash density. Figure 28, Figure 29, Figure 30, and Figure 31 illustrate the crash hotspots for the corridor. A discussion of the crash hotspots is provided below.

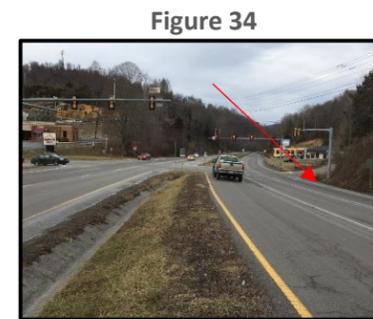
- The northbound approach right lane does not provide a separate lane for right-turning vehicles and thus acts as a shared through-right lane for northbound approaching vehicles (Figure 34). During field reviews, vehicles traveling in the right lane were observed braking abruptly and in some cases changing lanes quickly at the intersection in order to avoid rear-ending northbound right-turning vehicles. Based on the collision diagrams, rear-ends were prominent along the northbound approach in 2014, 2015, and 2017, and the lack of lane assignment notice could be attributing to these crash statistics. (See Recommendation A8)

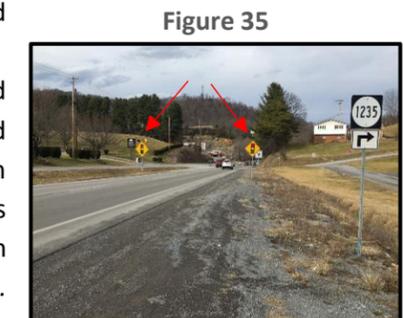
Figure 35

- Currently, approximately 830 feet east of the Claypool Hill Mall Road intersection, along the northbound lanes, two signal ahead advanced warning sign panels (W3-3) are provided on the sides of the road. The sign panel on the left side of the road, along the northbound lanes, is complemented with flashers; however, no flashing signal is provided with the advanced warning sign panel on the right side of the road (Figure 35). Based on the collision diagrams, rear-end crashes were prominent along the northbound lanes during 2014, 2016, and 2017, which could be attributed to these less distinct advanced warning signal signs. (See Recommendation A11)

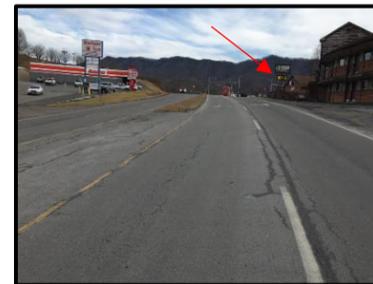
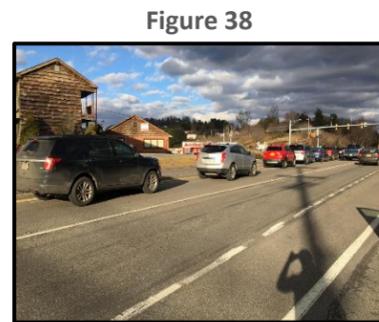
- The southbound approach to the intersection, based on the horizontal alignment of the approach, may have limited sight distance and ultimately has an obstructed view due to the Timberline Lodge building located on the northwest corner of the intersection (Figure 36 and Figure 37). Additionally, the plaque sign located on the northwest corner is obstructed due to vegetation. Based on the collision diagrams, rear-end crashes were prominent from 2012 through 2014 along the southbound approach. The lack of advanced warning signage provided along the southbound approach could be contributing to these crash statistics. (See Recommendation A15)

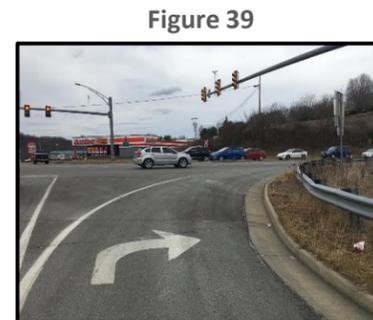
Figure 39

- Currently, the northbound approach right turn lane operates as a free-flow right turn lane, and vehicles are provided a receiving lane along the east leg of the intersection (Figure 39). Based on the collision diagrams, rear-end crashes were observed along the east leg of the intersection in 2016 and 2017. This free-flow right turn could be factoring into these crash statistics. (See Recommendation A18)

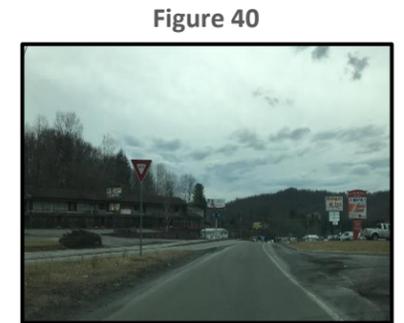
Figure 40

- Currently, a yield condition exists for southbound right turning vehicles proceeding westbound (Figure 40). Vehicles were observed stopping along the right turn approach, in order to yield into the westbound through lane, despite having their own receiving lane. (See Recommendation A19)

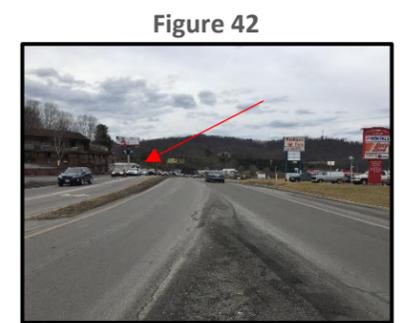
Figure 42

- During the PM peak hour period, vehicle queues were observed extending back north along the southbound approach and ultimately prevented vehicles from making right turns until the southbound through phase had green indication (Figure 42). This is partially due to the fact that the existing conditions do not provide a separate right turn lane for the southbound approach, therefore queued vehicles in the southbound through lane created vehicle blockages for the southbound right turn lane and partially because the signal timings may need to be adjusted. Additionally, during the PM peak hours, current green times do not provide the adequate times necessary for vehicles to proceed through in one cycle. (See Recommendation A21)

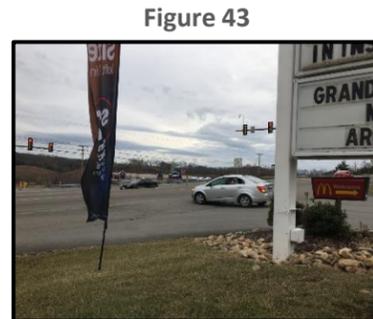
Figure 43

- Currently the signal heads for all approaches of the intersection have backplates, however the signal heads do not have yellow retroreflective borders. Based on collision diagrams, rear-end crashes were prominent from 2012 through 2015, and poor visibility of the signal heads could be attributing to these crash statistics. (See Recommendation A23)
- Pavement markings are faded for the eastbound, westbound, and northbound approaches, as well as the lane guidance striping in the intersection. Additionally, the southbound approach does not currently provide a stop bar. Vehicles were observed stopped in locations that extended into the intersection (Figure 43). (See Recommendation A24)
- Overhead street signs on the mast arms are not provided for any approaching vehicles. A small street sign post is provided on the southeast corner of the intersection. (See Recommendation A25)

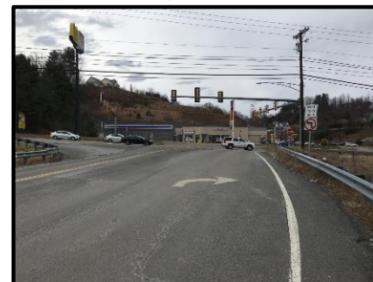
Figure 44

- Currently, the northbound approach exists as a right turn only condition. To enforce this right turn only condition, delineation posts are provided to act as a make-shift right turn channelized lane; however, these posts are broken and do not completely direct vehicles to the east leg receiving/merge lane. Additionally, two no left turn sign panels (R3-2) and a "Right Turn Only" sign panel (R3-5R) are provided along the right side of the northbound approach (Figure 44).

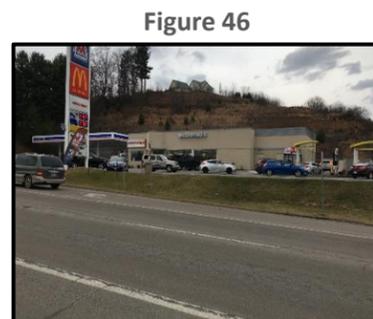
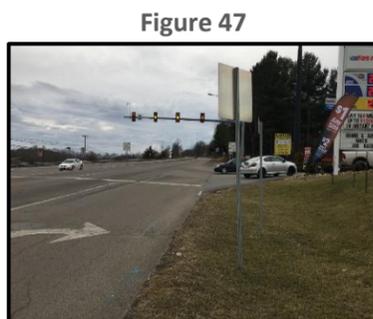
- During PM peak hour observations, vehicle queues, due to the McDonald's drive thru, were observed extending back to the intersection (Figure 46 and Figure 47). In some scenarios, westbound right turning vehicles and eastbound left turning vehicles were unable to turn into the driveway due to the drive thru queues.

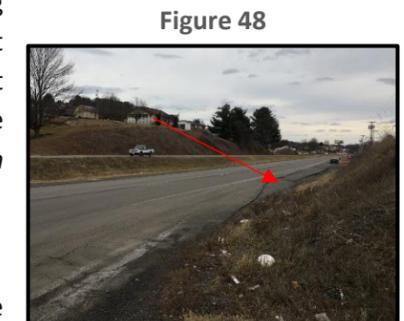
Figure 48

- Currently, a partially paved shoulder lane exists between the intersection of US 460/US 19 at Route 610 and the intersection of US 460/US 19 at Clay Drive. Along this stretch of corridor, several commercial driveways and unpaved roadway entrances exist along the right side of the road along the eastbound lanes (Figure 48). The stretch of road is a downhill segment in which vehicles appear to be traveling in excess of the posted speed limit of 45 mph. During the field review, vehicles were entering and exiting these driveways along this stretch of corridor frequently. (See Recommendation A31)

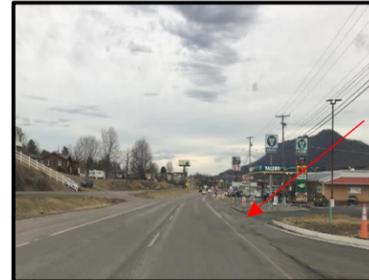
Figure 49

The right lane operates as a shared through right lane for vehicles turning onto these driveways or streets. This shared lane condition coupled with little overhead lighting forced (as observed in the field) through vehicles to brake or change lanes abruptly in order to avoid near-miss rear-end collisions. The limited lighting and high posted speed along this corridor posed unsafe conditions for through and right turning vehicles. Based on the collision diagrams, non-collision crashes, such as overturns, fire/explosion, running of road, or cargo loss, along with one pedestrian crash occurred from 2012 through 2017, and were a result of speeding and visibility issues along this corridor segment's eastbound and westbound lanes. (See Recommendation A46)

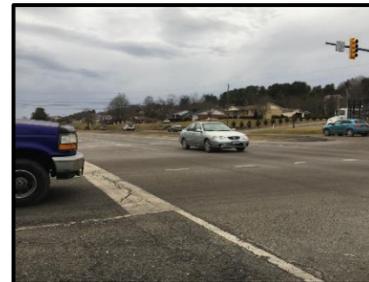
Figure 50

- Currently the signal heads for all approaches of the intersection have backplates, however the signal heads do not have yellow retroreflective borders. (See Recommendation A38)
- Overhead street signs on the mast arms are not provided for any approaching vehicles. A small street sign post is provided on the southwest corner of the intersection. (See Recommendation A39)
- Pavement markings are faded along all approaches of the intersection. (See Recommendation A40)
- Currently, the eastbound right turn lane is a terminal lane; however, no indication is provided for vehicles that the lane is a right turn only condition. (See Recommendation A41)
- The northbound right turn lane left sight distance may be obstructed due to the location of the stop bar for the northbound through and left turn lanes (Figure 50). (See Recommendation A42)

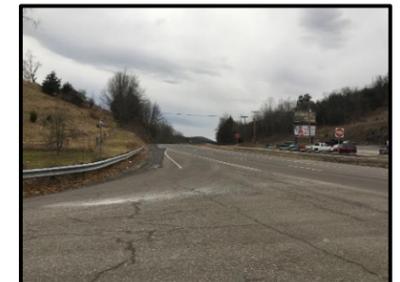
Figure 51

- The pavement marking for all approaches at the intersection are faded. (See Recommendation A47)
- Currently, the northbound left sight distance is limited due to the horizontal and vertical alignment of the eastbound approach (Figure 51). The eastbound approach provides vehicles advanced warning intersection sign panels (W2-1) and 45 mph speed limit advisory signs, with advanced flashing signals along the side of the road; however, vehicles appeared to be not adhering to this cautionary speed limit. Northbound vehicles were observed making turning movements within inadequate gaps in order to proceed eastbound or westbound due to the limited sight distance and the speeds of eastbound traveling vehicles. (See Recommendation A48)
