US ROUTE 19 CORRIDOR STUDY

Between Worthing Way and Stone Mountain Road

May 2019

May 2019 | Final

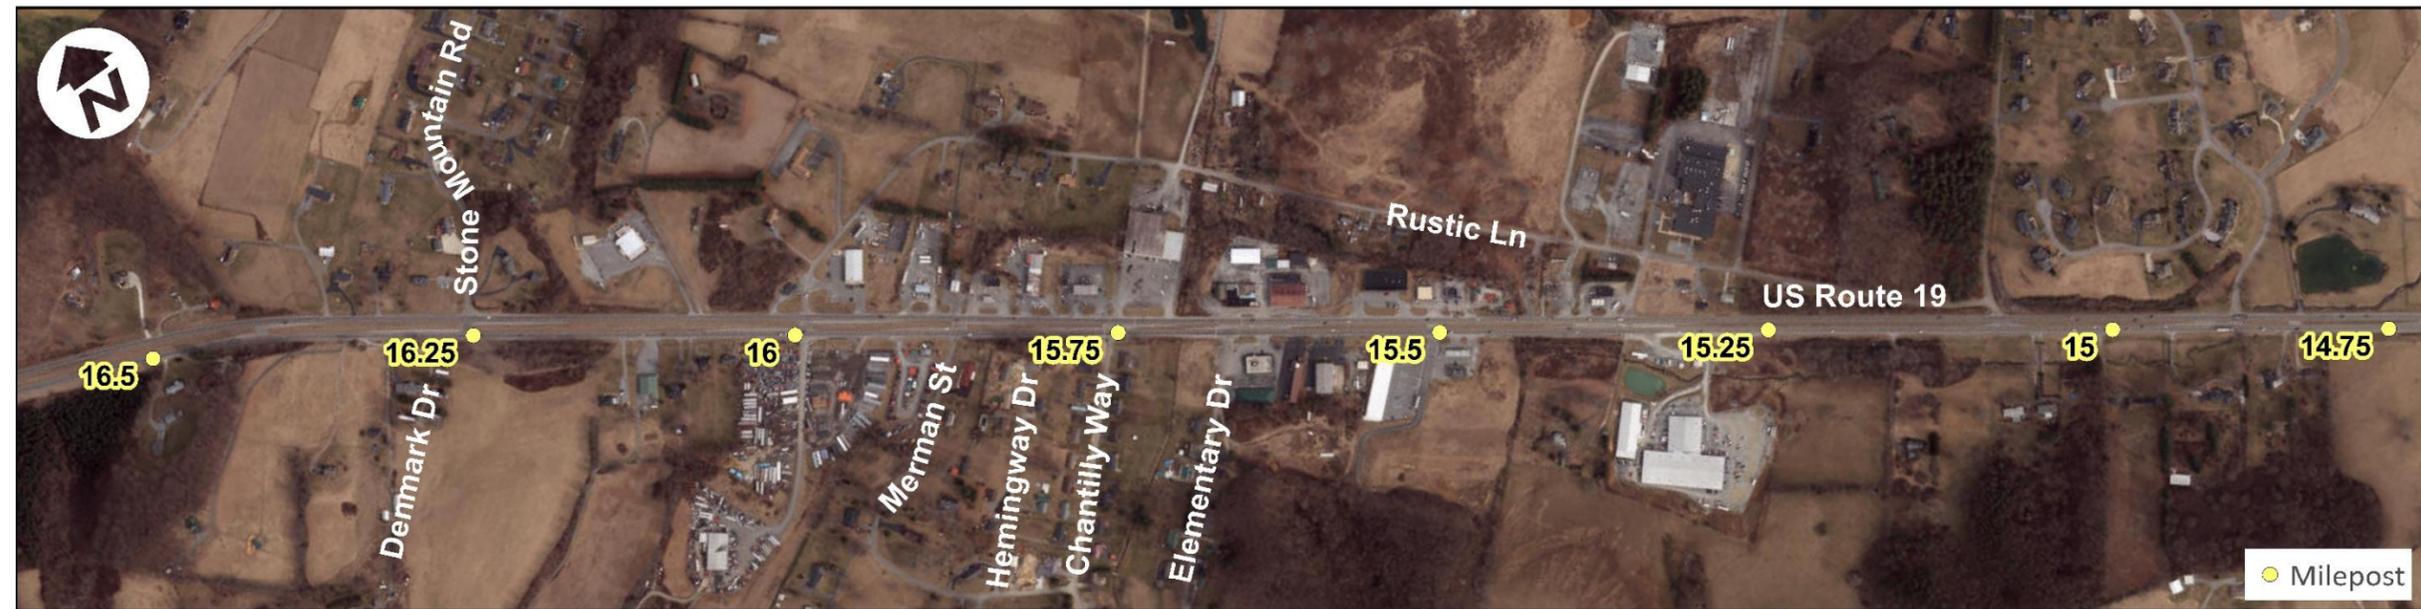
Figure 7: Crash Type Histograms

Crash activity by quarter-mile segments of roadway, or crash density, on northbound and southbound US Route 19 is shown on the histograms in **Figure 7**. The histograms illustrate the frequencies and types of crashes that occurred in each quarter-mile segment. Because US Route 19 is a divided roadway, crashed that occurred in the northbound and southbound directions were broken into separate histograms.

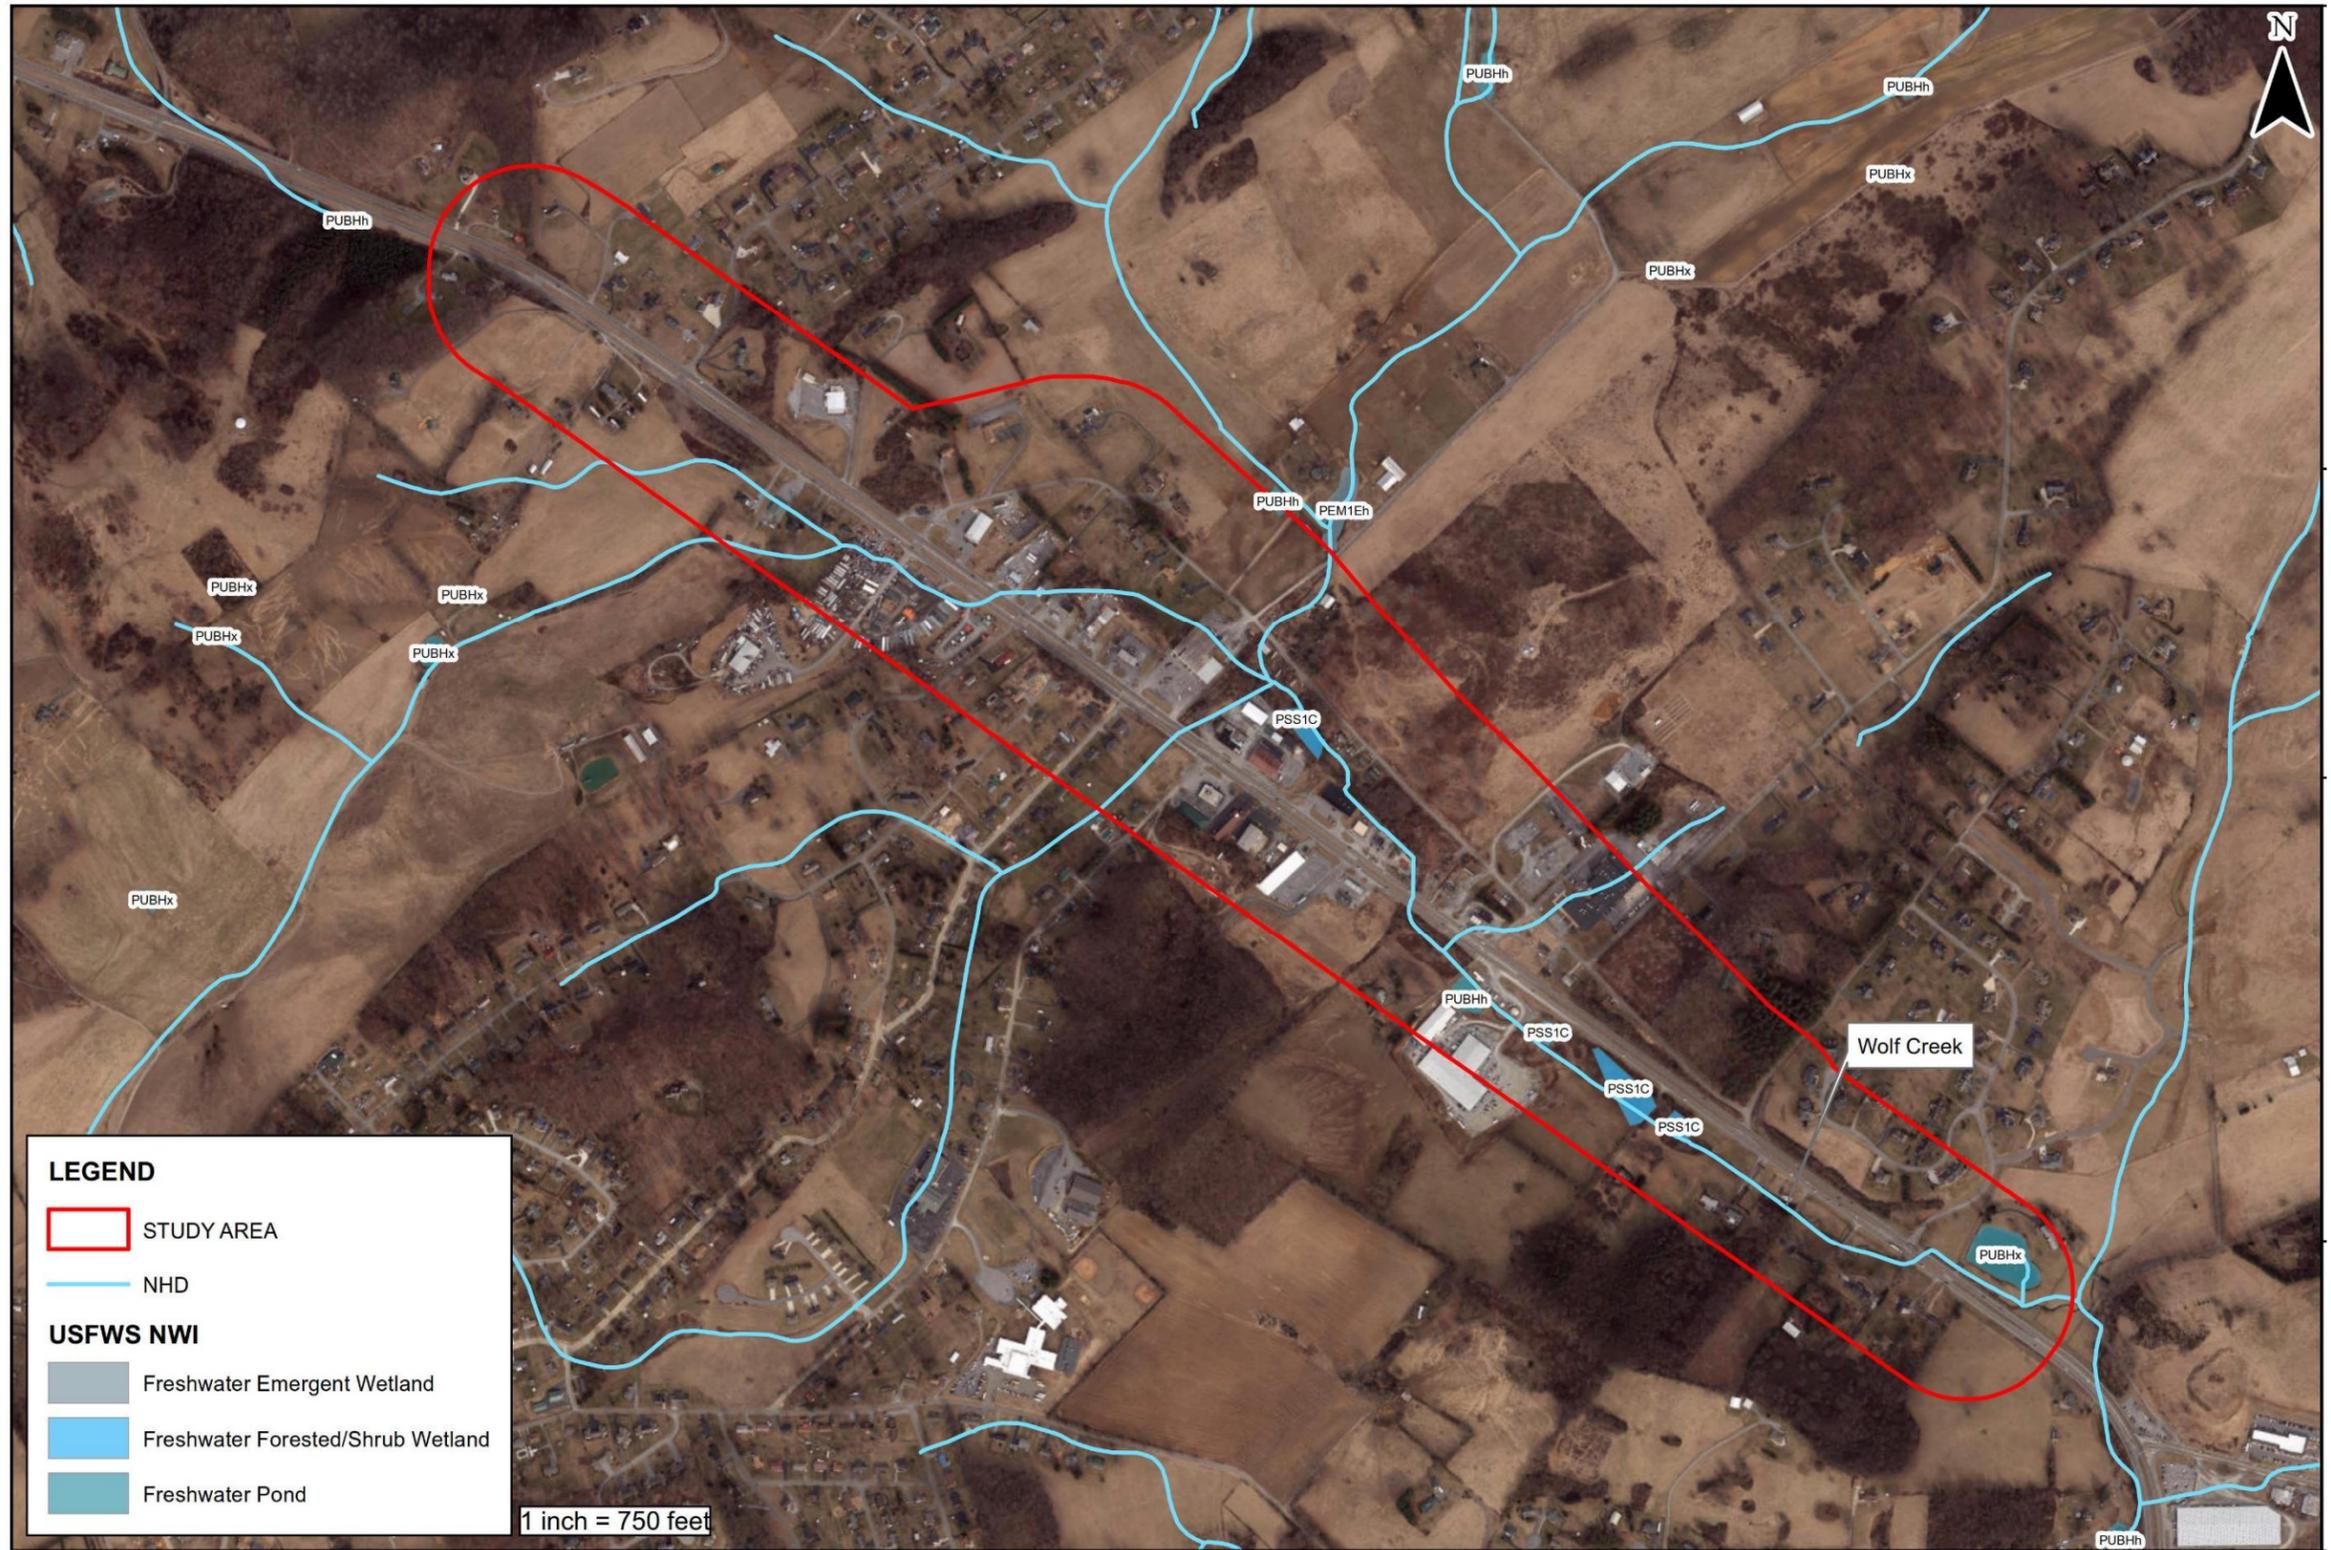
Figure 15: National Wetland Inventory and Nation Hydrology Dataset Map

- Wolf Creek and its associated tributaries were identified within portions of the project corridor. Wolf Creek enters the project corridor in the south along the northern side of US Route 19 and crosses beneath Route 19 at the intersection of US Route 19 and Worthing Way. Wolf Creek runs parallel to US Route 19 until it crosses beneath US Route 19 between Keywood Animal Clinic and Lyons Den Pizza. The stream continues northwest crossing beneath Rustic Lane and flowing into a PEM1Eh wetland system within the northern portion of the project corridor. A tributary of Wolf Creek flows south from the PEM1Eh wetland, crossing US Route 19 and continuing south out of the project corridor. Another tributary of Wolf Creek continues northwest and eventually meanders south, crossing US Route 19 and continues southwest outside of the project corridor.

- Wolf Creek and its associated unnamed tributaries are located within the central and southeastern half of the project corridor. The primary channel of the system appears to have perennial flow and drains in a southeastern direction.
- Two palustrine open water (POW) systems were observed within the project corridor within the southeastern and southcentral portion of the project corridor.
- Palustrine Scrub-Shrub (PSS) wetlands were observed within the central area of the project corridor, bordering Wolf Creek, and within the southeastern portion of the project corridor adjacent to Rustic Lane.

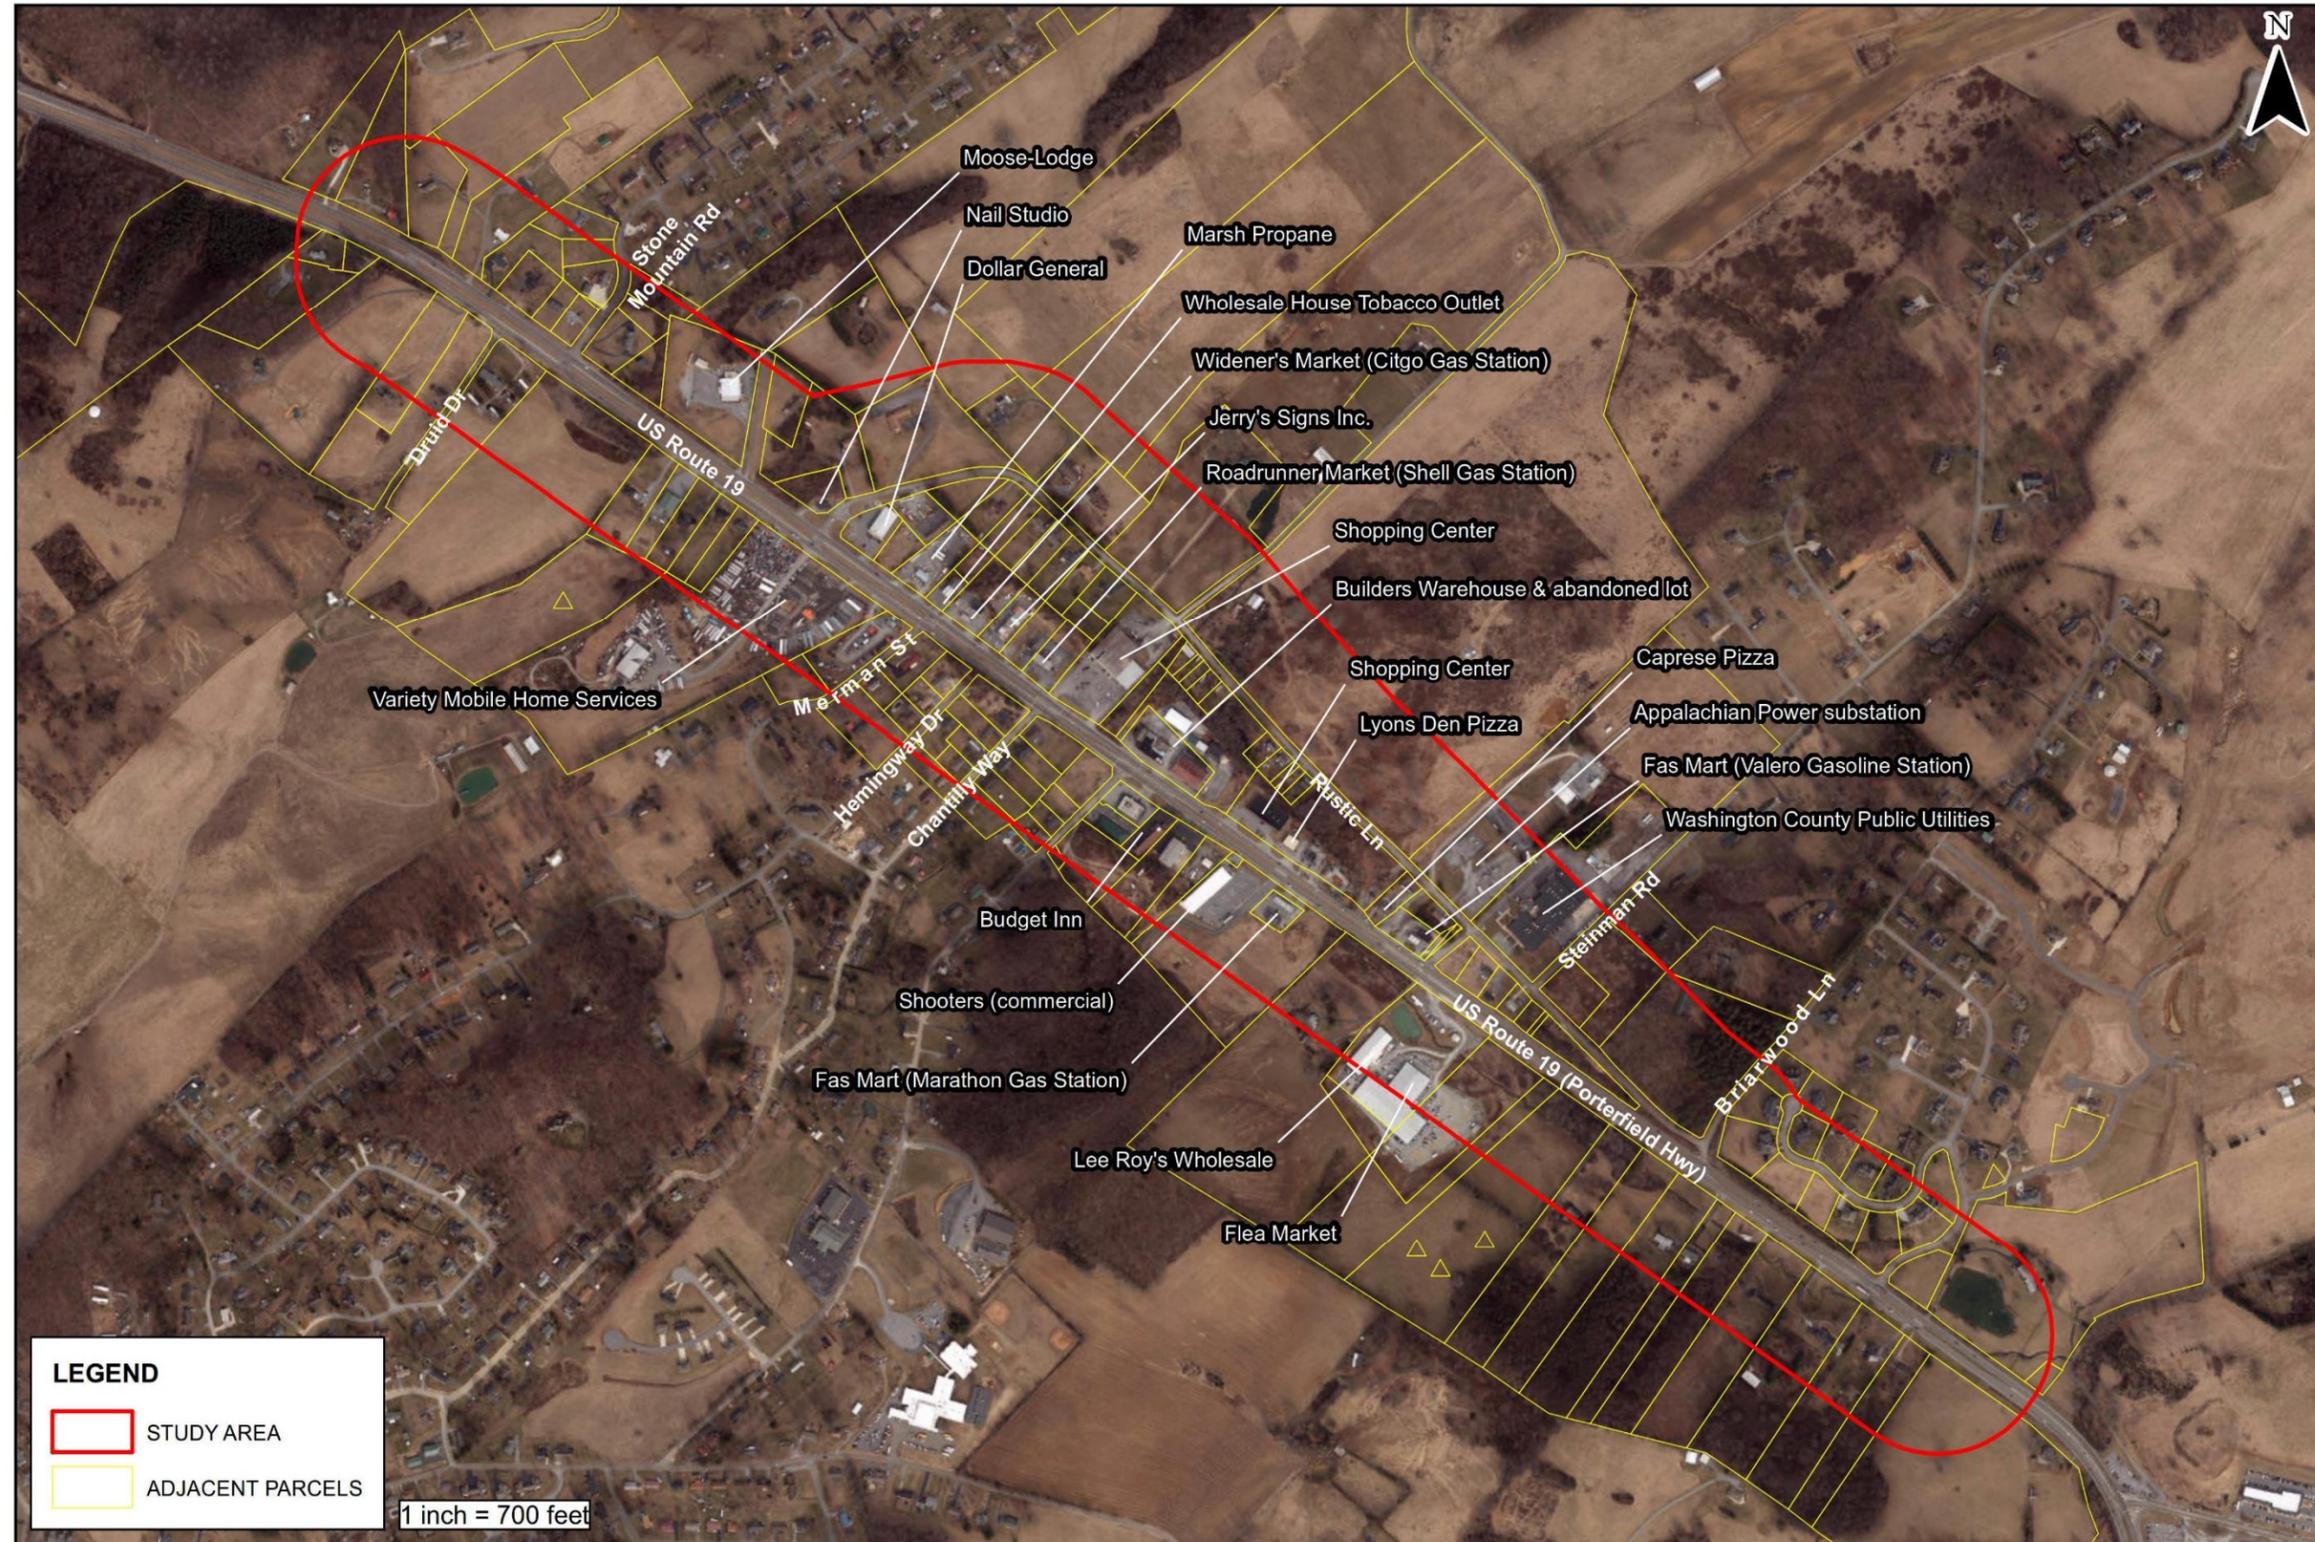
Figure 16: Pertinent Environmental Site Features

In addition to a review of GIS data, a site visit was conducted on December 21, 2017 to review the project corridor and adjacent properties from public thoroughfares. Multiple segments of overhead powerlines with pole-mounted transformers were observed within the project corridor along US Route 19 and Rustic Lane. While a detailed inspection of each pole-mounted transformer for the presence of a non-PCB (poly-chlorinated biphenyls) sticker was not ascertainable, no stressed vegetation or staining around the poles was observed. Additionally, many of the residential structures within and adjacent to the project corridor contained 500-750-gallon heating oil aboveground storage tanks (AST). Stained vegetation was not observed around the ASTs that were visible from public thoroughfare. According to a county official at the Washington County Sheriff’s Office, a Phase I ESA was conducted on the Washington County Utilities property at 20281 Rustic Lane when the property was purchased from
