Final Report

Survey for Freshwater Mussels in Ivy Creek, in Proximity to the
Proposed Route 29 Bypass Corridor

December 2011

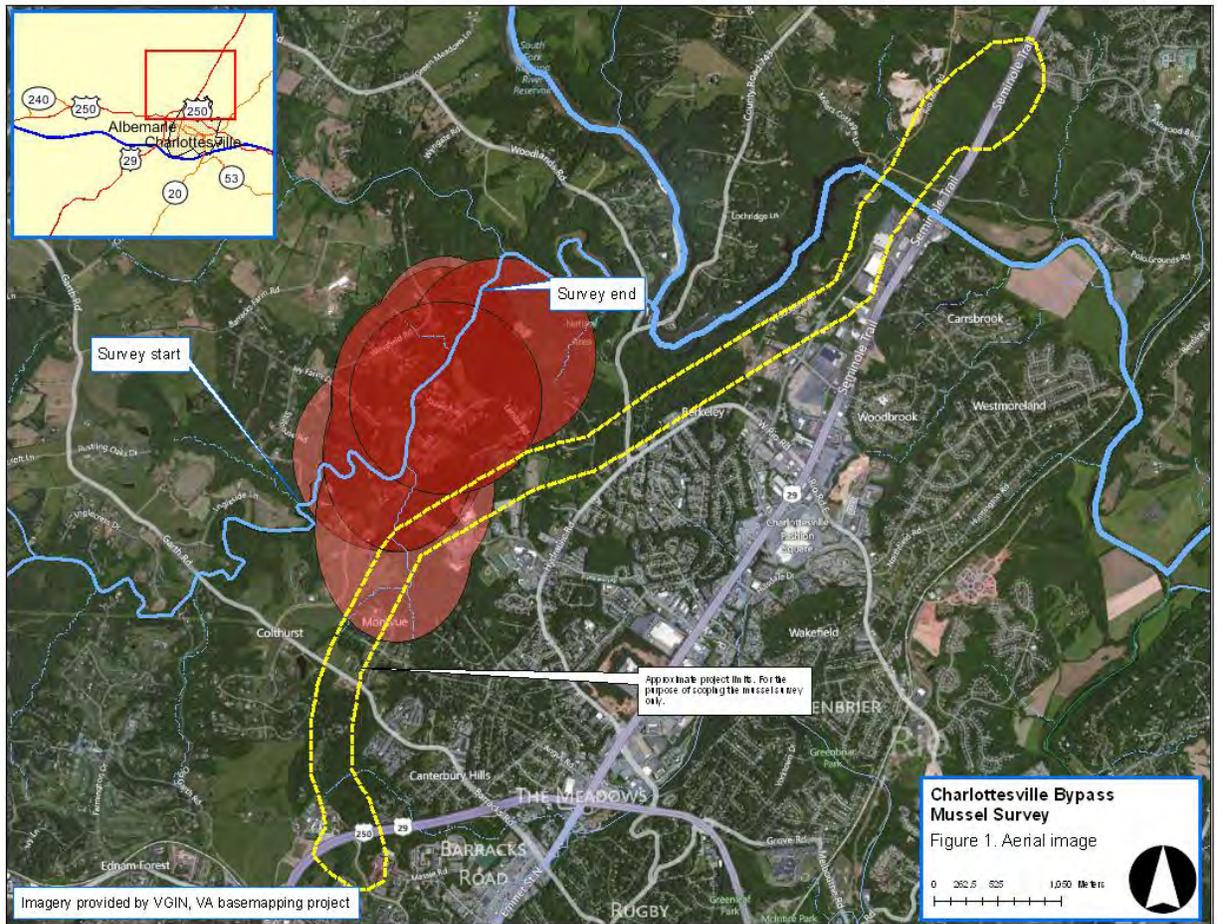
Figure 1. Aerial map provided by VDOT illustrating suggested survey limits for the Ivy Creek survey and location of proposed US 29 Bypass corridor as of September 2011.

A proposed bypass roadway for Route 29 may impact tributaries to Ivy Creek and a reach of the South Fork Rivanna River in Albemarle County, Virginia (Figures 1 and 2). Recent survey efforts suggest there is a strong likelihood that the federally endangered James spiny mussel (*Pleurobema collina*) persists in Ivy Creek (Beaty and Neves 1997, Stephenson 1997). At least two other native mussels are known to inhabit Ivy Creek, so it is possible that additional state-protected species, including the green floater (*Lasmigona subviridis*), may inhabit this stream and its perennial tributaries. Moreover, recent sampling conducted by Ostby and Angermeier (2011) has documented *P. collina* in several tributaries to the Rivanna River. In anticipation of U. S. Fish and Wildlife Service (USFWS) and Virginia Department of Game and Inland Fisheries (VDGIF) information requests, the Virginia Department of Transportation has requested that Virginia Tech survey stream reaches within the project study corridor and in the vicinity of the proposed bypass roadway. These reaches include a 1000 m reach of the South Fork Rivanna River, an approximately 3,000 m reach of Ivy Creek (Figures 1 and 2), and a 1,500 m reach of an Ivy Creek tributary.

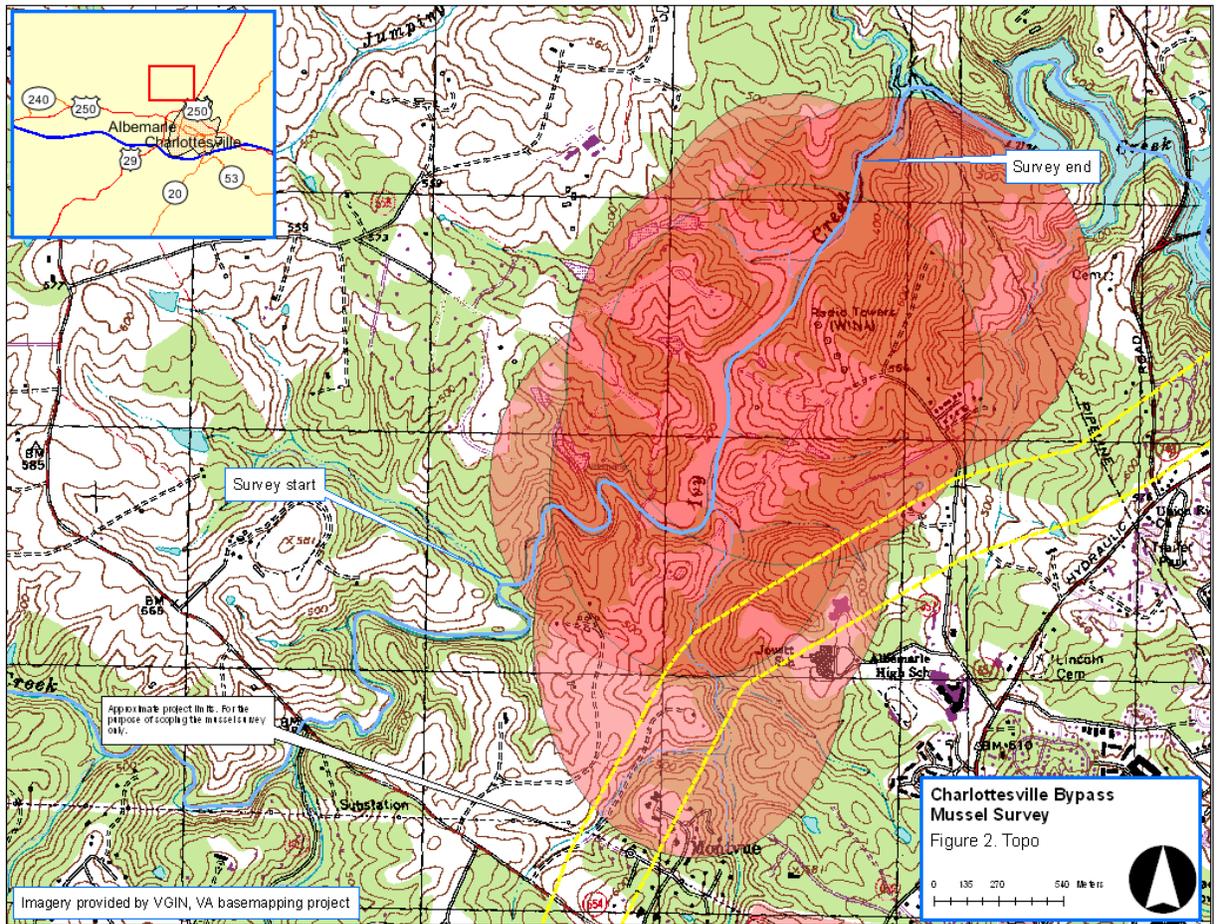
Figure 2. Detailed topographic map provided by VDOT of suggested survey limits on Ivy Creek.

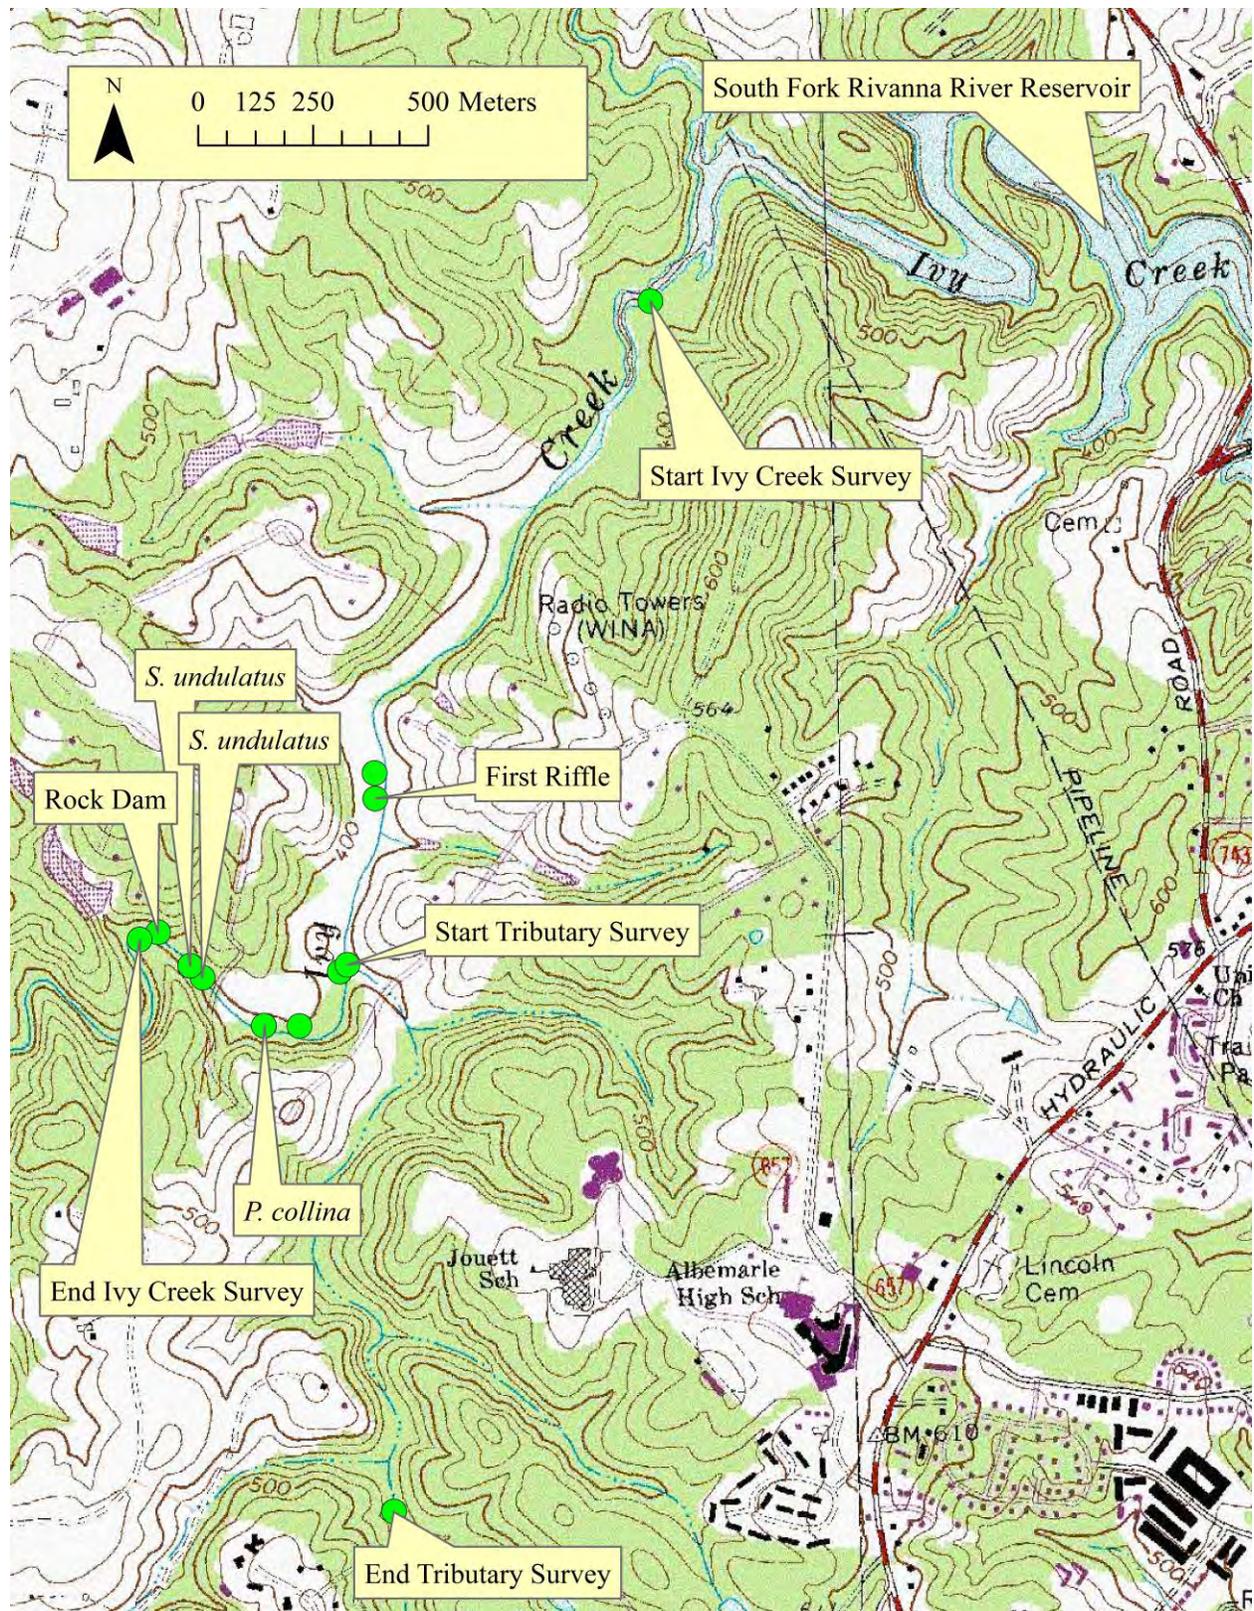
Figure 3. Topographic map of surveyed reaches of Ivy Creek and one of its major unnamed perennial tributaries.

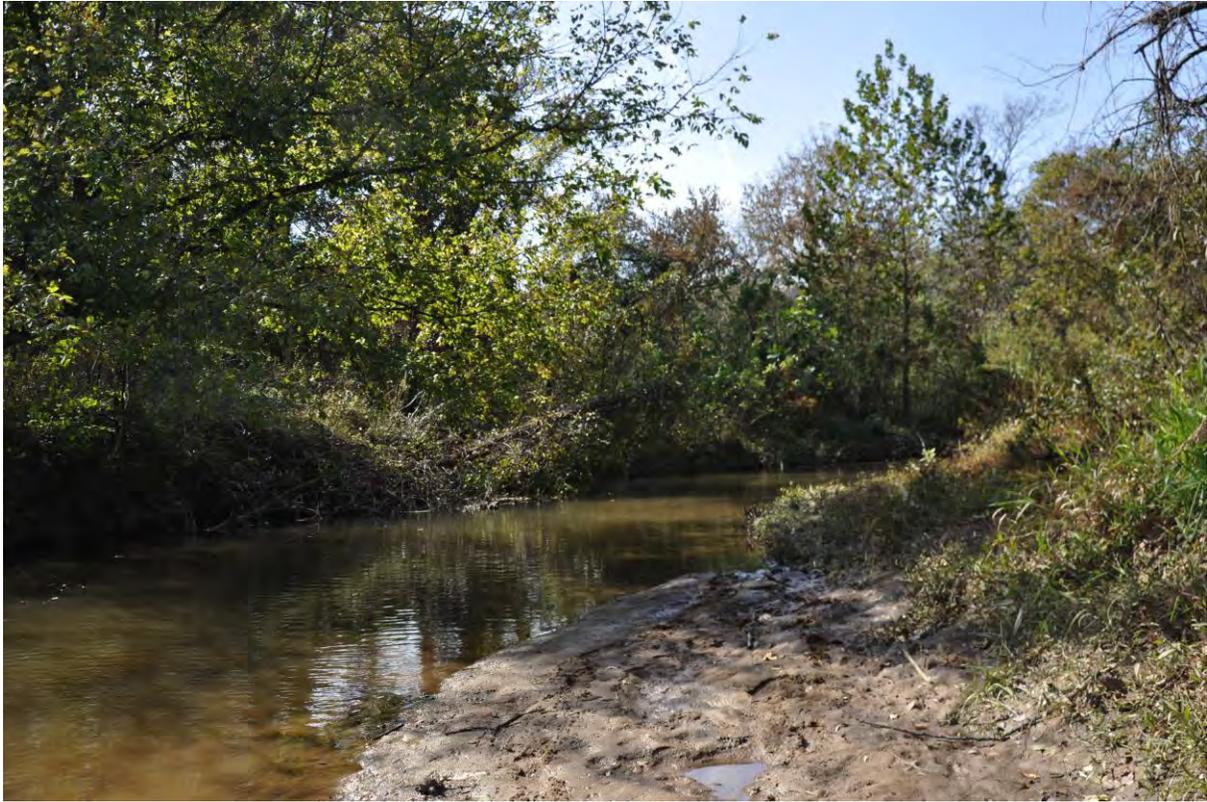
We started the survey of Ivy Creek in a zone that transitioned from a free-flowing stream into an arm of the South Fork Rivanna Reservoir (WGS84, 38.095929, -78.504106; 17S, E 718863.90, N 4219401). Here flow slowed, depth increased, and the amount of silt and decaying plant matter covering the stream bottom increased greatly. The lower portion of Ivy Creek (extending 1,400 m upstream from the starting point) was extremely unstable and degraded (Figures 4 and 5). While many tributaries to the upper Rivanna River system are impacted by land use and incised into the surrounding landscape, this reach appears to be among the most disturbed that we have observed. The channel was deeply incised in the surrounding flood plain. Banks were often steep and in some places actively eroding. Bankfull heights were often 3 m above the stream surface. Bankfull width was 12-15 m and except at point bars, wetted width was 10 – 13 m. This reach was entirely run habitat, with a stream bottom that was 95% sand.

Figure 4. Ivy Creek near downstream start point. A point bar is in the foreground photo (right).

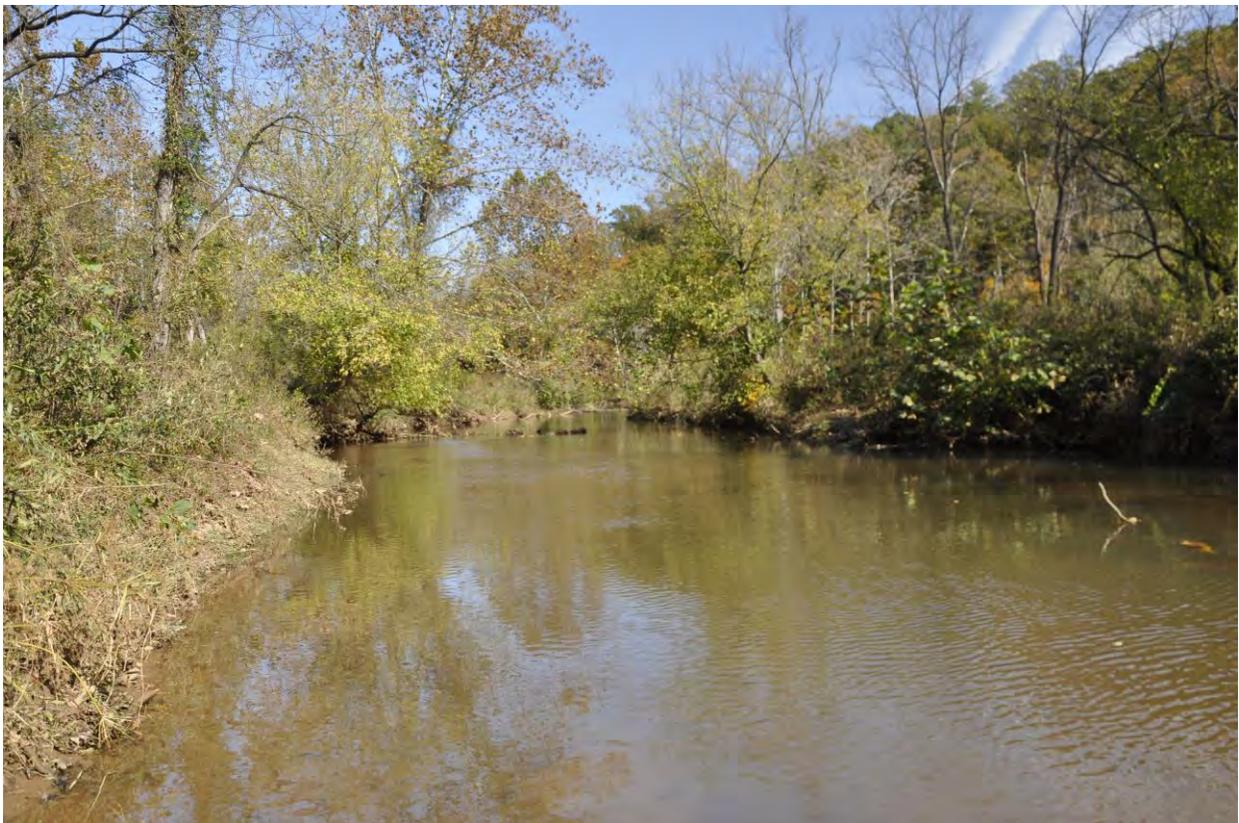
Many parts of the stream bottom were unstable—even at low flows sand was moving downstream and our feet often sunk 10 - 20 cm into the sandy bottom. The only habitat complexities in this entire 1,400 m reach were at outside bends across from point bars and where large woody debris had dammed the channel or otherwise redirected flow. Where large woody debris constricted or dammed flow, depth could change from 2 m to 0.2 m abruptly. Otherwise thalweg depth was usually 50 cm. The only place that larger substrates, such as boulders and cobbles, were observed was along the outside of bends where flow increased noticeably (this stream bottom type composed less than 5% of the downstream 1,400 m surveyed reach). Since the stream bottom was very homogenous, our ability to detect mussels at the stream bottom interface was extremely high.

Figure 5. Homogenous stream form typical of the downstream 2000 m of surveyed reach of Ivy Creek. Sand was the only substrate type in this photographed habitat.

The degraded condition of the downstream portion of Ivy Creek is the likely consequence of ongoing and historically intense land use upstream or intense land use in the local riparian zone, or both. This stream transports a large volume of sediment and probably contributes a significant amount of sediment now filling the South Fork Rivanna River Reservoir. We have observed many tributaries in the Rivanna River system whose channels are incised and whose stream bottom is predominantly sand; however, none appear as unstable and deeply incised as the lower reach of Ivy Creek. The stream may also suffer extreme fluctuations in discharge (total volume of water in the channel). Stevenson (1997) observed a much narrower wetted width (3-5 m) than we did. Our surveys were conducted following a substantial rainfall occurring during a relatively wet autumn. While *P. collina* is often observed in sandy habitats or in gravel moderately embedded by sand, the stream bottom in the reach extending from 200 downstream of the private bridge to the impoundment is considerably unstable, such that we find it unlikely that it can support a viable, recruiting population of *P. collina* even though one live specimen and shells of this species have been observed here in the past (Figure 14). We suspect that mussel occurrences in this reach have likely been transported downstream to this habitat. Most live mussels have been observed closer to the private bridge crossing of Ivy Creek, in what we suspect was and continues to be more stable instream habitat.

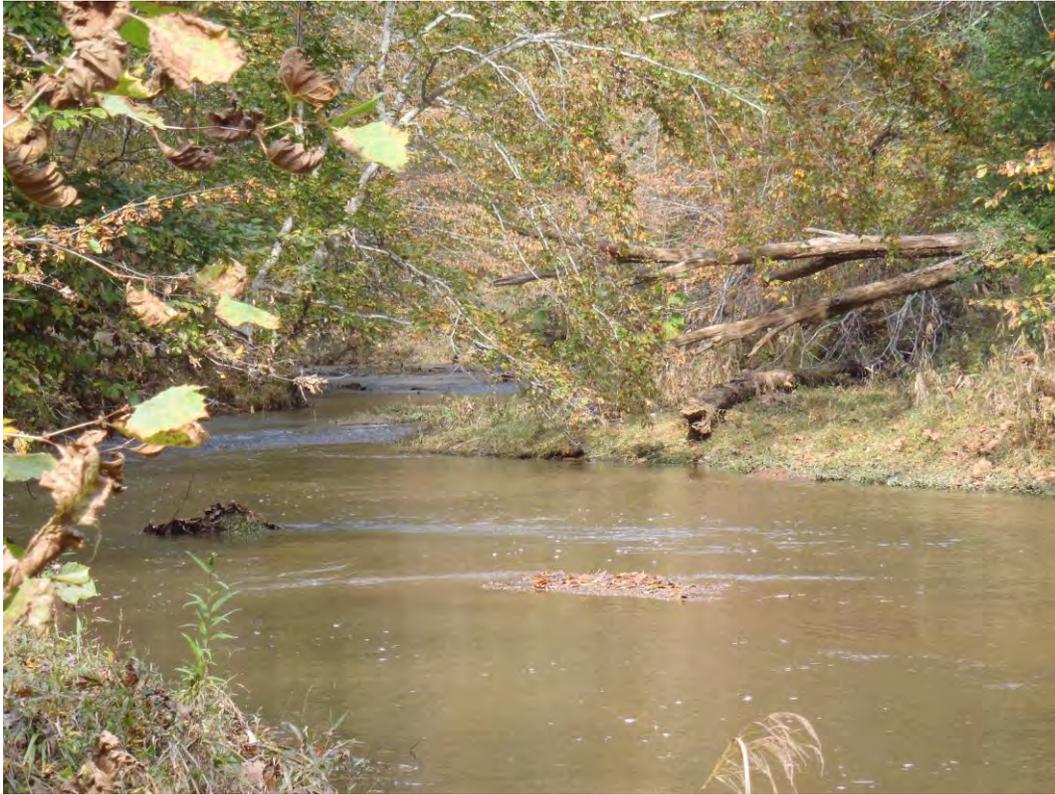
Instream habitat improved approximately 1,400 upstream of the start point; here, other instream habitats typical of streams draining the Blue Ridge province, such as riffles, were first observed (Figure 6 and 7). Additionally, other substrate types became more prevalent. Nevertheless, riffles were still rare, sand continued to be the dominant substrate type, and the stream remained 2 to 3 m below the flood plain. The best instream habitat was observed approximately 200 m downstream of a private bridge (formerly a state road crossing to the survey terminus at 38.08371199, -78.51717202; 17S E 717753.94, N 4218014.50). While instream habitat greatly improved near and especially upstream of the bridge, there were multiple areas of bank erosion and undercutting. In the reach directly downstream of the private bridge, we found 2 live *P. collina* in a gravel and cobble substrate mix, moderately embedded by sand (38.0819630250334, -78.5141490027308; 17S, 718024.1, 4217827). Both were found in close proximity to each other. Their shell lengths were 54 and 57 mm. We also found 2 *Strophitus undulatus* (creeper) upstream of the bridge with lengths of 46 and 49 mm.

Figure 6. Ivy Creek habitat appeared less impacted near the bridge crossing.

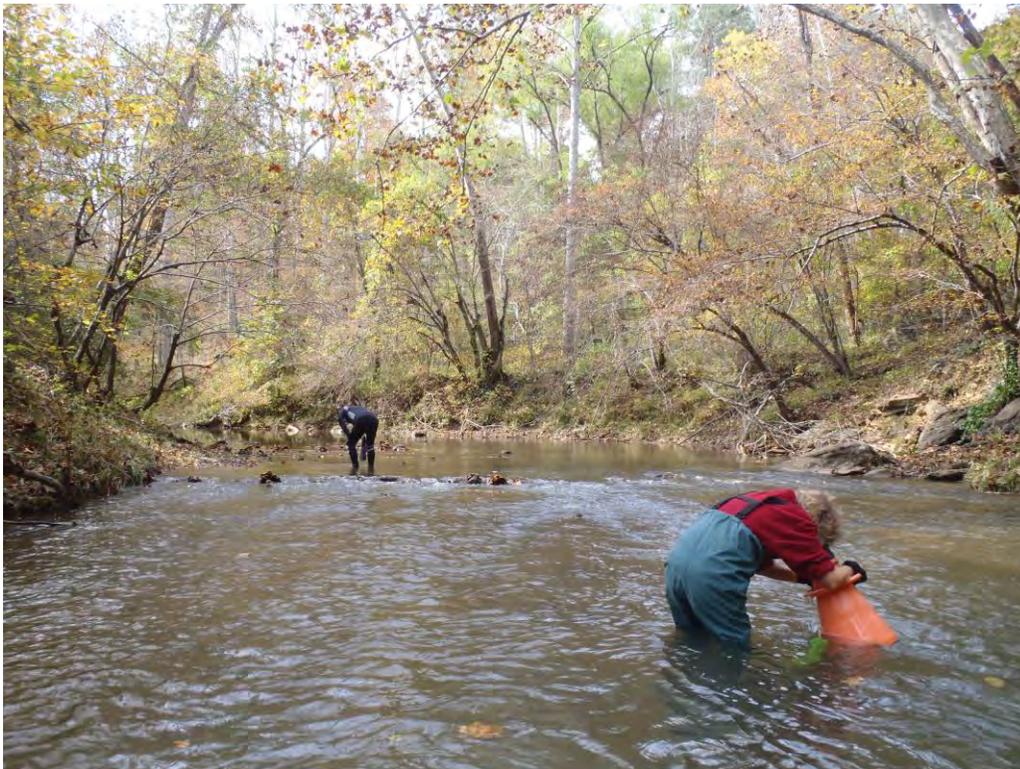
Figure 7. The upstream portion of Ivy Creek that we surveyed had a greater diversity of instream habitats, and its channel appeared more stable.

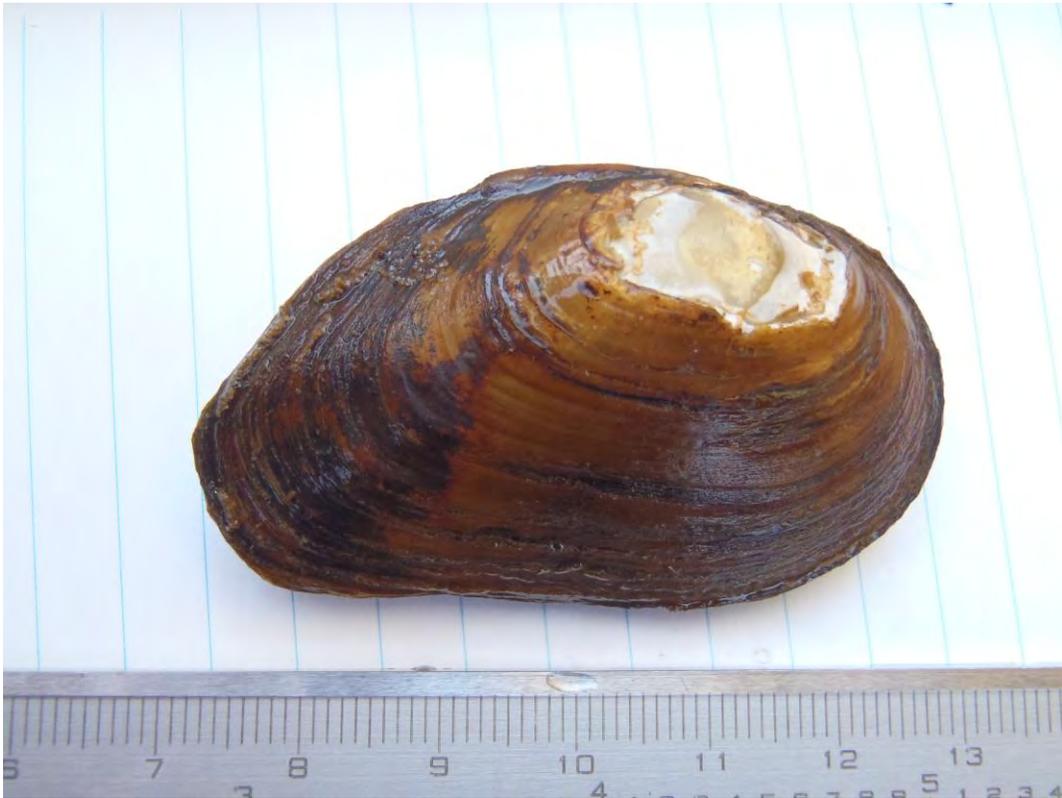
In total, we expended 22 person-hours surveying Ivy Creek and observed only 2 federally endangered *P. collina* and 2 live *S. undulatus* (photoed representatives of each species are Figures 8 and 9, respectively). We observed no snails. The Asian clam *Corbicula fluminea* was rare downstream of the private bridge crossing, but abundant upstream of the bridge to the survey terminus.

Figure 8. Live *P. collina* observed in Ivy Creek.

If the Route 29 Bypass project moves forward, efforts should be made to minimize impacts to what may be a low density, but persistent population of *P. collina* inhabiting selective instream habitats of Ivy Creek. Because this stream exhibits disturbance, is a suspected contributor of sediments to the South Fork Rivanna River Reservoir, and supports a population

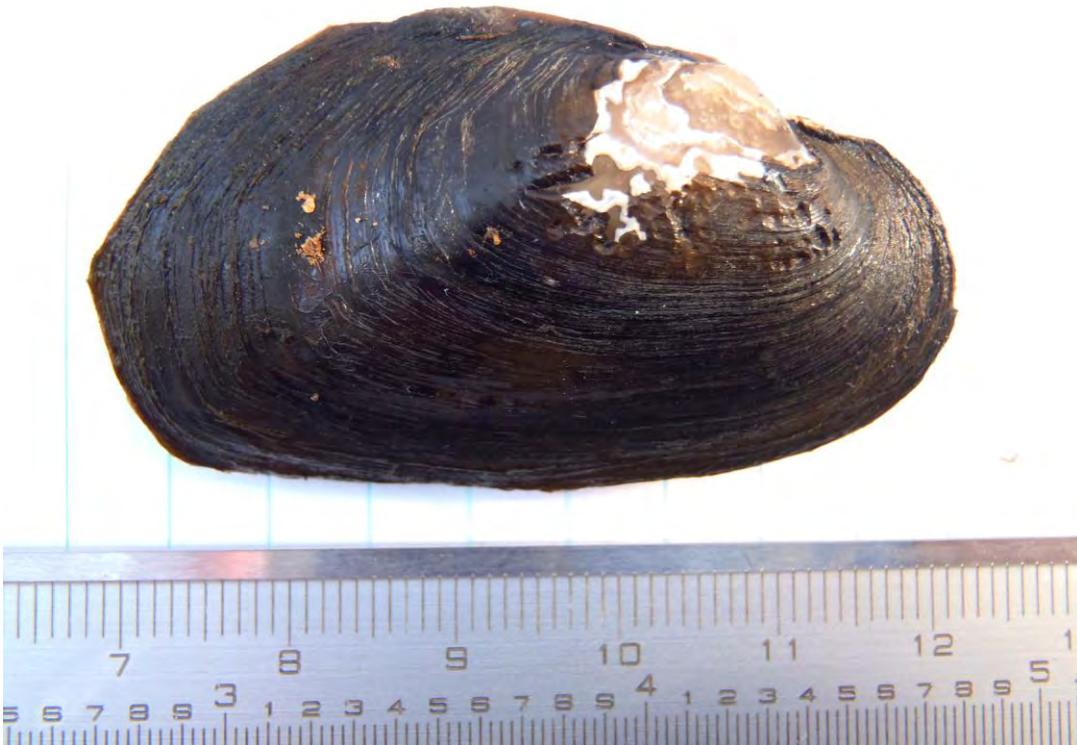
Figure 9.

Live *S. undulatus* observed in Ivy Creek

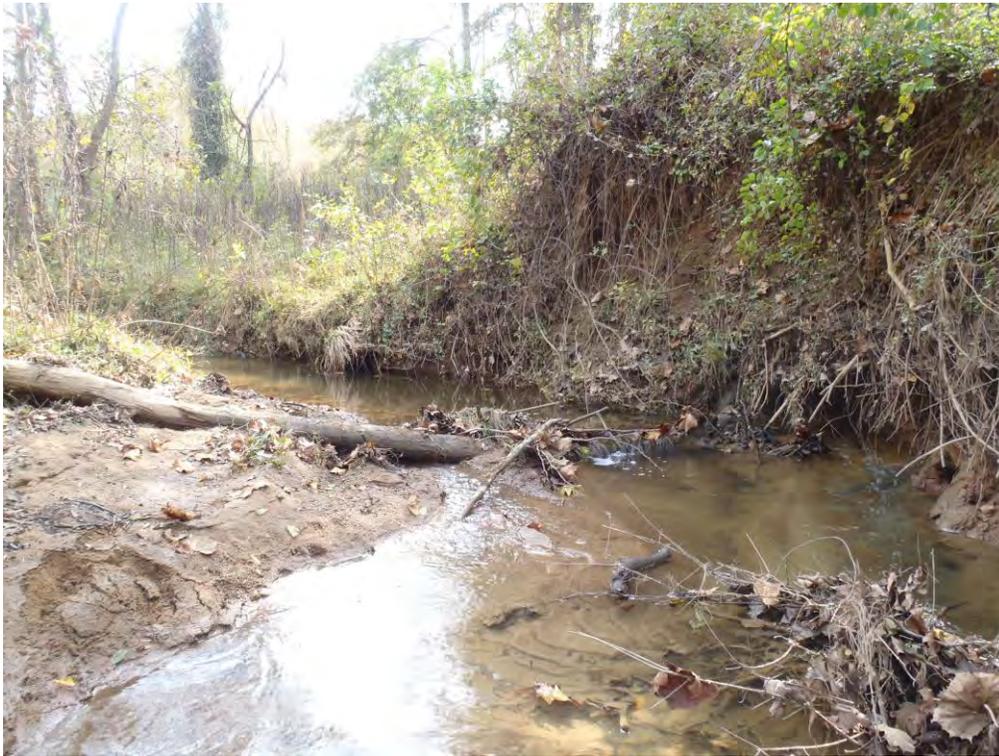
Downstream of a private bridge (formerly a state road) to its mouth, this tributary was similar to the reach of Ivy Creek at its confluence (Figure 10). It had unstable banks, and sand was the dominant substrate type. Upstream of the private bridge, this stream flowed mostly through a forested landscape. Unlike Ivy Creek, this stream was often influenced by an exposed bedrock streambed, had stable and low banks, and a considerable diversity of instream habitats and substrate types (Figures 11 and 12). Riffles and fast runs were minimally embedded by fine sediments. Mean thalweg depth was 0.3 m. Mean bankfull width was 5 m, and wetted width was 2 to 5 m. Banks were usually less than 1 m above the stream surface. We surveyed this

Figure 10. The reach of the unnamed tributary (Tributary K) downstream of the bridge and especially just upstream of its mouth, appeared to be more unstable than the reach upstream of the bridge.

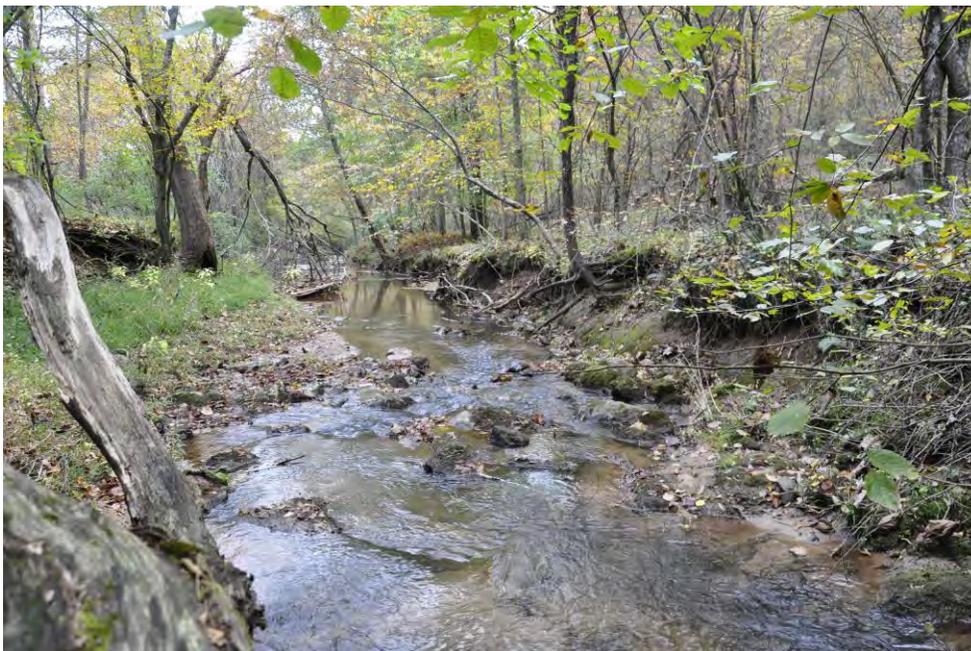
Figure 11. Habitat typical of the reach of the unnamed tributary flowing through the forested landscape. While healed over, there are signs of past erosion along banks.

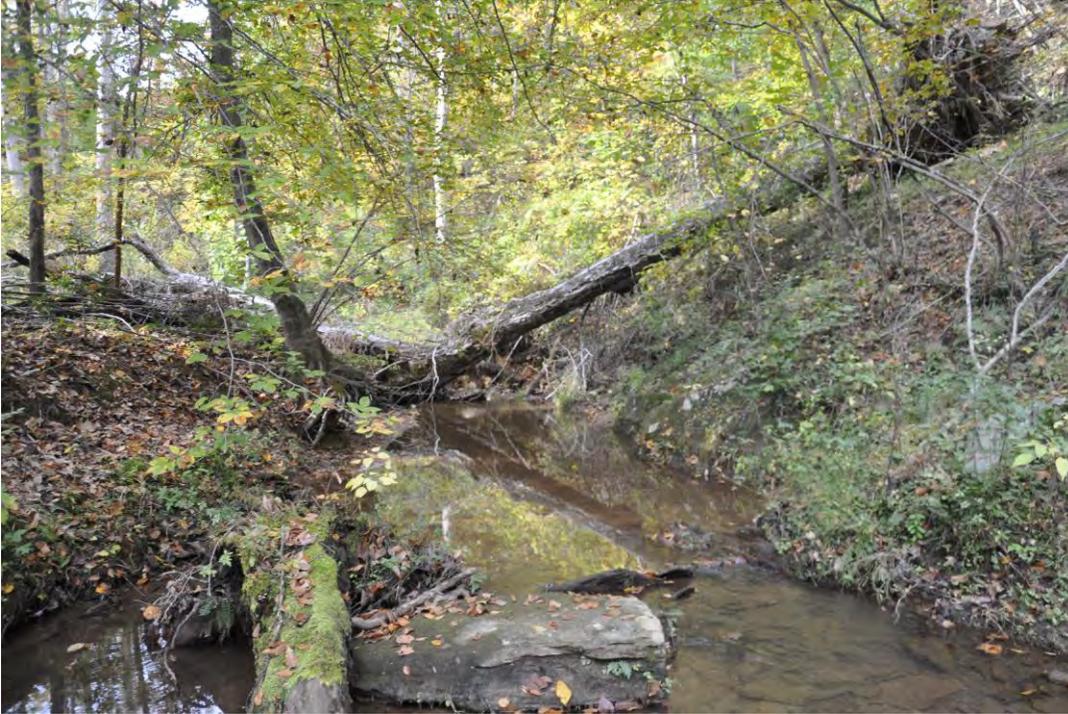
Figure 12. Unnamed tributary near upstream survey terminus.

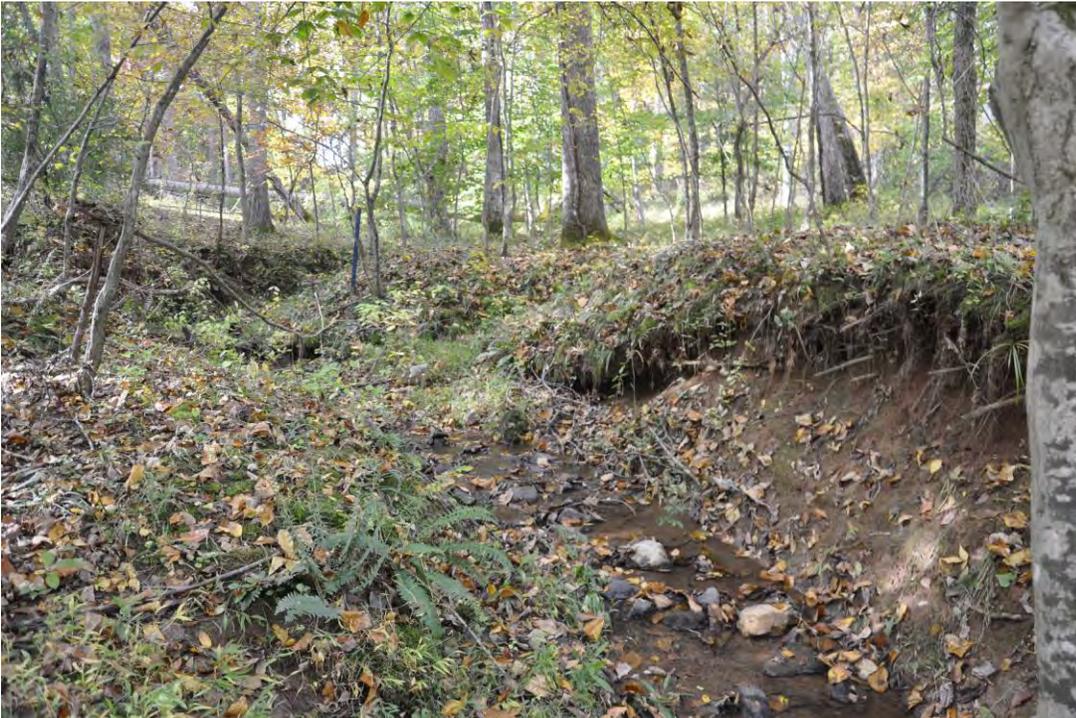
stream from its mouth to a point approximately 1,500 m upstream. Small tributaries feeding this stream were usually too small to support mussels and likely went dry during late summer and early fall (Figure 13). In an 8 person-hour effort, we found no evidence of freshwater mussels, snails or *C. fluminea*.

Figure 13. This photographed stream was typical of those feeding the unnamed tributary.

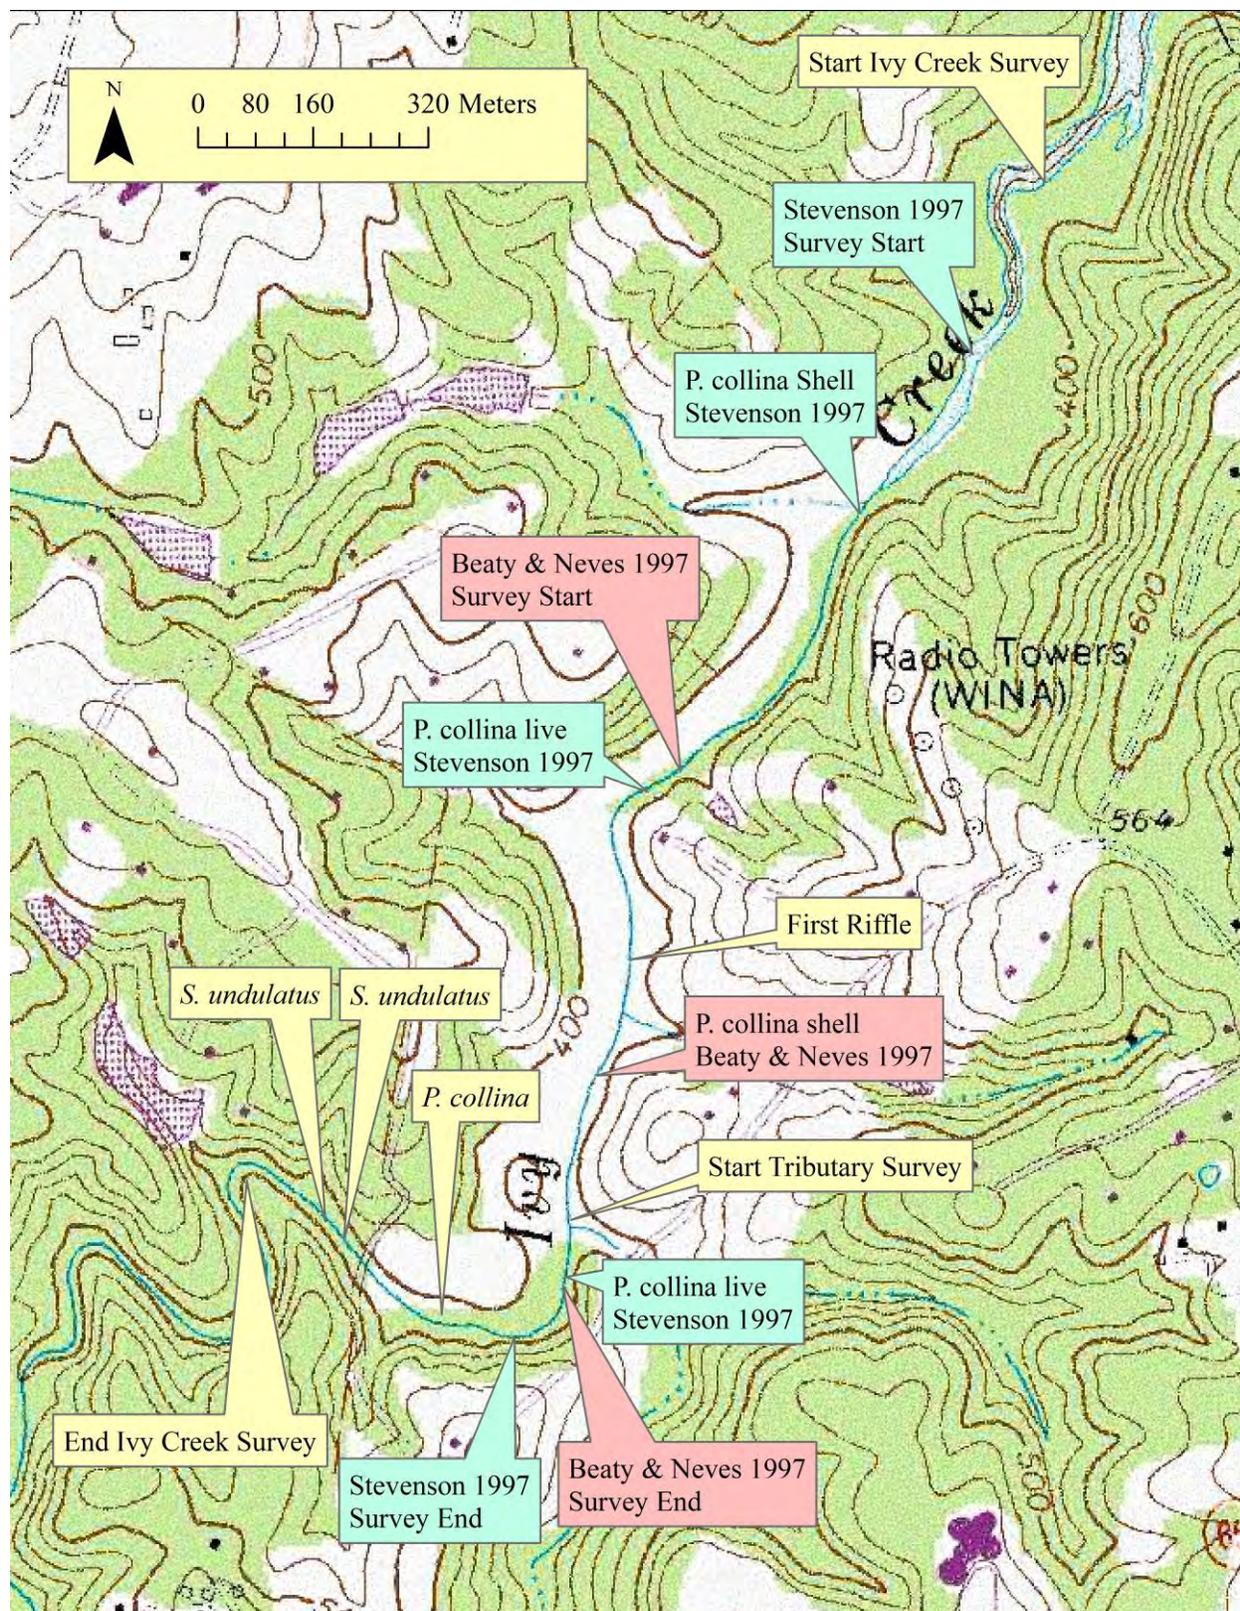
Figure 14. Survey boundaries and observations of *P. collina* in previous survey efforts in Ivy Creek. Because previous surveys did not use modern geo-referencing techniques, placement of earlier survey are based on maps in earlier reports.
