ENVIRONMENTAL ASSESSMENT

Route 29 Bypass

MANAGEMENT SUMMARY FOR ARCHITECTURAL SURVEY

August 3, 2012

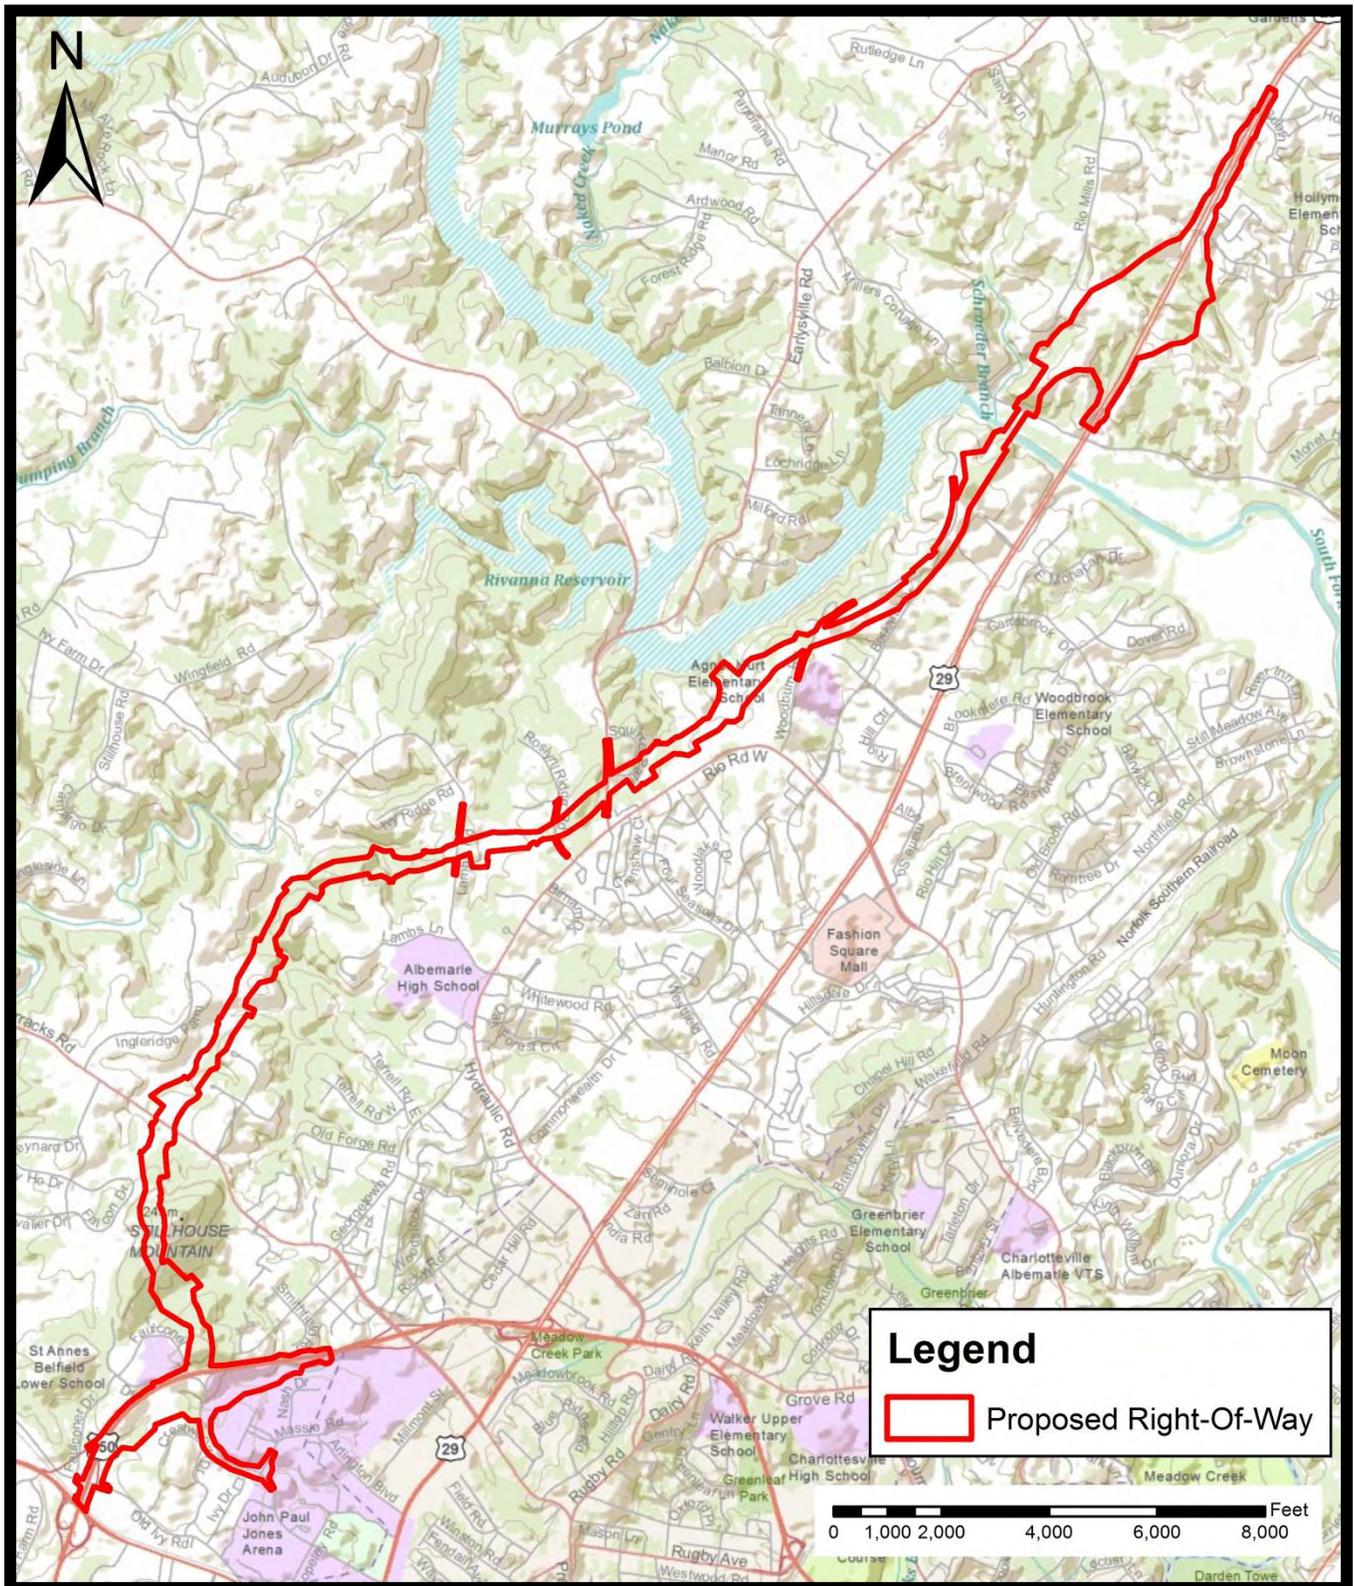
Figure 1.1-2: The Proposed Right-of-Way (ROW) for the Current Project. Note that the APE Includes the ROW (for Direct Effects), and Those Resources Adjacent to and Visible from the ROW Footprint (to Include Indirect Effects).

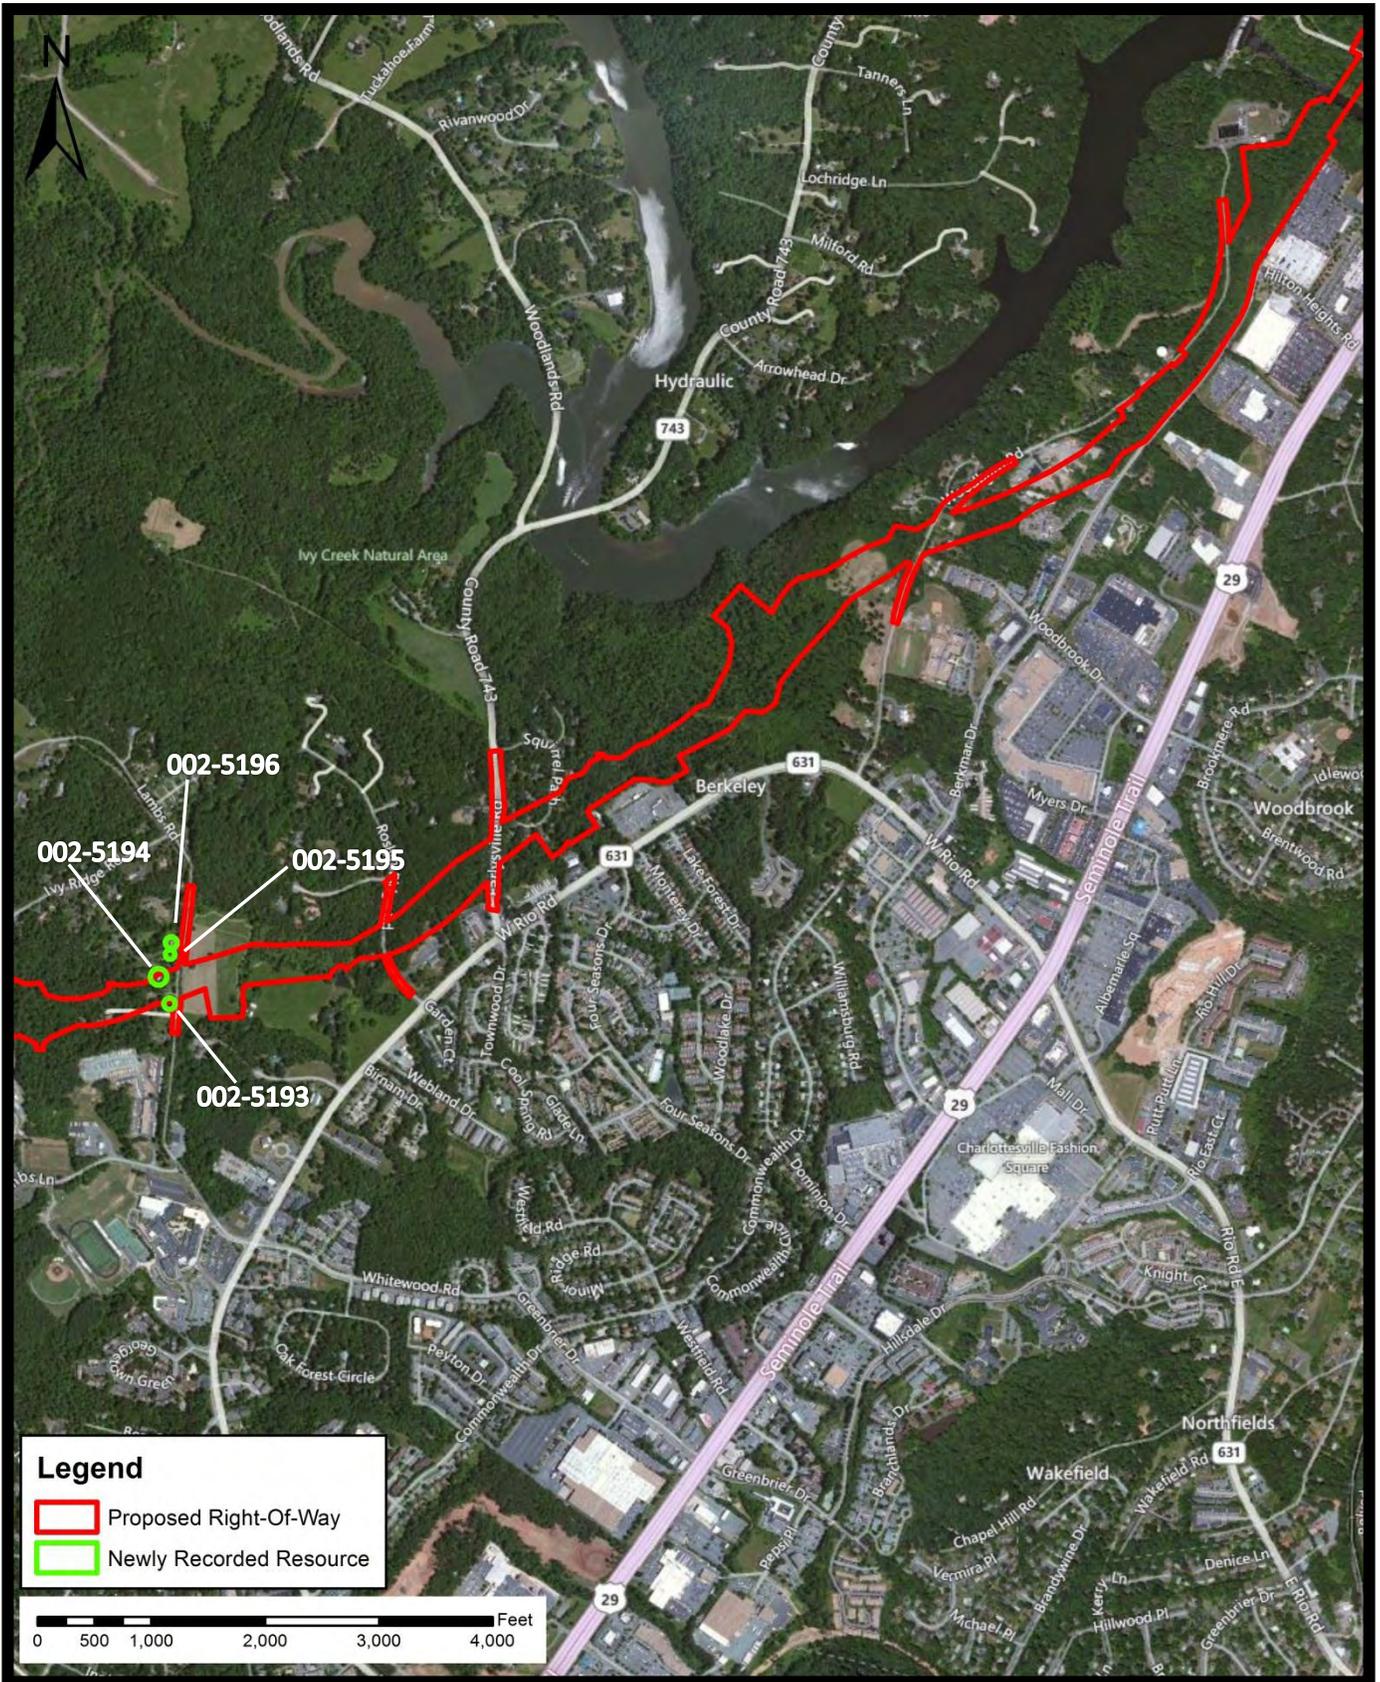
Figure 1.3-2: Locations of Newly Recorded Architectural Resources in the Current APE.

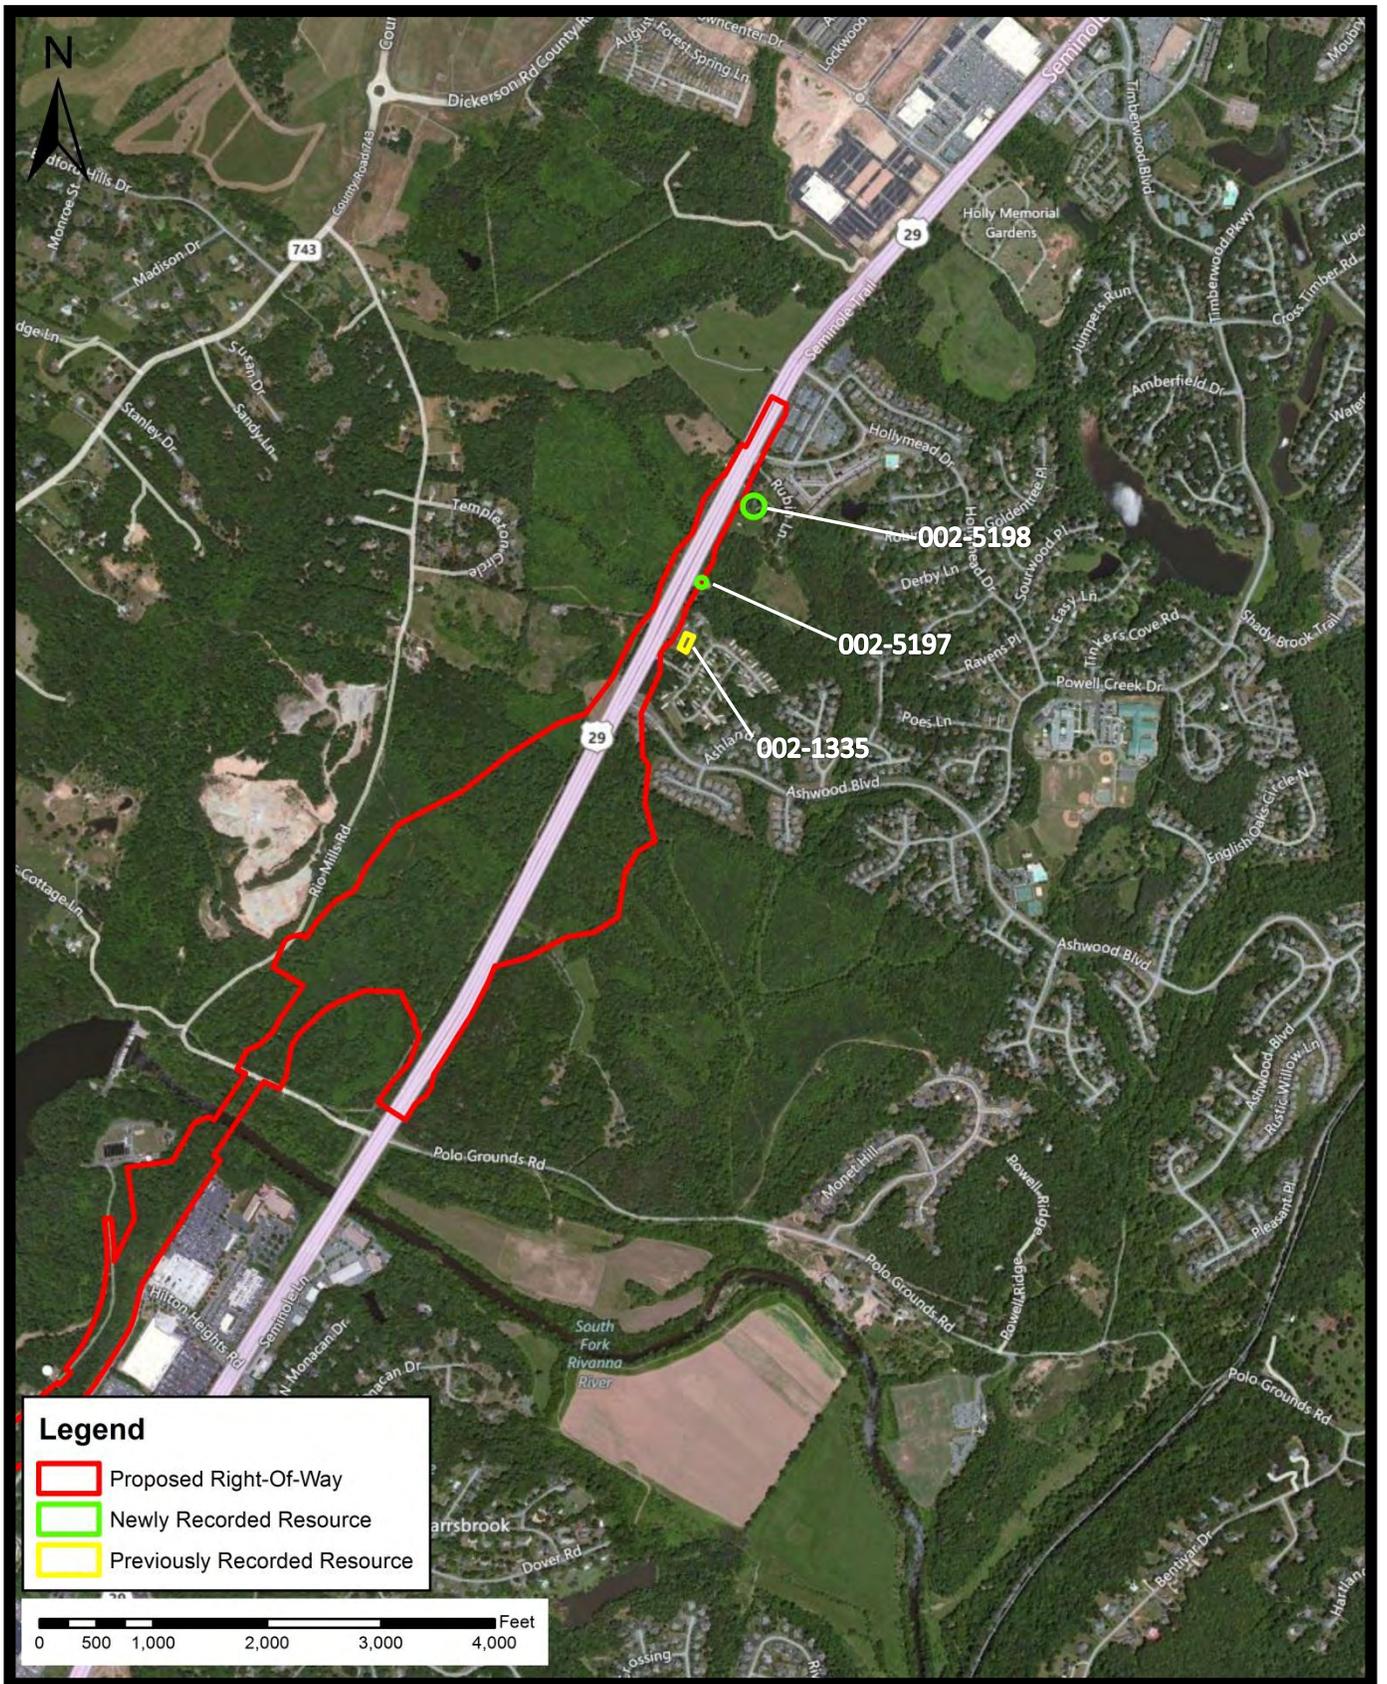
Figure 1.3-3: Locations of Newly Recorded Architectural Resources and Unevaluated Previously Recorded Resource in the Current APE.

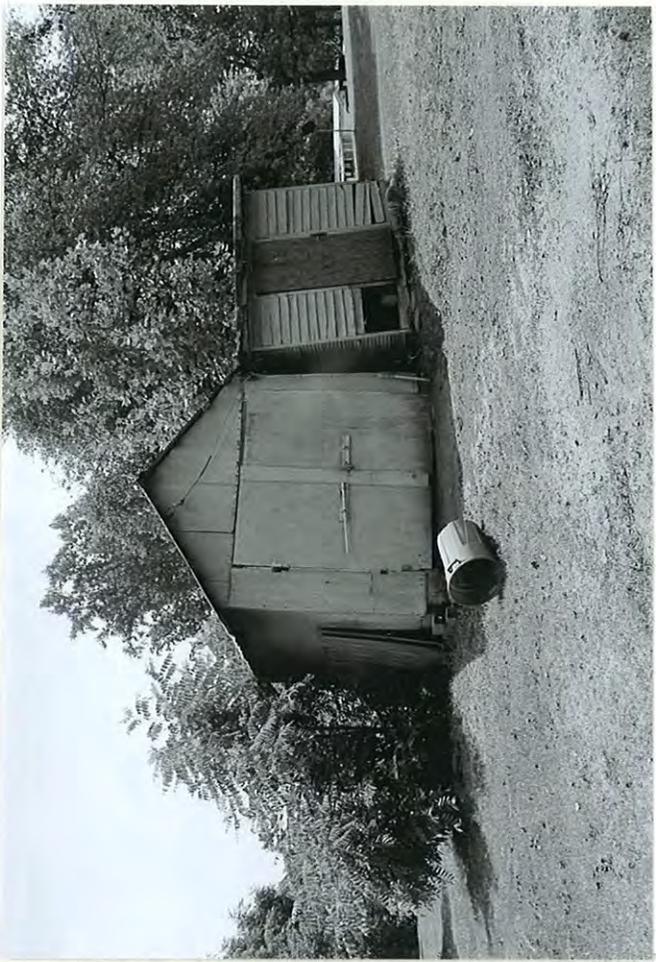
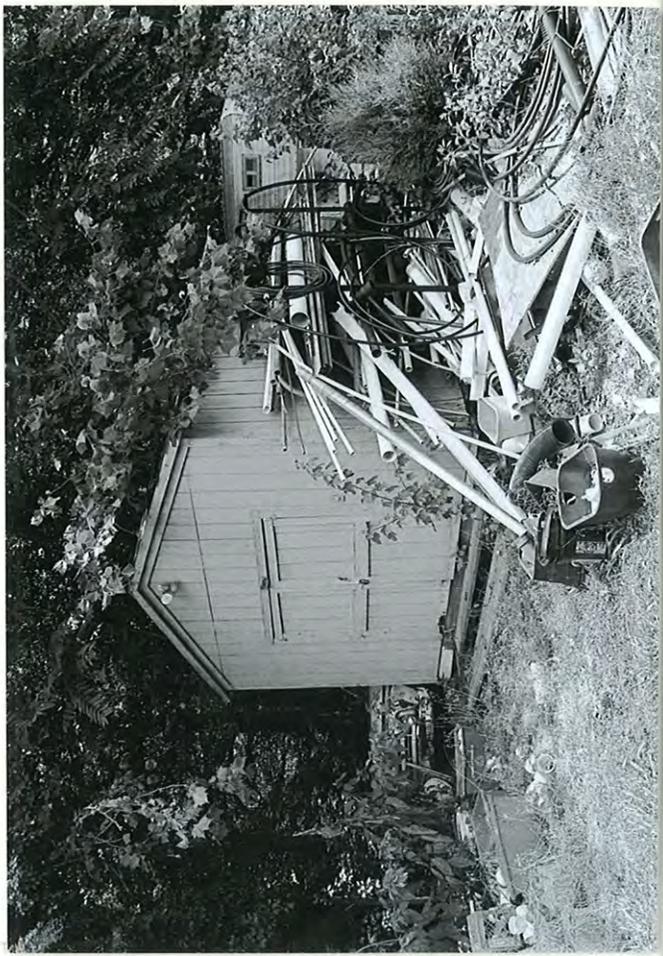
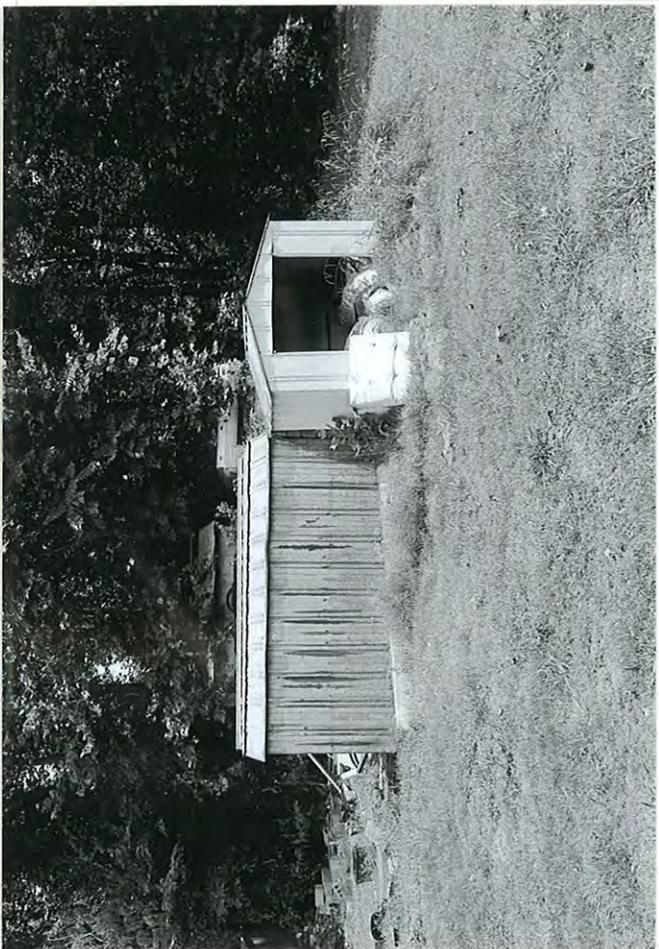
July 2012: Overall, this property retains a low level of integrity. The replacement of the original siding and windows on the motel units and the alterations to the rental-office building have affected its integrity, and the complex lacks significance and represents a common design for the period of construction and place. Furthermore, the complex has no significant association with any event or person important to our nation's history and does not appear to have the ability to yield important information. This architectural resource is recommended as not eligible for the NRHP under Criteria A, B, C, or D.

Motel, Route 29
002-1335
July 21, 2012
J. van den Turk, CCR
View of motel rental office, looking NE

Motel, Route 29
VDHR # 002-1335
7/21/2012
J. vanden Turk, CCR
View of Motel, looking W

Motel, Route 29
VDHR # 002-1335
7/21/2012
J. van den Turk, CCR
Detail of Motel Rental office window

Motel, Route 29
VDHR # 002-1335
7/21/2012
J. vanden Turk, CCR
View of Motel, looking S

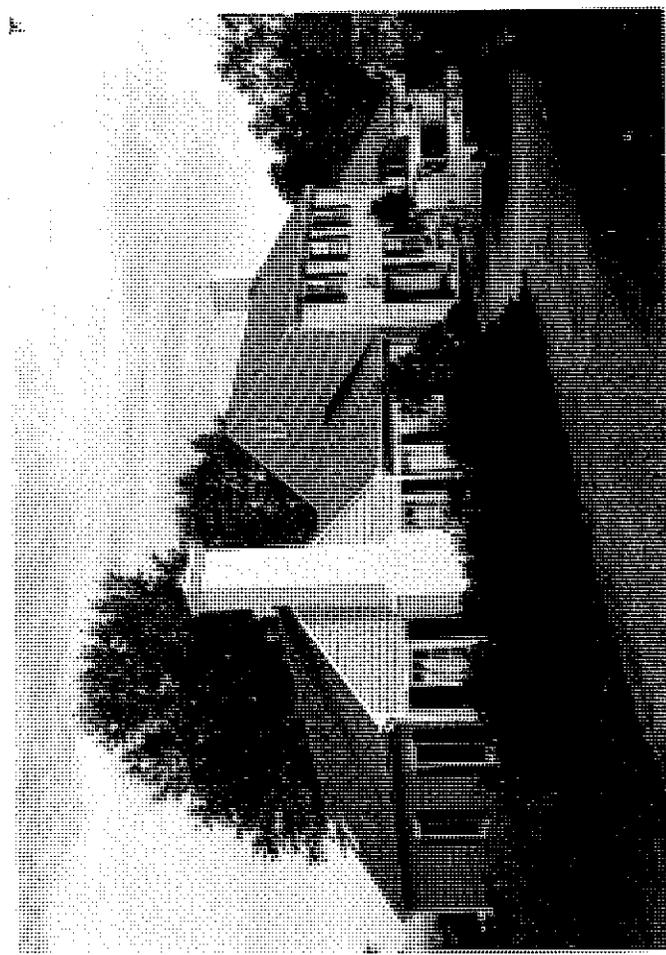
July 2012: Overall, this property retains a high level of integrity. However, the dwelling lacks significance and represents a common design for the period of construction and place. Furthermore, the dwelling has no significant association with any event or person important to our nation's history and does not appear to have the ability to yield important information. This architectural resource is recommended as not eligible for the NRHP under Criteria A, B, C, or D.

Stilfield (House, 2805 Barracks Rd.)
VDHR# 002-5189
7/21/2012
J. van den Hurk, CCR
View of House, looking N

Stilfield (House, 2805 Barracks Rd.)
VDHR# 002-5189
7/21/2012
J. van den Hurk, CCR
View of Garage/Pool house, looking N

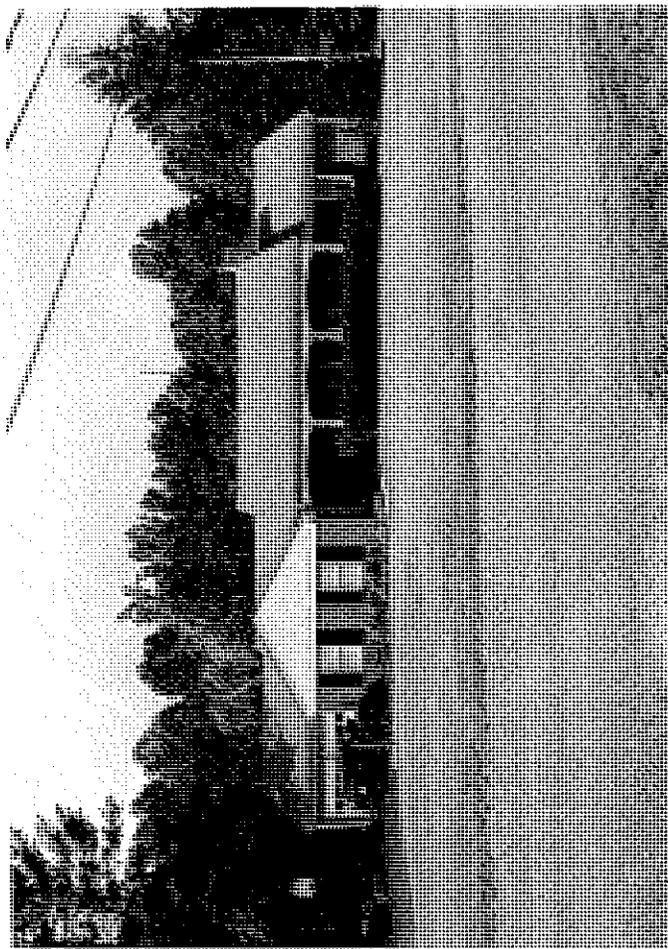
July 2012: Overall, this property retains a high level of integrity. However, the dwelling lacks significance and represents a common design for the period of construction and place. Furthermore, the dwelling has no significant association with any event or person important to our nation's history and does not appear to have the ability to yield important information. This architectural resource is recommended as not eligible for the NRHP under Criteria A, B, C, or D.

House, 219 Montvue Drive
VDHR # 008-5190
7/21/2012
J. van den Hurk, CCR
View of House, looking NE

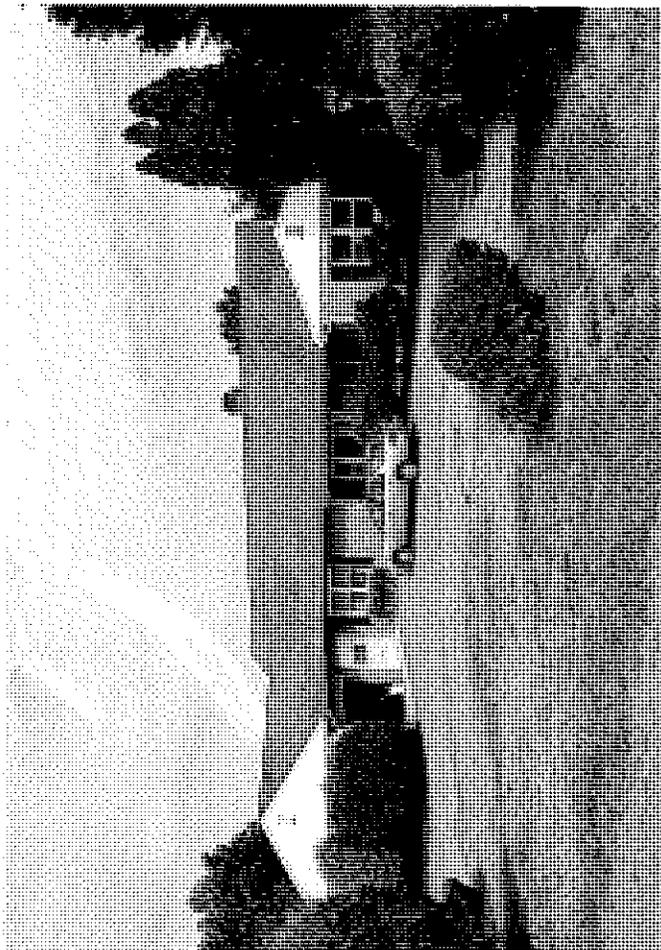
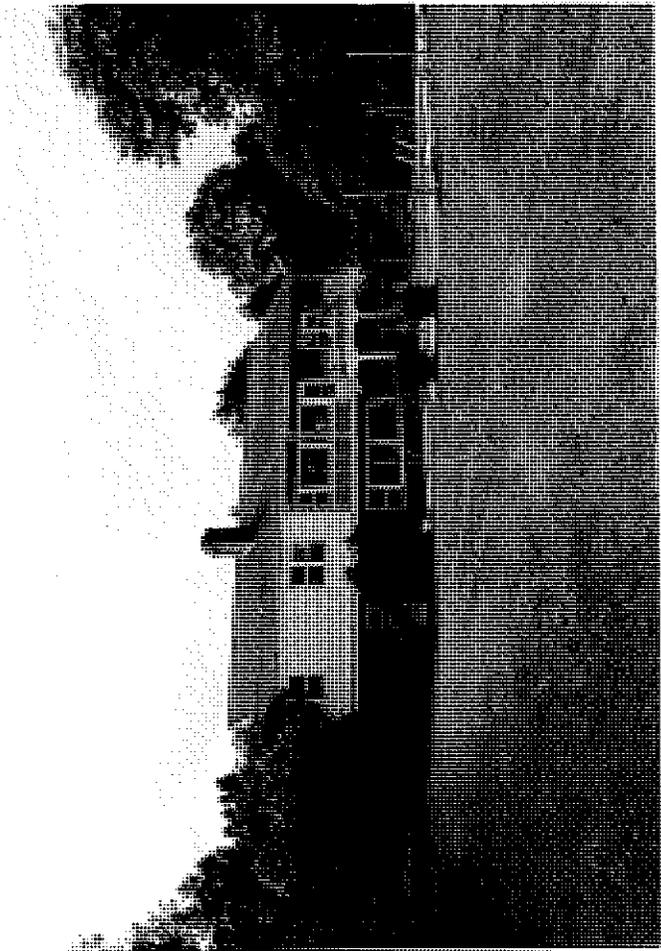
July 2012: Overall, this property retains a high level of integrity. However, the dwelling lacks significance and represents a common design for the period of construction and place. Furthermore, the dwelling has no significant association with any event or person important to our nation's history and does not appear to have the ability to yield important information. This architectural resource is recommended as not eligible for the NRHP under Criteria A, B, C, or D.

House, 223 Montvue Drive
VDHR# 002-5191
7/21/2012
J. van den Hurk, CCR
View of House, looking SE

House, 223 Montvue Drive
VDHR# 002-5191
7/21/2012
J. van den Hurk, CCR
View of House, looking NW

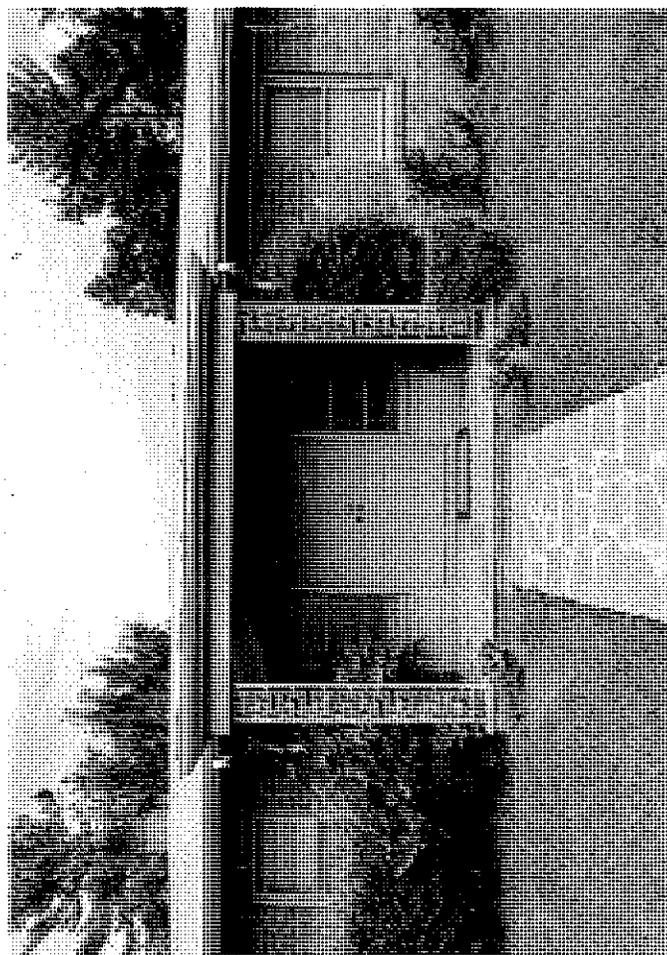
House, 225 Montvue Drive
VDNR# 002-5192
7/21/2012
J. van den Hurk, CCR
Detail of Entry

House, 225 Montvue Drive
VDNR# 002-5192
7/21/2012
J. van den Hurk, CCR
View of House, looking NW

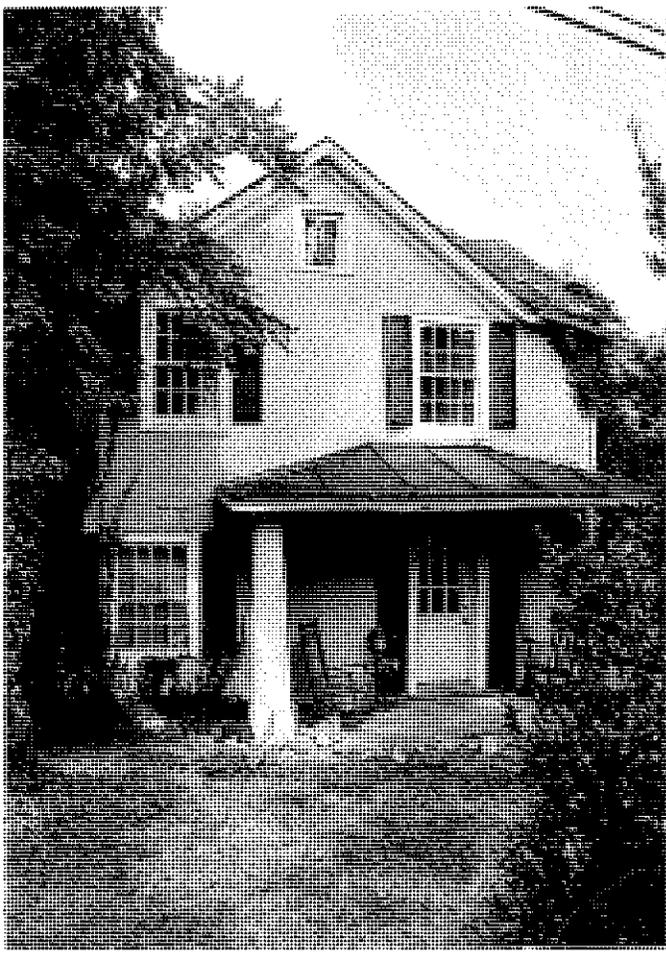
July 2012: Overall, this property retains a low level of integrity. The addition of the stucco has affected its integrity, and the dwelling lacks architectural significance. Furthermore, the dwelling has no significant association with any event or person important to our nation's history and does not appear to have the ability to yield important information. This architectural resource is recommended as individually not eligible for the NRHP under Criteria A, B, C, or D.

House, 1975 Lambs Road
VDHR# 002-5193
7/21/2012
J. van den Hurk, CCR
View of House, Looking SE

House, 1975 Lambs Road
VDHR# 002-5193
7/21/2012
J. van den Hurk, CCR
View of House, Looking W

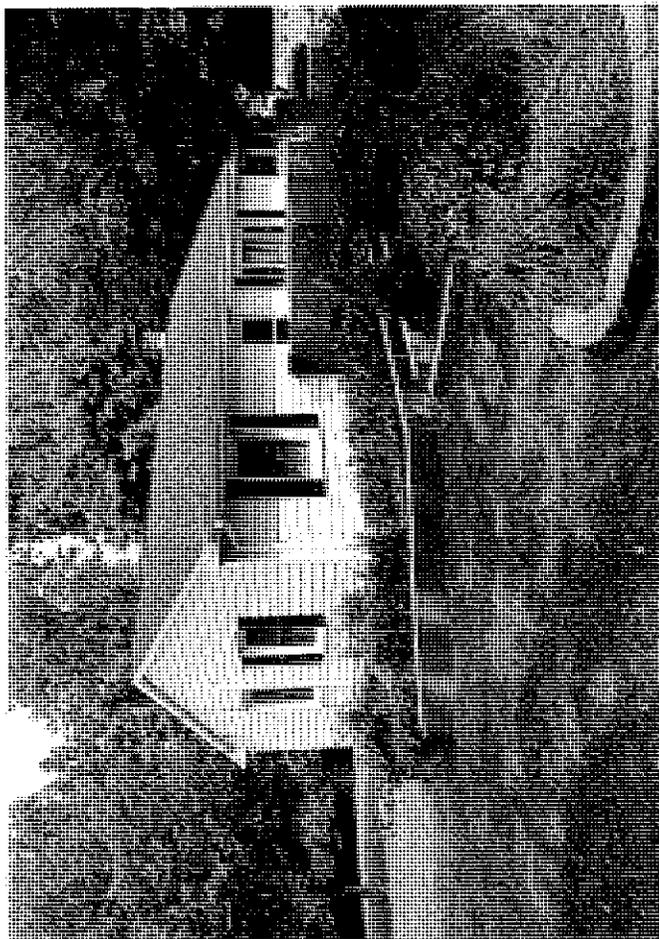
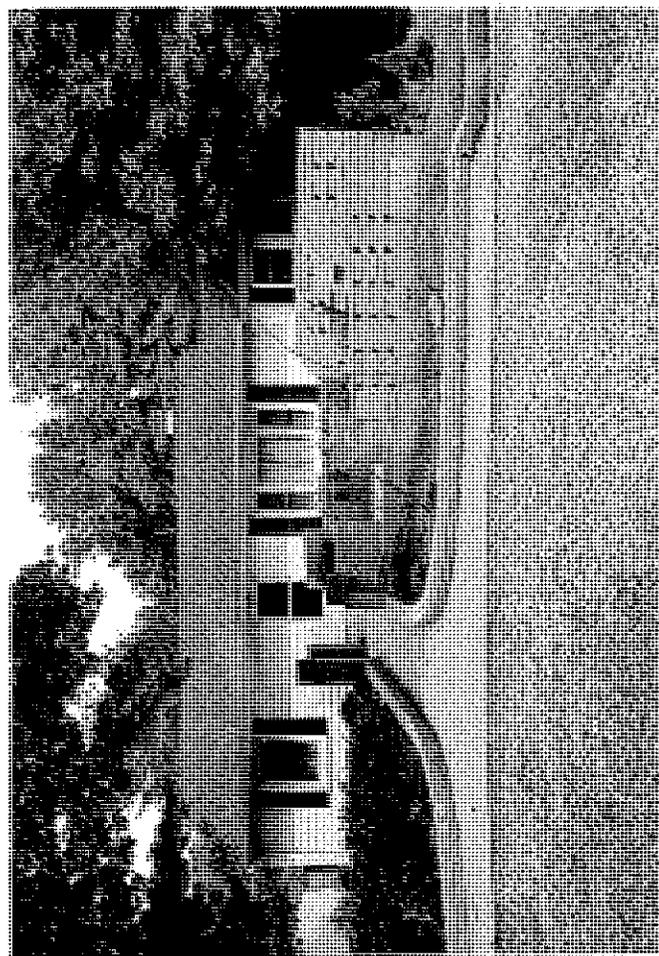
July 2012: Overall, this property retains a low level of integrity. The replacement of the original siding and windows have affected its integrity, and the dwelling lacks significance and represents a common design for the period of construction and place. Furthermore, the dwelling has no significant association with any event or person important to our nation's history and does not appear to have the ability to yield important information. This architectural resource is recommended as not eligible for the NRHP under Criteria A, B, C, or D.

House, 1935 Lambs Road
VDHR # 002-5195
7/21/2012
J. van den Hurk, CCR
View of House, looking W

House, 1935 Lambs Road
VDHR # 002-5195
7/21/2012
J. van den Hurk, CCR
View of House, looking NW

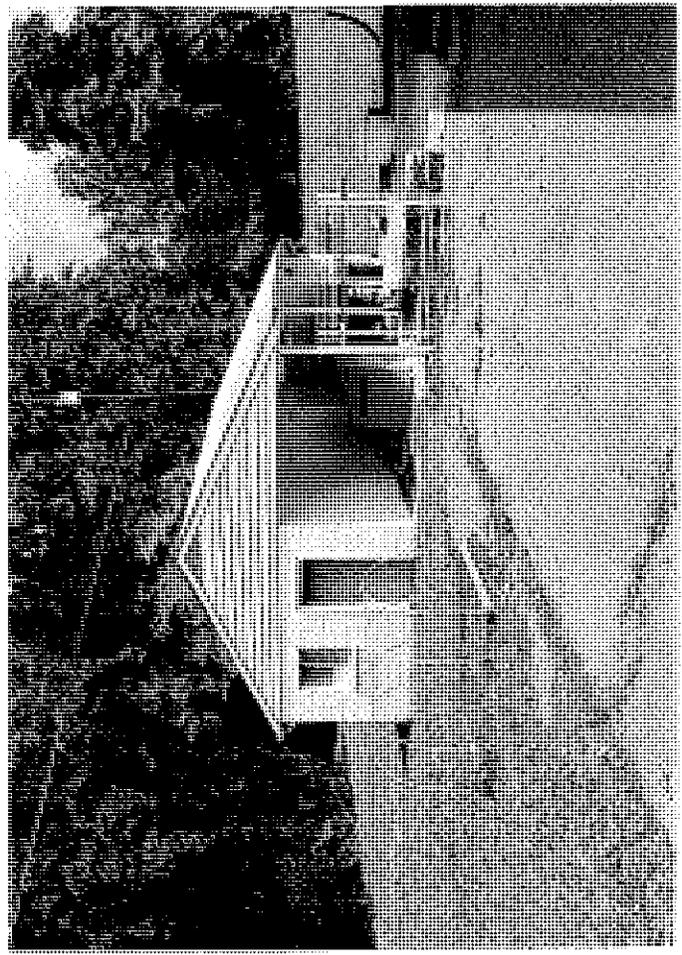
House, 1925 Lambs Road
VDHR 002-5196
7/21/2012
J. van den Hurk, CCR
View of House, looking West

House, 1925 Lambs Road
VDHR# 002-5196
7/21/2012
J. van den Hurk, CCR
View of House, looking NE

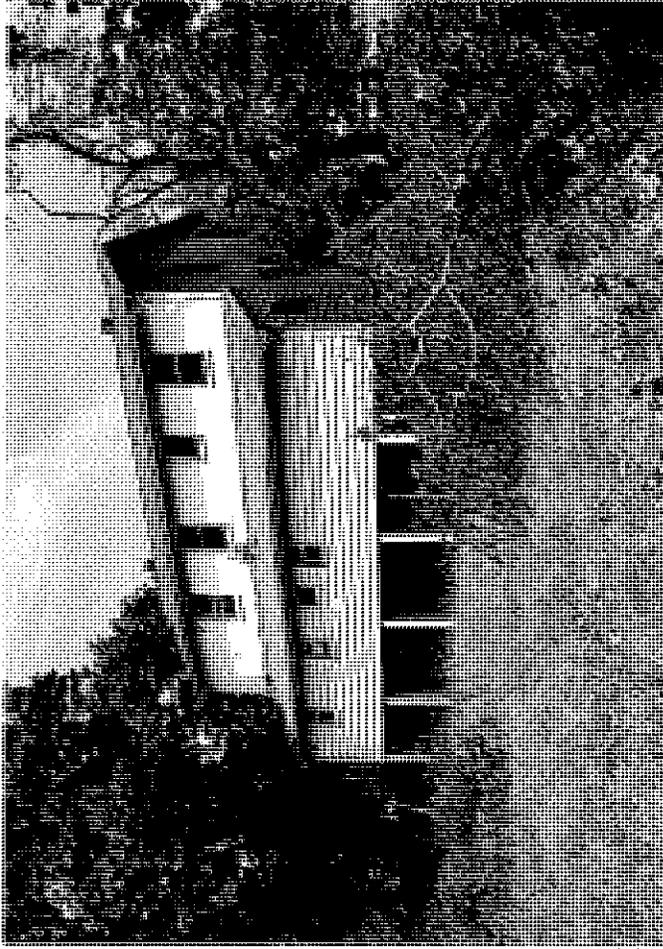
Store, 2891 Seminole Trail
VDHR# 002-5197
7/21/2012
J. van den Hurk, CCR
View of building, looking W
