Route 151 Corridor Study

Public Information Meeting

March 14, 2013

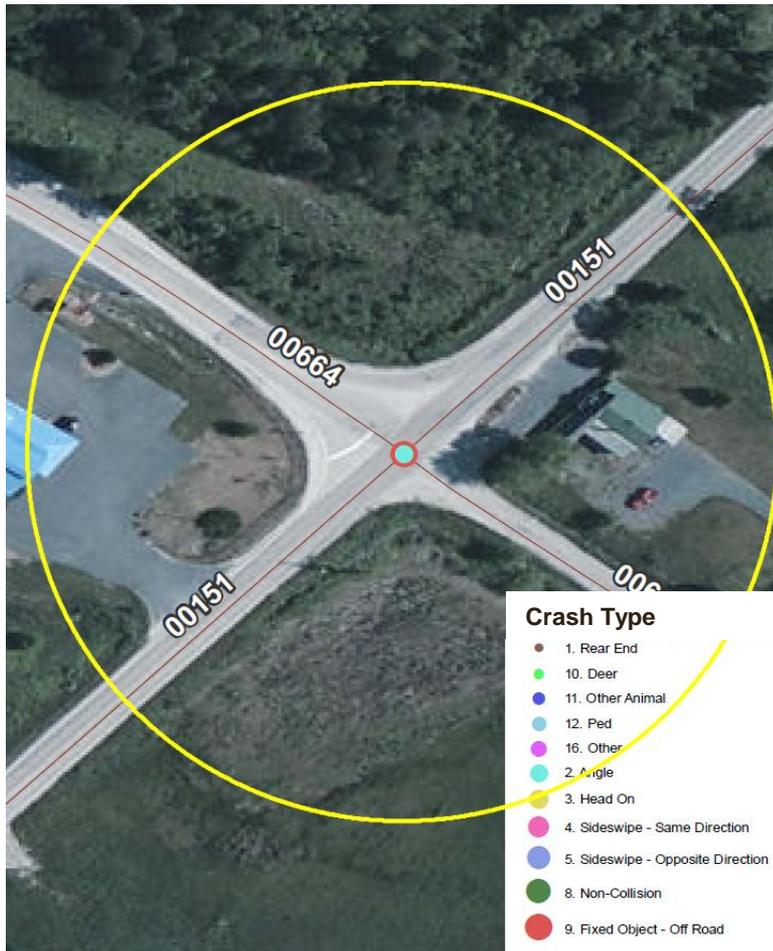
1) Rte. 151 at Rte. 664 (Beech Grove Road)

Two crashes

- Angle
- Off-road

Issues

- Heavy southbound right turn traffic
- Overgrown vegetation
- Confusing signage

Potential improvements

- Add southbound offset right turn bay
- Trim vegetation in northwest quadrant
- Adjust signage along northbound Rte. 151

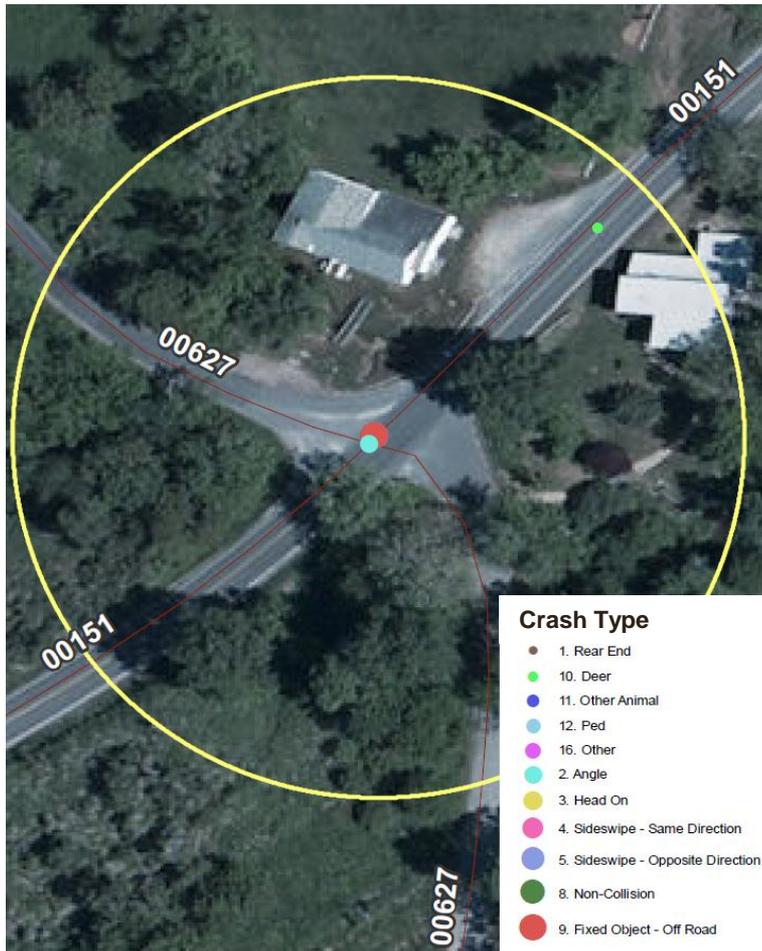
2) Rte. 151 at Rte. 627 (Spruce Creek Lane)

Three crashes

- Angle
- Off-road
- Wildlife

Issues

- Poor sight distance
- Odd alignment of Rte. 627 affects turning traffic
- Location of driveways within intersection area
- Potential historic structure (mill foundation)

Potential improvements

- Modify embankment in southwest quadrant
- Realign Rte. 627 to improve sight distance
- Add intersection-ahead signage with flashers on the northbound approach

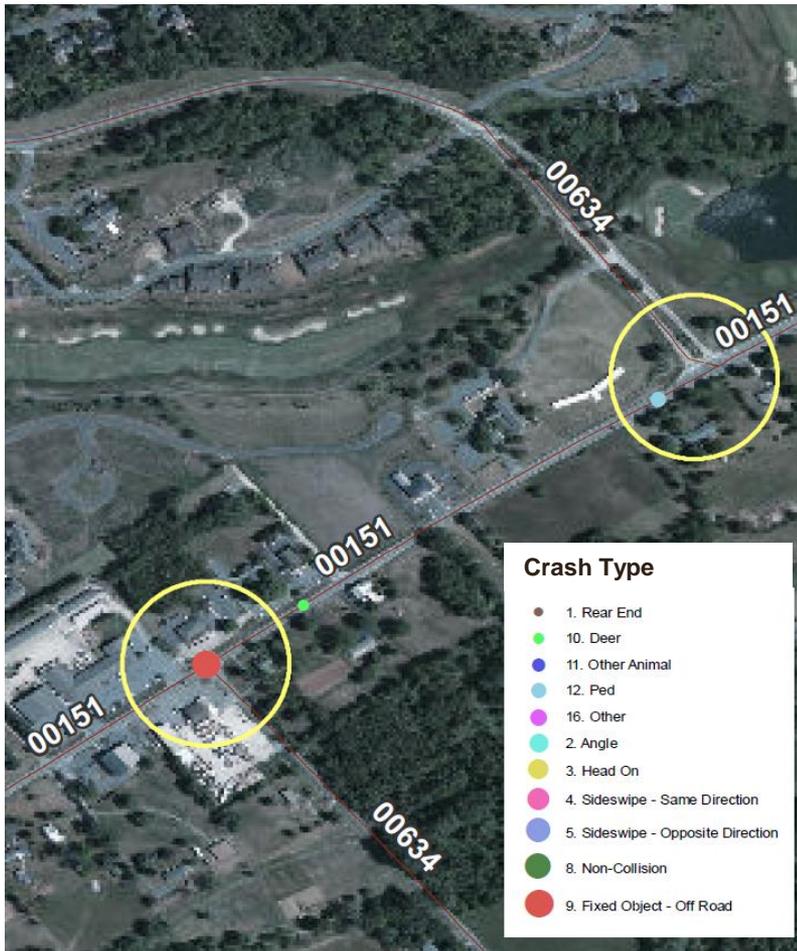
3) Rte. 151 at Rte. 634 (Nellysford area)

Three crashes

- Pedestrian
- Off-road
- Wildlife

Issues

- Lack of pedestrian facilities
- Access Management/Poor inter-parcel connectivity
- Vegetation on Rte. 634 (Adial Road) limits sight distance approaching Rte. 151

Potential improvements

- Add sidewalks for pedestrians
- As new development or re-development occurs, improve access management and inter-parcel connectivity
- On Adial Road, trim vegetation and relocate stop sign
- Reduce speed limit to 35 mph through Nellysford

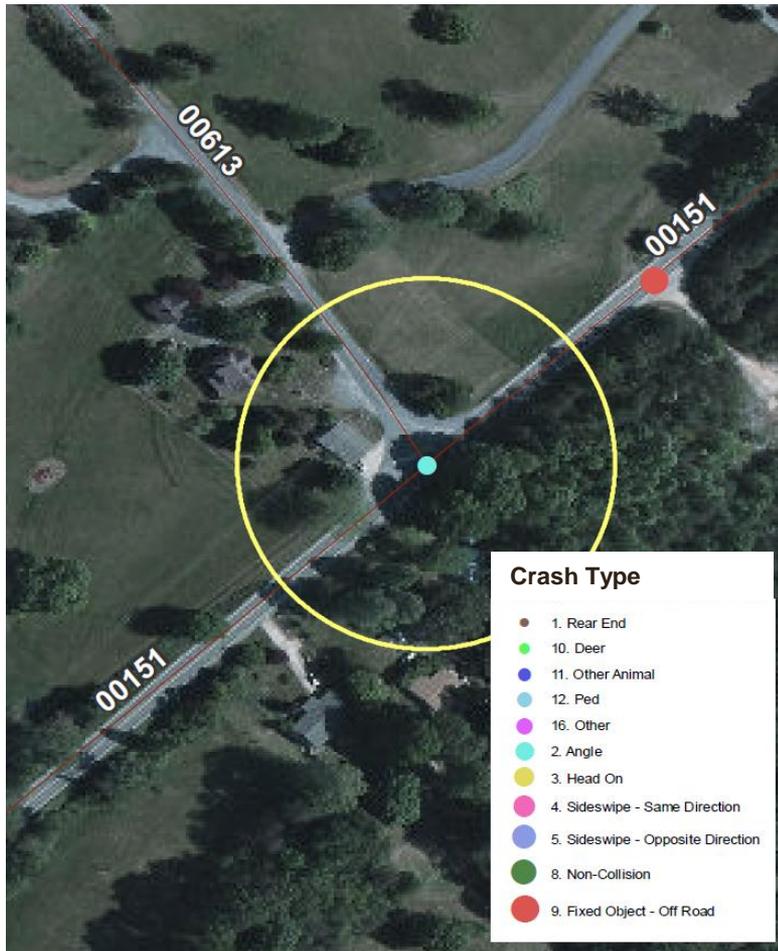
4) Rte. 151 at Rte. 613 (Rodes Farm and Lodebar Estates)

Two crashes

- Angle
- Off-road

Issues

- Crest in road between Rodes Farm Road and Lodebar Estates limits sight distance
- Embankment along east side of Rte. 151 also contributes to sight distance issues
- Drivers have to be aggressive turning onto Rte. 151

Potential improvements

- Regrade roadway in area to improve sight distance
 - Reduce crest of hill
 - Regrade embankment

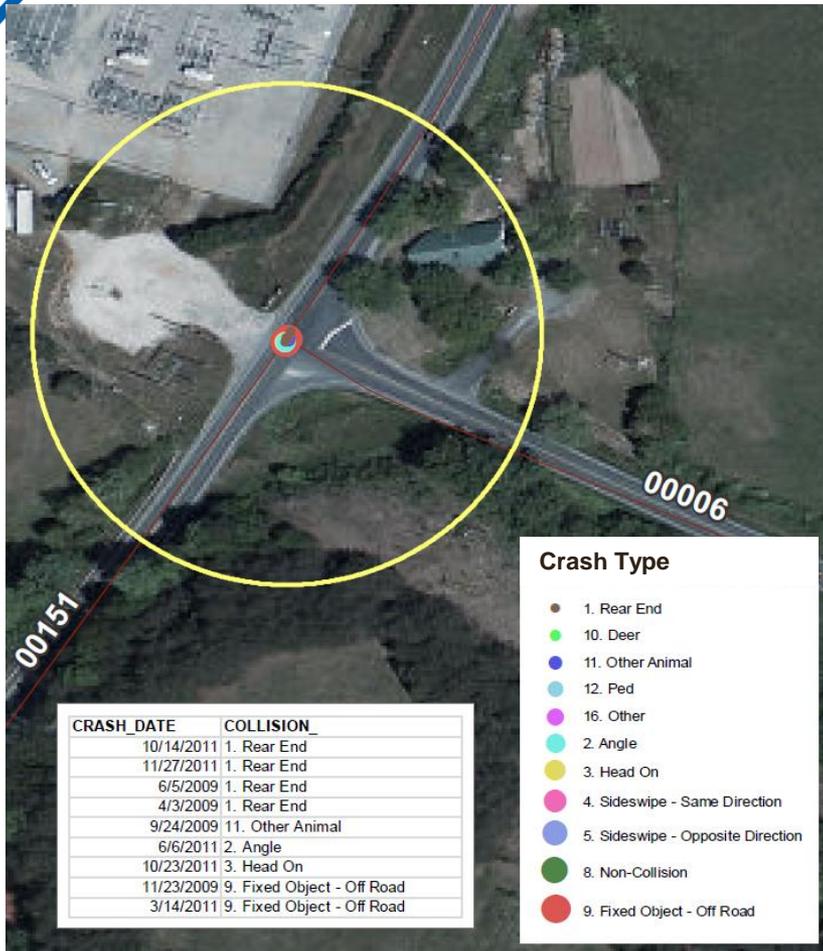
5) Rte. 151 at Rte. 6 (River Road)

Multiple crashes

- 4 Rear-end
- 1 Angle
- 2 Off-road

Issues

- Heavy turning truck traffic
- Lack of turn lane
- Narrow receiving area, vehicles are crossing yellow lines (traveling into opposite lane)

Potential improvements

- Widen east leg of intersection for wider receiving area to accommodate turning vehicles
- Consider roundabout

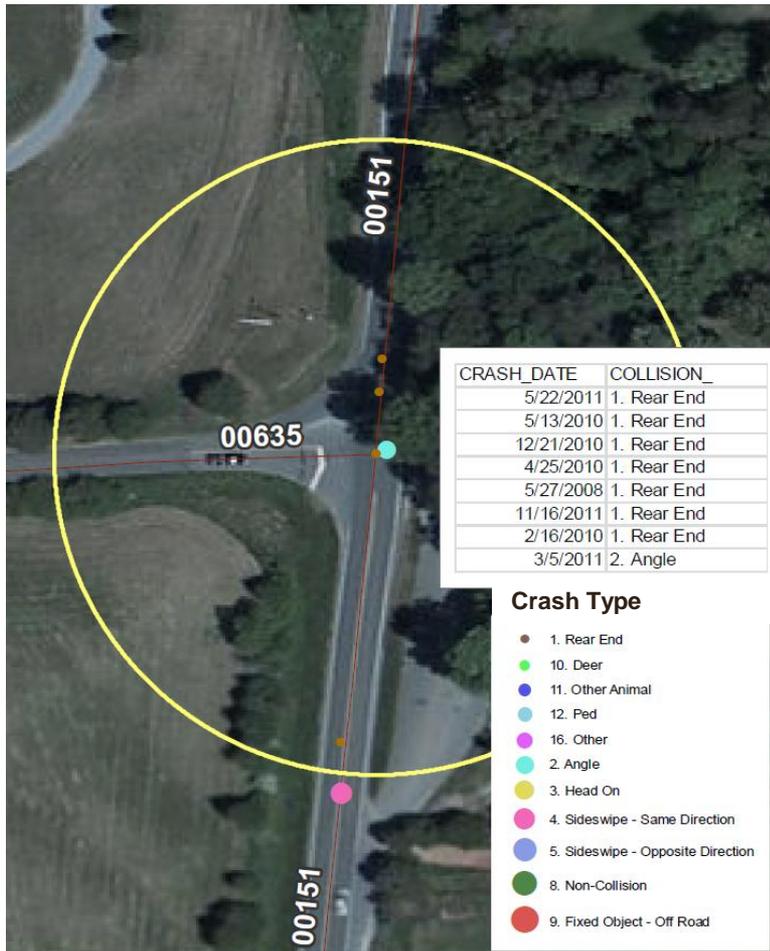
6) Rte. 151 at Rte. 635 (Rockfish School Lane)

Multiple crashes

- 7 Rear-end
- 1 Angle

Issues

- **Increased in crashes last two years**
 - Due to addition of Recycling Drop-off at Community Center
 - Park activities generate high traffic: soccer fields, horse and dog shows
- **Lack of turn lanes**

Potential improvements

- **VDOT is currently in process to obtain HSIP grant to add a northbound turn lane**

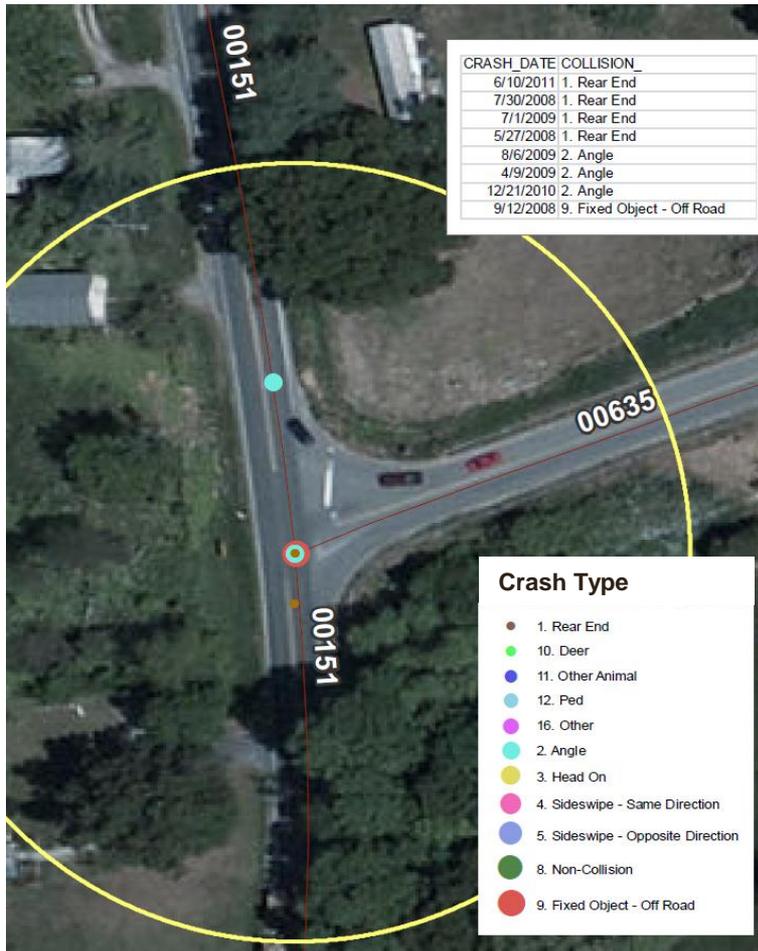
7) Rte. 151 at Rte. 635 (Greenfield Road)

Multiple crashes

- 4 Rear-end
- 3 Angle
- 1 Fixed object/off-road
- Most in 2008 & 2009

Issues

- Location recently improved
- Short northbound right turn bay

Potential improvements

- Extend northbound right turn bay

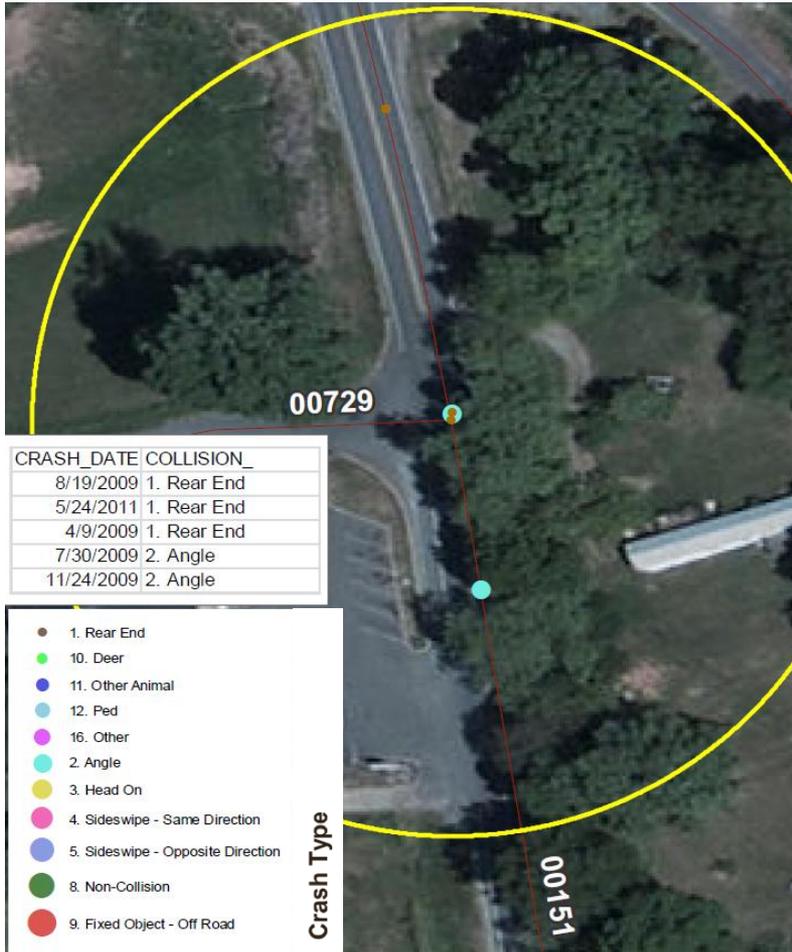
8) Rte. 151 at Rte. 729 (Creek Road)

Multiple crashes

- 3 Rear-end
- 2 Angle

Issues

- Turning traffic and lack of turn bays
- Heavy traffic generator (store)

Potential improvements

- Restripe roadway to provide northbound left turn into the store's southern access
- Add a southbound right turn bay onto Creek Road

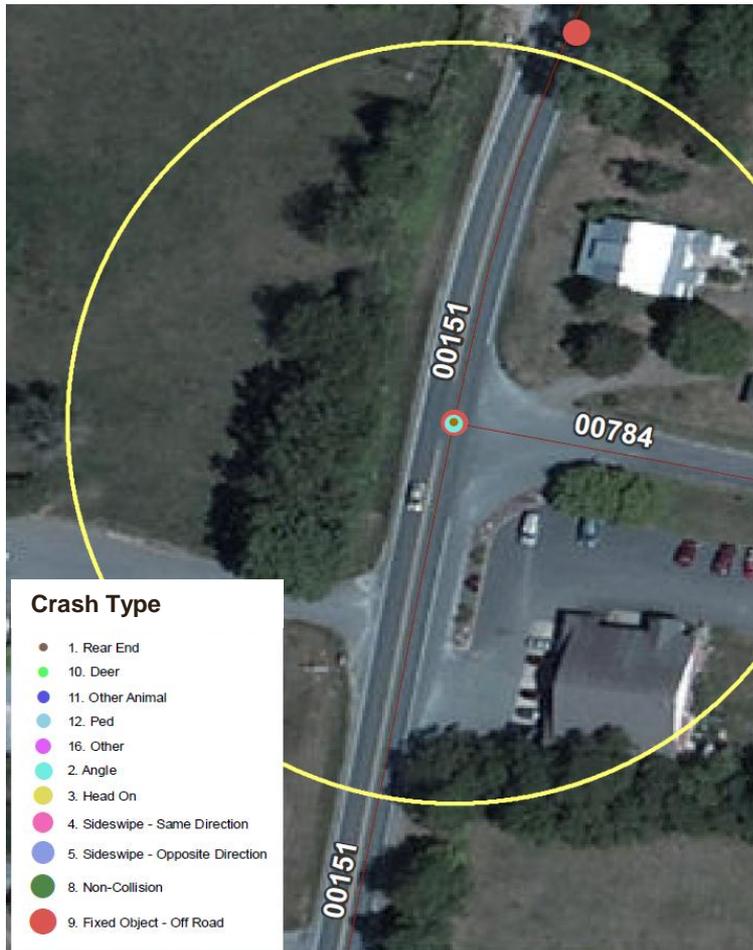
9) Rte. 151 at Rte. 784 (Bland Wade Lane)

Multiple crashes

- 1 Rear-end
- 1 Angle
- 2 Off-road

Issues

- Limited sight distance due to hill in northeast quadrant
- Limited sight distance due to dip in road to the south
- Businesses (Fitness Center, former Doctor's office) at intersection
 - Traffic cuts through Fitness Center lot

Potential improvements

- Regrade hill to improve sight distance and eliminate dip in road
- Add a northbound right turn bay
- 35 mph advisory speed sign with flashers already present

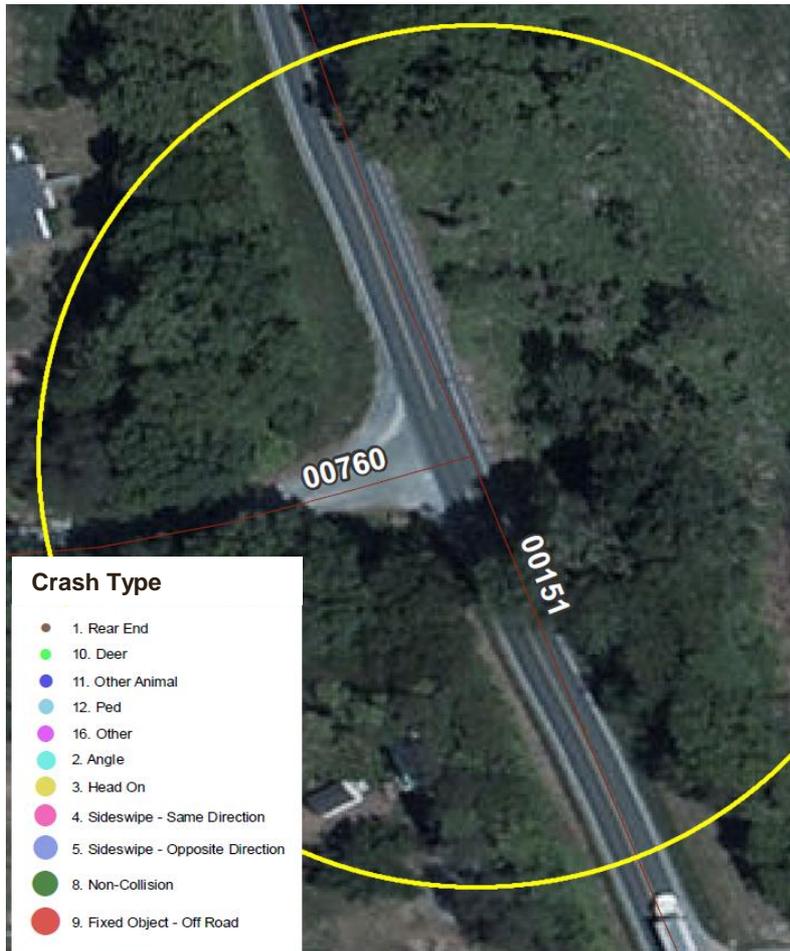
10) Rte. 151 at Rte. 760 (Sunrise Drive)

No reported crashes for analysis years

- **Crash debris present south of intersection during site visit**
- **Guardrail condition indicates two accidents**

Issues

- Limited sight distance due to crest in roadway to the south
- Portion of guardrail in poor condition

Potential improvements

- Regrade roadway to reduce crest
- Modify embankment in southwest quadrant
- Rehabilitate guardrail and improve drainage

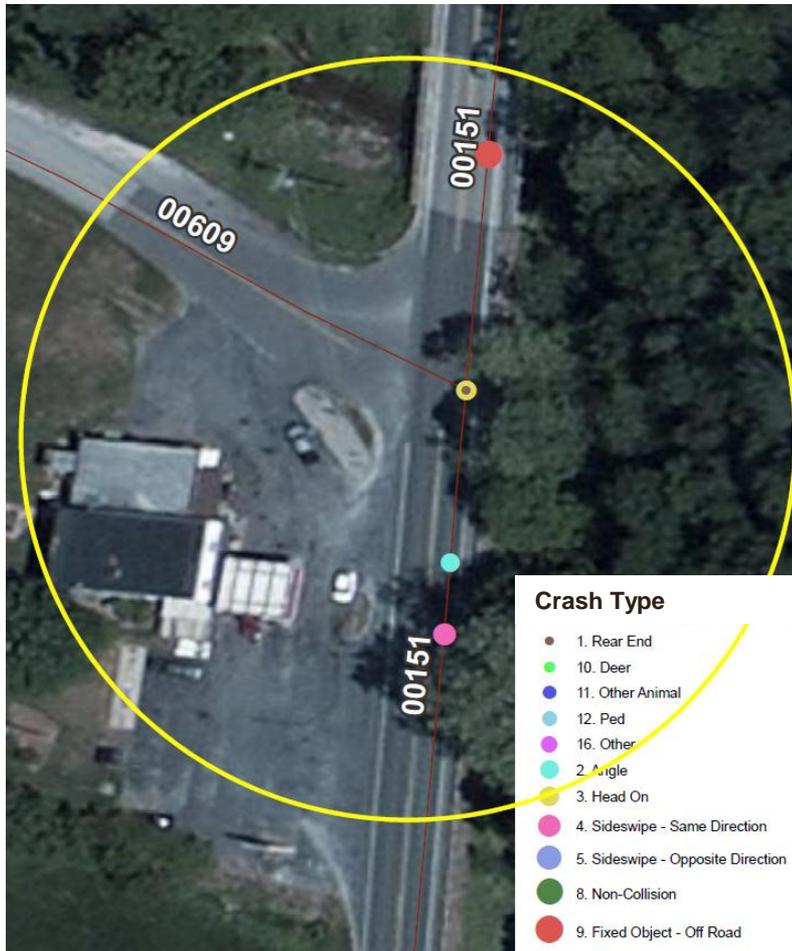
11) Rte. 151 at Rte. 609 (Mill Lane)

Multiple crashes

- 1 Rear-end
- 1 Angle
- 1 Fixed Object/Off-road
- 1 Sideswipe

Issues

- **Poor sight distance**
 - Goodwins Creek bridge
 - Overgrown vegetation
- **Driveways of gas station in close proximity of intersection**

Potential improvements

- **Trim vegetation**
- **Improve access management**
- **Improve signage on Rte. 151 for Rte. 609**
- **Widen bridge structure**

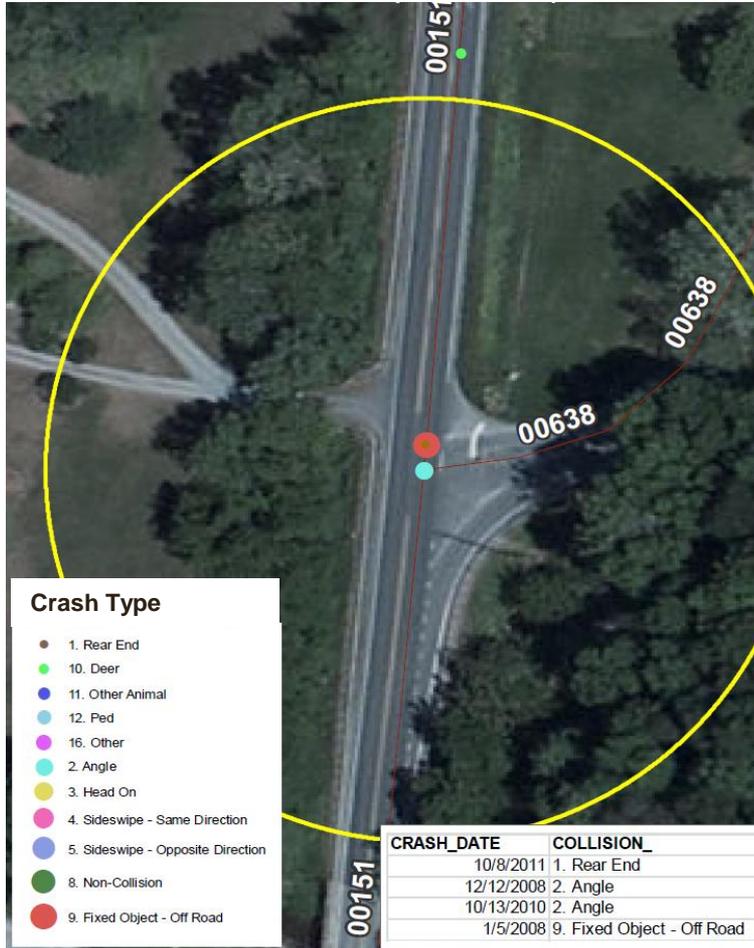
12) Rte. 151 at Rte. 638 (Avon Road - south)

Multiple crashes

- 1 Rear-end
- 1 Angle
- 1 Fixed Object/Off-road

Issues

- Driver inattention
- Overgrown vegetation in southeast quadrant limits sight distance
- Stop bar too far back

Potential improvements

- Move stop bar closer to roadway to improve sight distance
- Trim vegetation

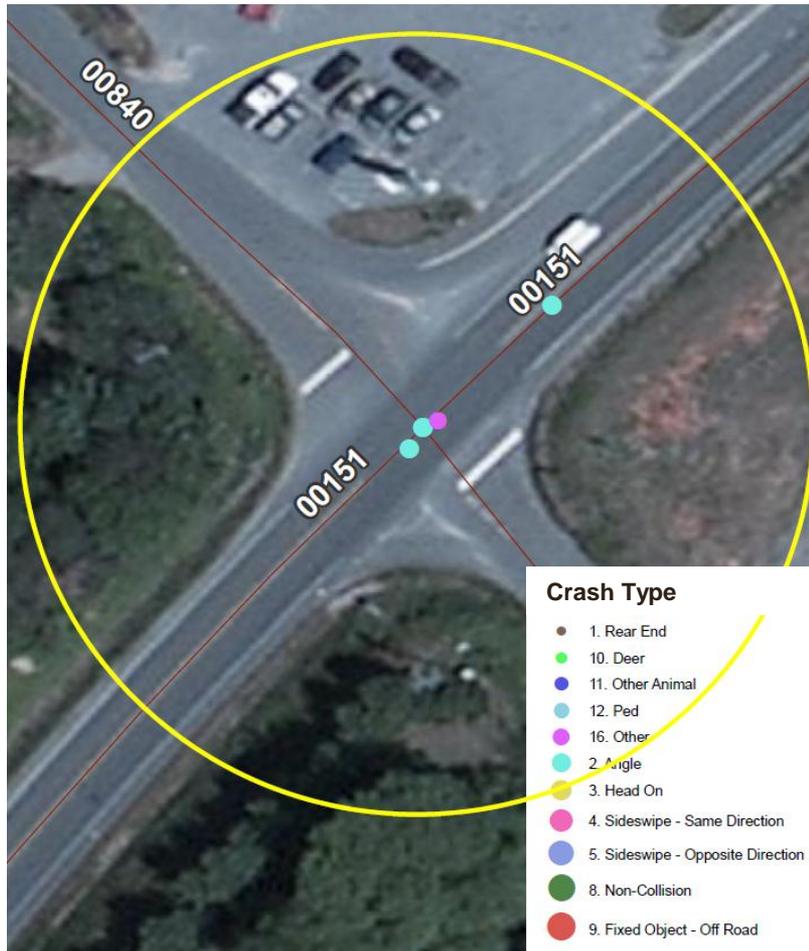
13) Rte. 151 at Rte. 840 (Tanbark Road)

Multiple crashes

- 3 Angle
- 1 other

Issues

- Site of two fatalities in a 2012 crash
- Yellow lines and stop bars faded on Tanbark Road
- Crest on Tanbark Road limits approach sight distance
- Embankments limits sight distance

Potential improvements

- Refresh yellow lines and stop bars and relocate stop sign
- Add intersection ahead signs on Rte. 840
- Add 45mph advisory sign to the existing Intersection Warning Sign
- Regrade Tanbark Road to improve visibility to Rte. 151
- Improve Tanbark Road at Greenberry Road
- Cut embankment back in southwest quadrant
 - Not possible to cut embankment in southeast quadrant

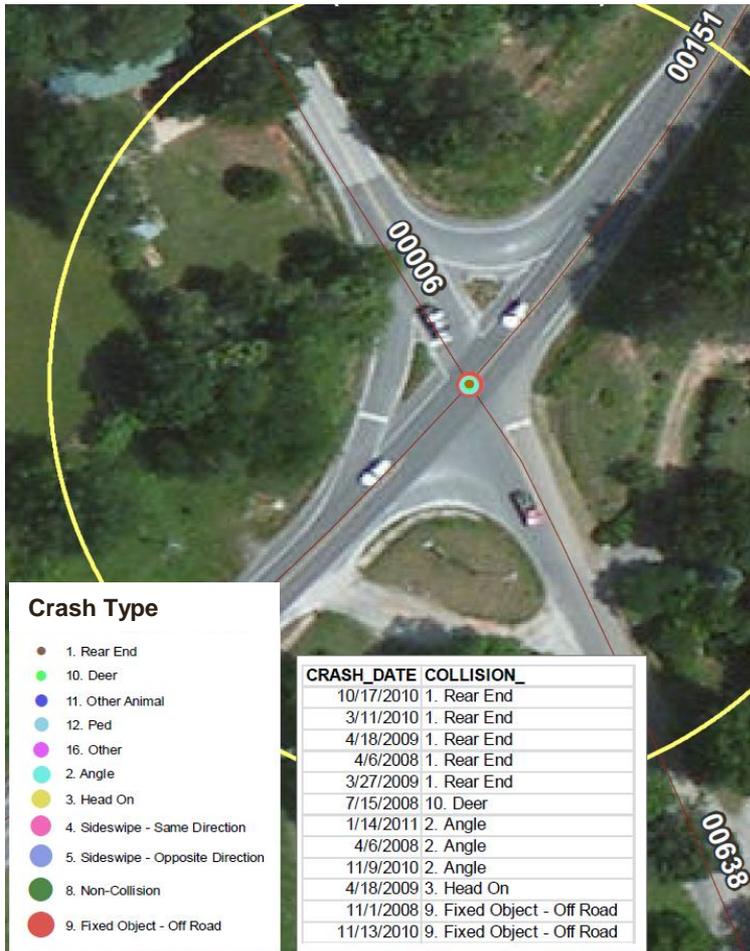
14) Rte. 151 at Rte. 6 (Afton Mountain Road)

Multiple crashes

- 5 Rear-end
- 3 Angle
- 4 other types

Issues

- Minor road dips on approach to Rte. 151, hiding view until vehicles near intersection
- Vegetation in southwest quadrant limits sight distance
- Stop signs not consistent in size
- Eastbound right turn approach is at an awkward angle, drivers looking over shoulder to see southbound vehicles
- Dip on Rte. 151 to the south limits sight distance
- Heavy turning volume during tourist season

Potential improvements

- Regrade Rte. 6, and make stop signs a consistent size
- Reconfigure eastbound right turn lane or add acceleration lane
- VDOT is currently in process to obtain HSIP grant to add turn lanes
- VDOT recently reviewed Rte. 151 to the north, improved signage

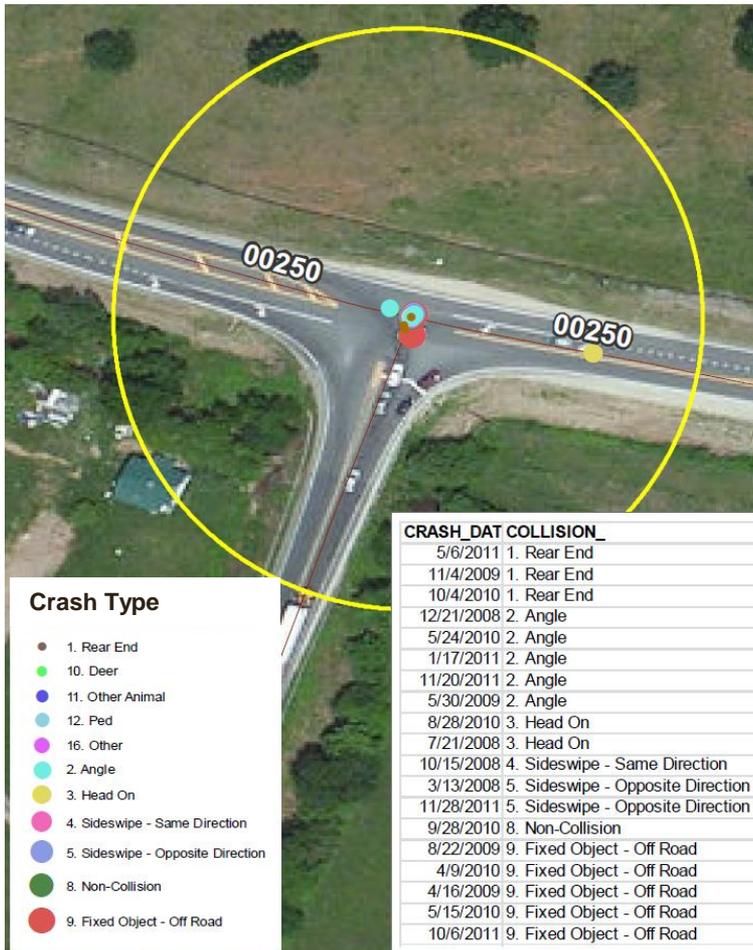
15) Rte. 151 at US 250 (Rockfish Gap Turnpike)

Multiple crashes

- 3 Rear-end
- 5 Angle
- 2 Head-on
- 5 Fixed Object/Off-road
- 4 other types

Issues

- **Heavy turn movements with short turn bays**
 - Eastbound US 250 right turning vehicles block Rte. 151 traffic's view of the through movement
 - Westbound US 250 left turning traffic queue extends into through lane, through vehicles driving around on grass area

Potential improvements

- **Offset the eastbound right turn bay by 12 feet to improve visibility of eastbound through vehicles**
- **Extend the westbound left turn lane**
- **Add a northbound right turn lane with an acceleration lane**
- **Consider a traffic signal or a roundabout**
