Existing Corridor Conditions

Figure 3-5

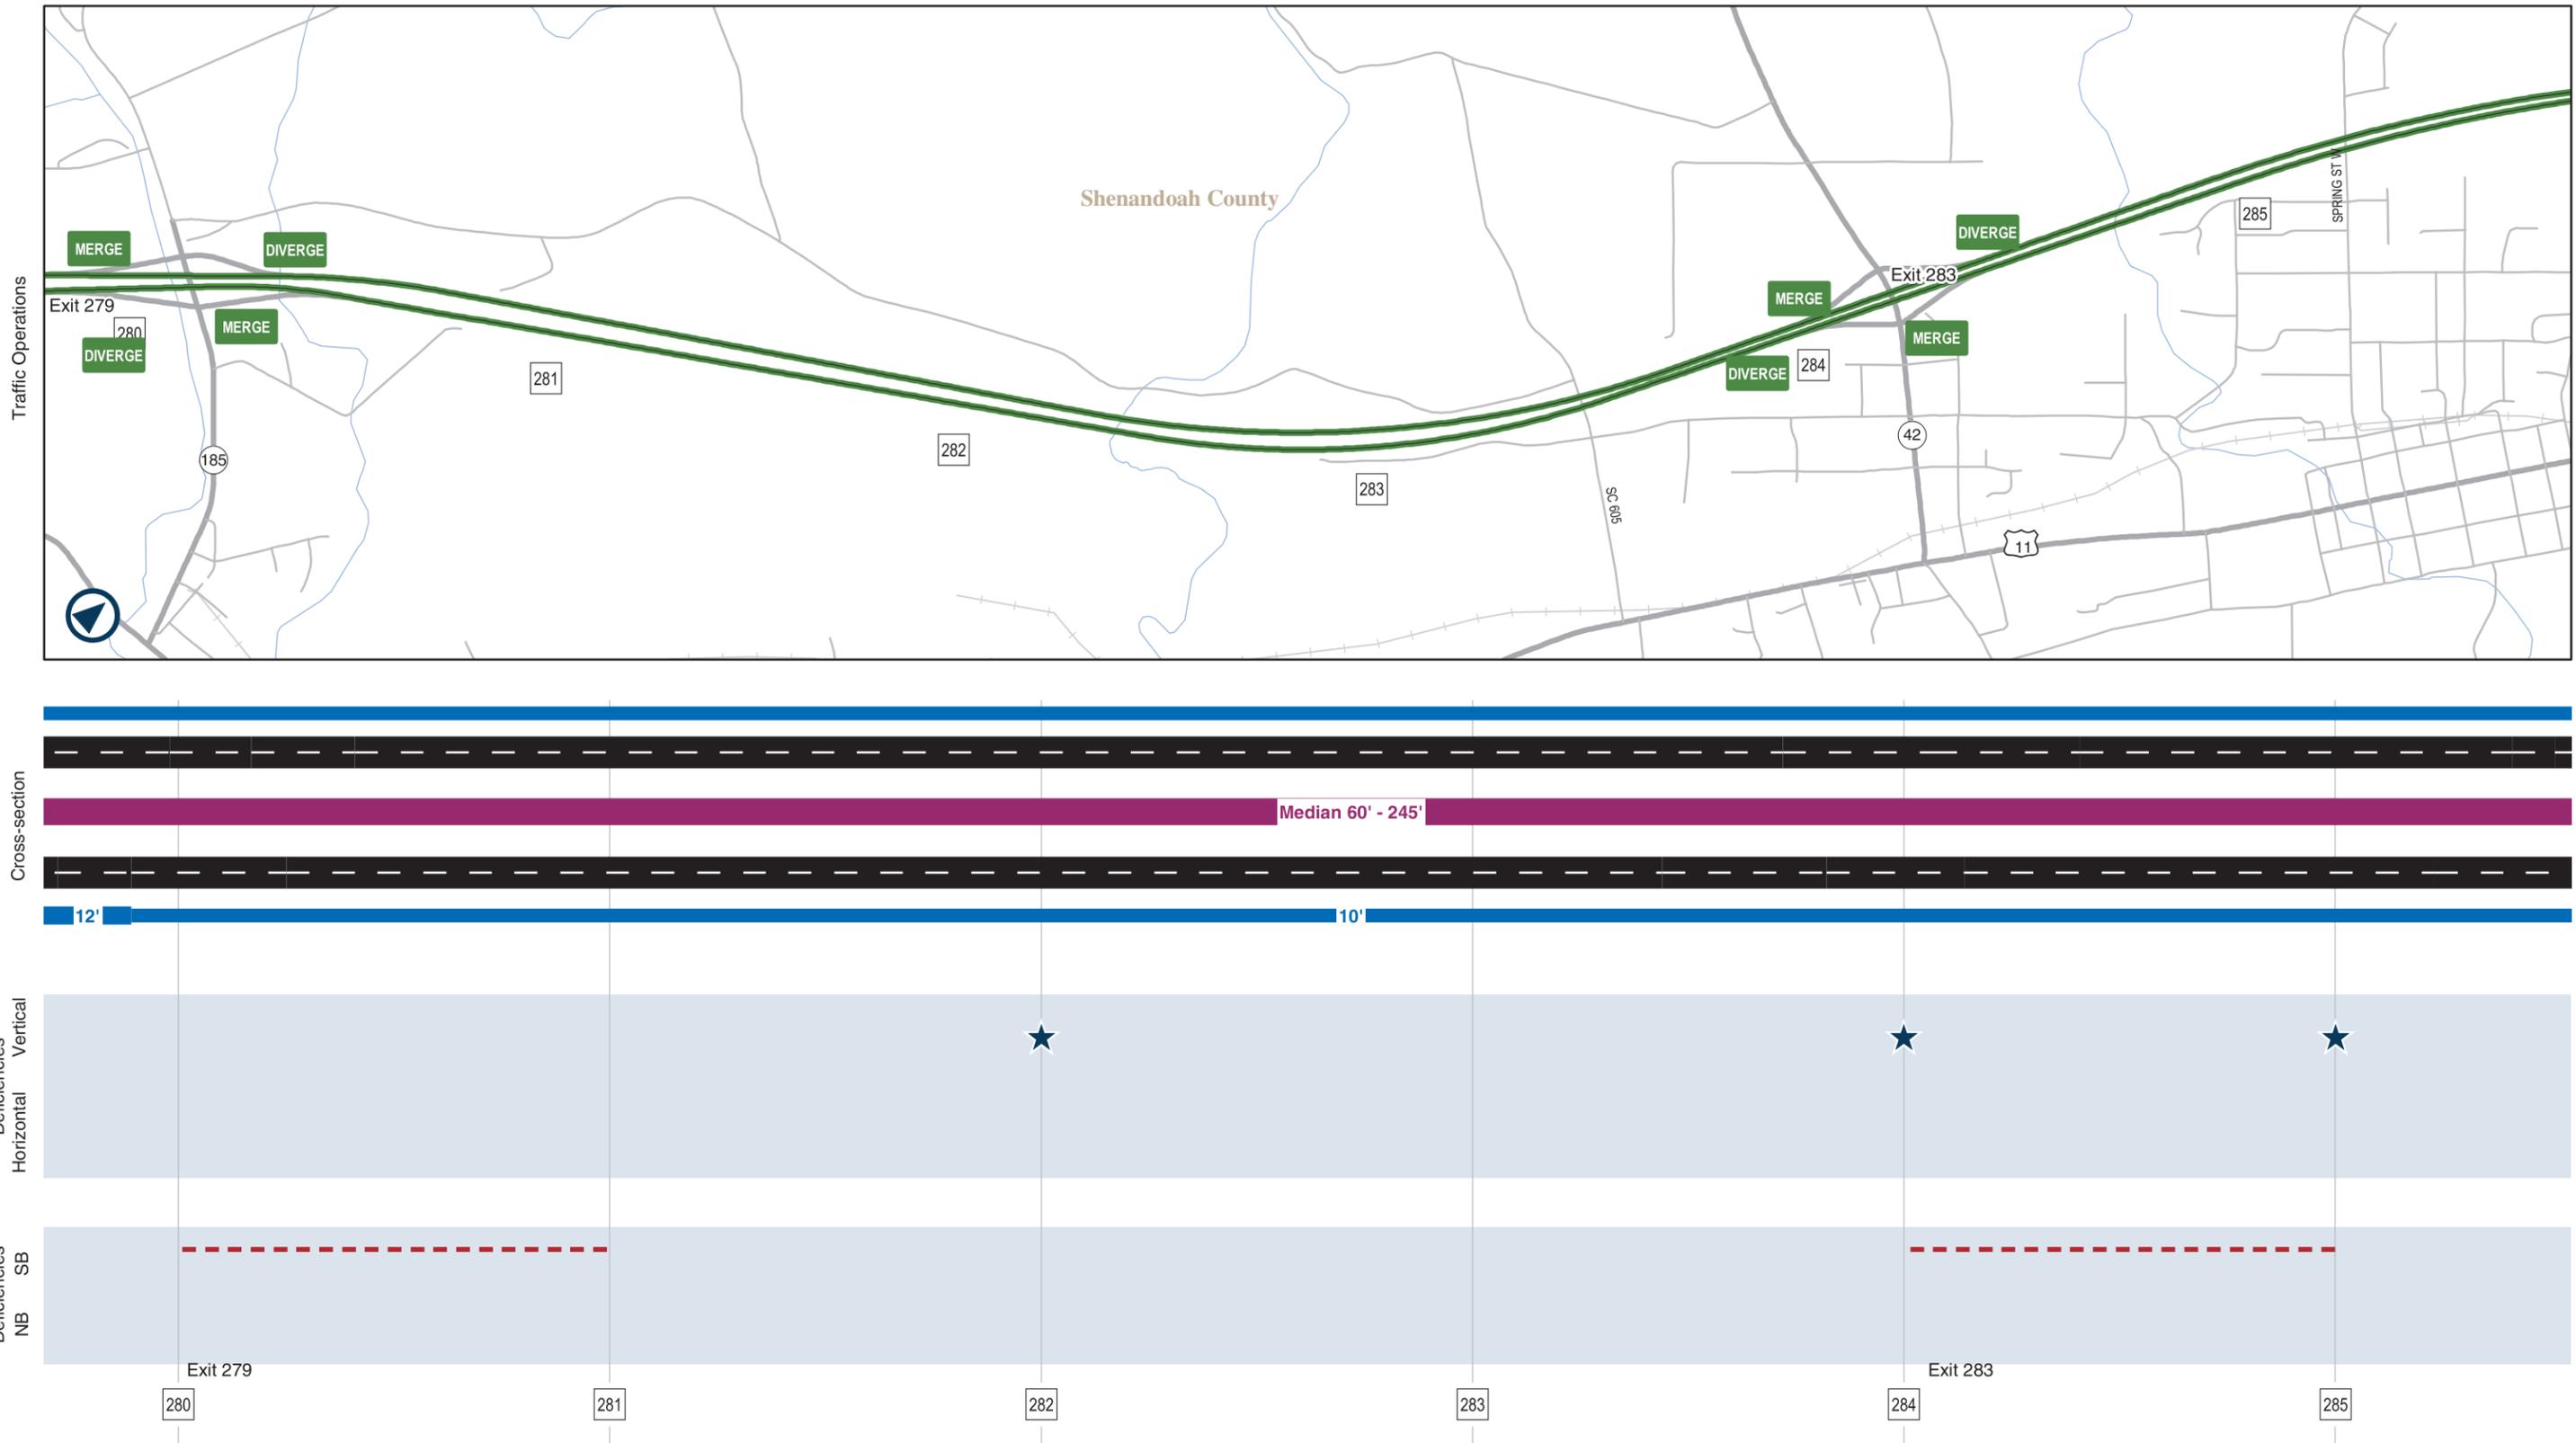
Sheet 50 of 57

# Milepost	Ramp LOS	Mainline LOS	Cross-section	Vertical Deficiencies*	Horizontal Deficiencies*	Safety Deficiencies (2000-2002)
	Ramp MERGE A/B	A/B	SB Shoulder	▲ Grade Exceeds Standard	— Segment	★ Fatal Crash
	Ramp MERGE C Urban	C Urban	SB Roadway	■ Insufficient Sight Distance	● Location	- - - High Crash Segment
	Ramp MERGE C Rural	C Rural	Median	● Substandard Vertical Curve	See Table 3-4 for Interchange Deficiencies	
	Ramp MERGE D	D	NB Roadway	★ Substandard Vertical Clearance		
	Ramp MERGE E/F	E/F	NB Shoulder

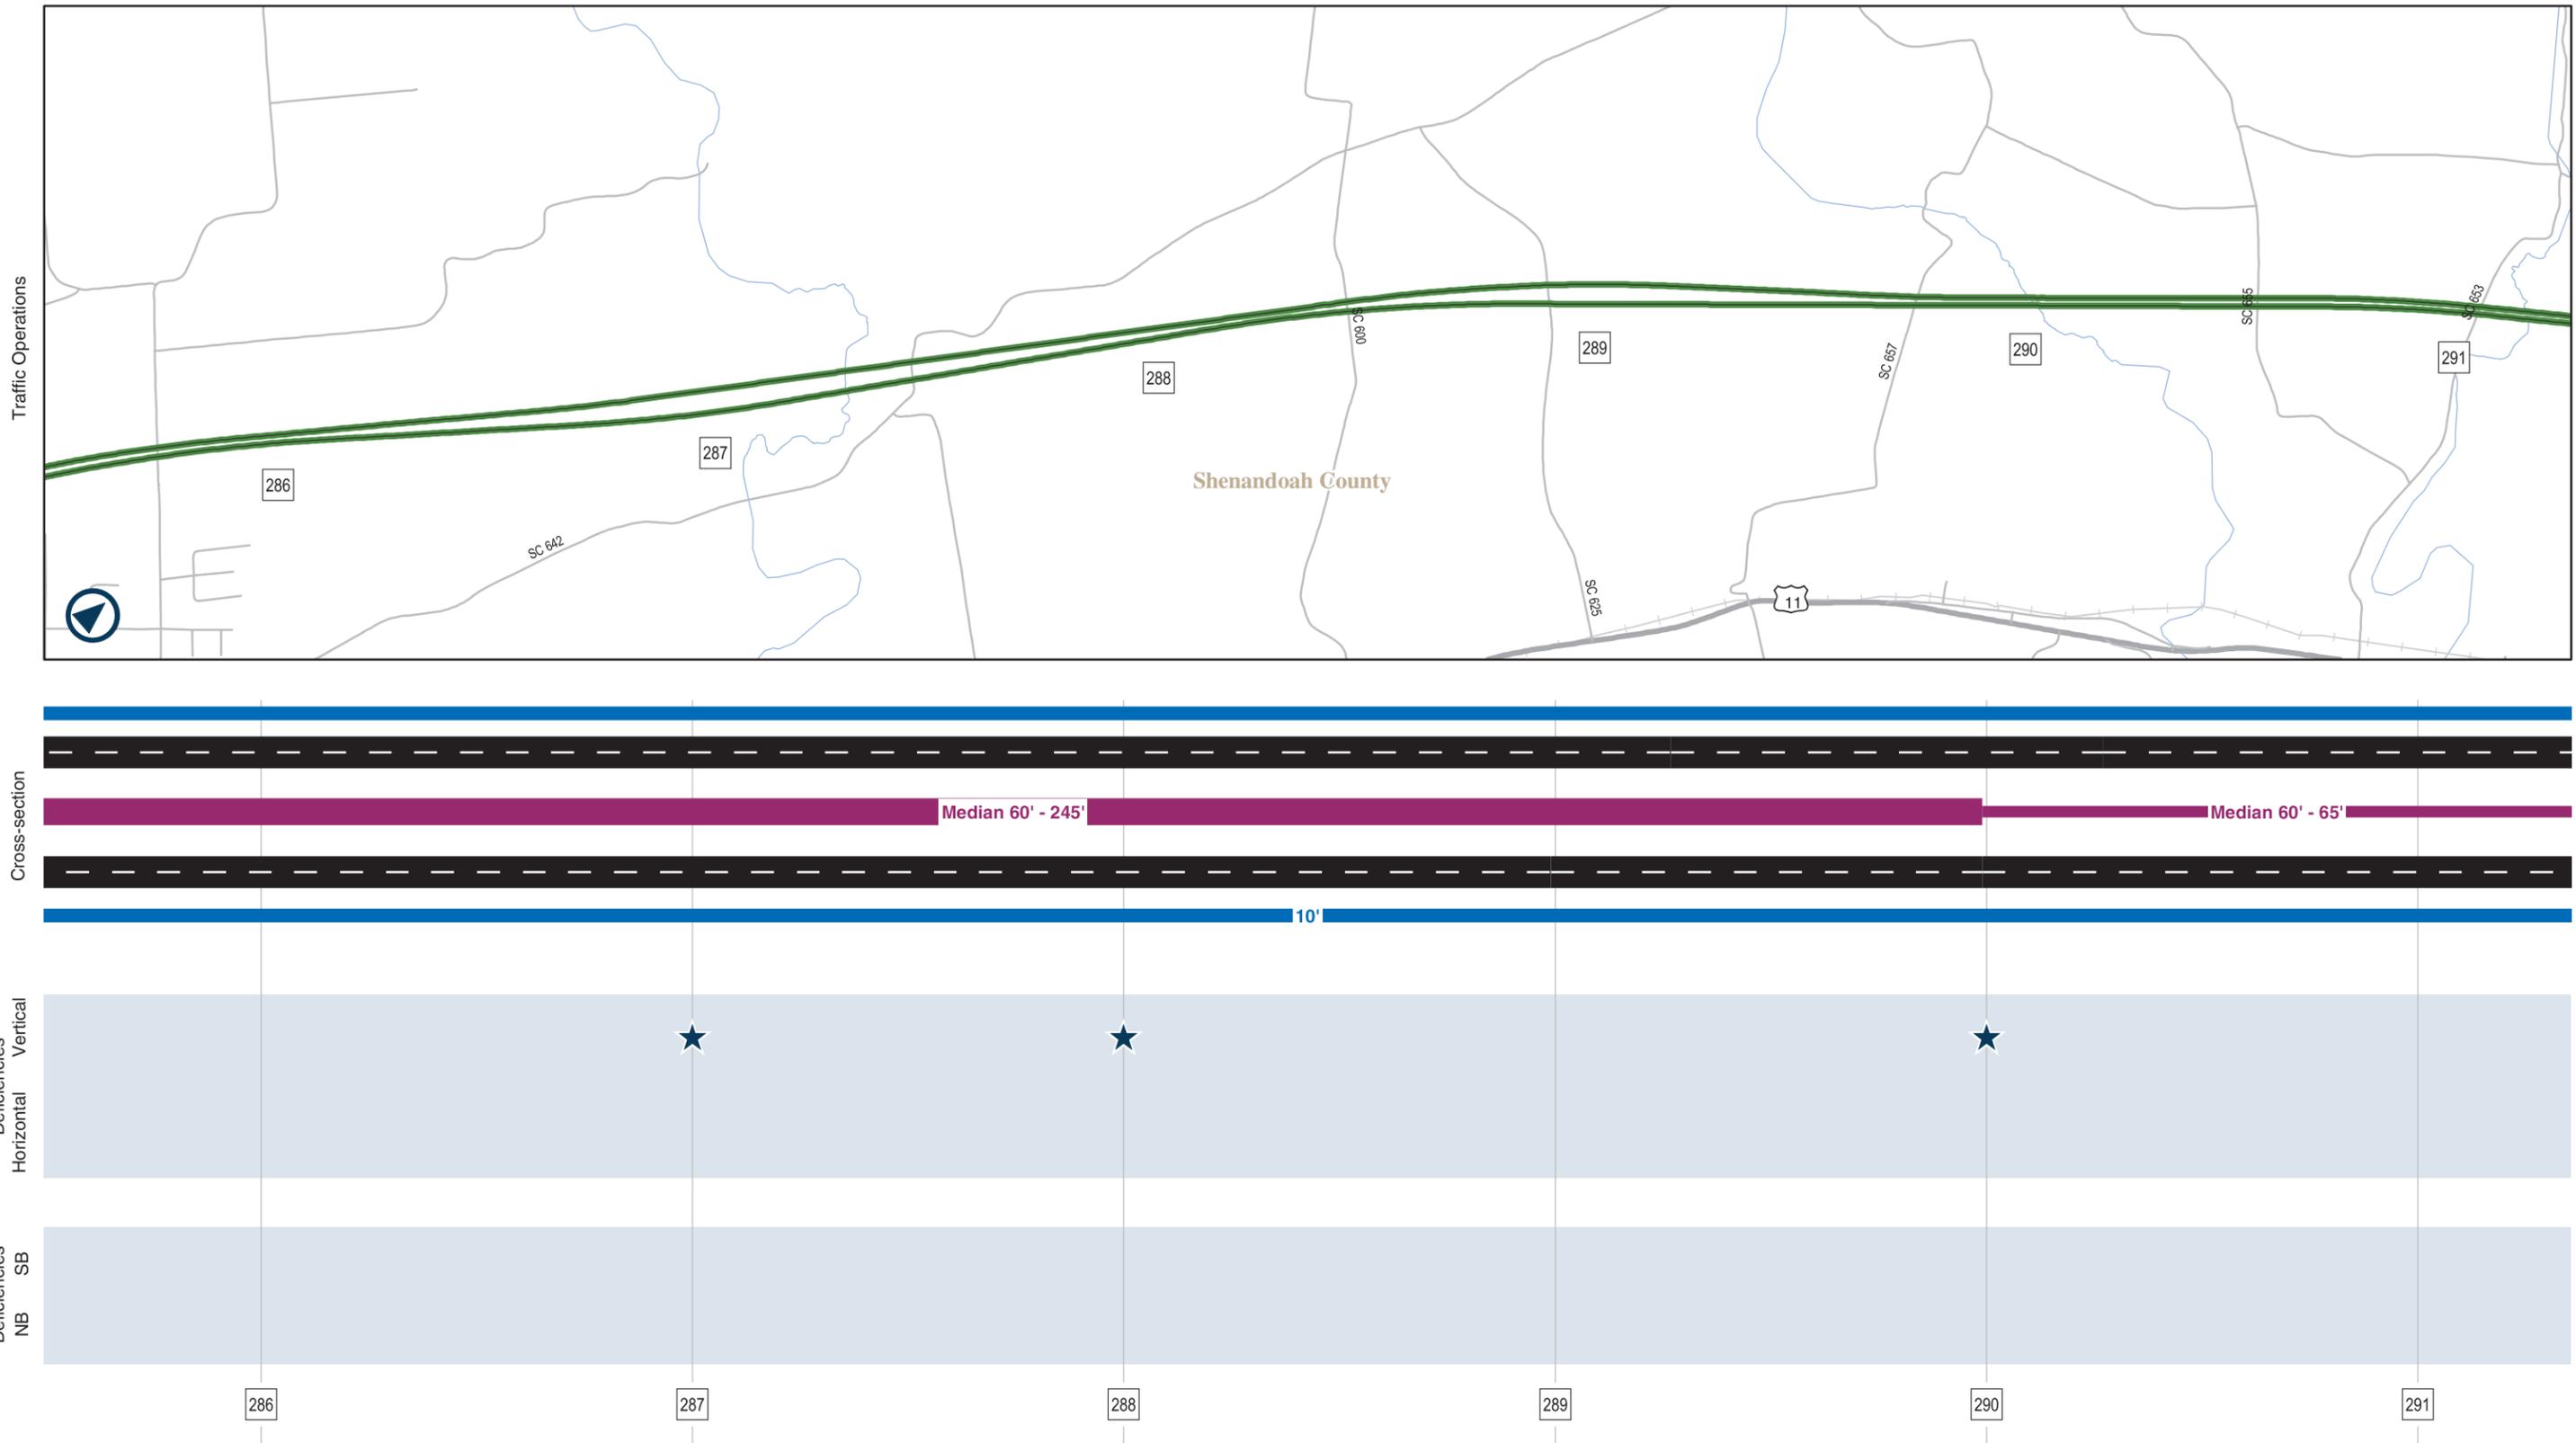
Sheet 51 of 57

# Milepost	Ramp LOS	Mainline LOS	Cross-section	Vertical Deficiencies*	Horizontal Deficiencies*	Safety Deficiencies (2000-2002)
	Ramp MERGE A/B	A/B	SB Shoulder	▲ Grade Exceeds Standard	— Segment	★ Fatal Crash
	Ramp MERGE C Urban	C Urban	SB Roadway	■ Insufficient Sight Distance	● Location	--- High Crash Segment
	Ramp MERGE C Rural	C Rural	Median	● Substandard Vertical Curve	See Table 3-4 for Interchange Deficiencies	
	Ramp MERGE D	D	NB Roadway	★ Substandard Vertical Clearance		
	Ramp MERGE E/F	E/F	NB Shoulder

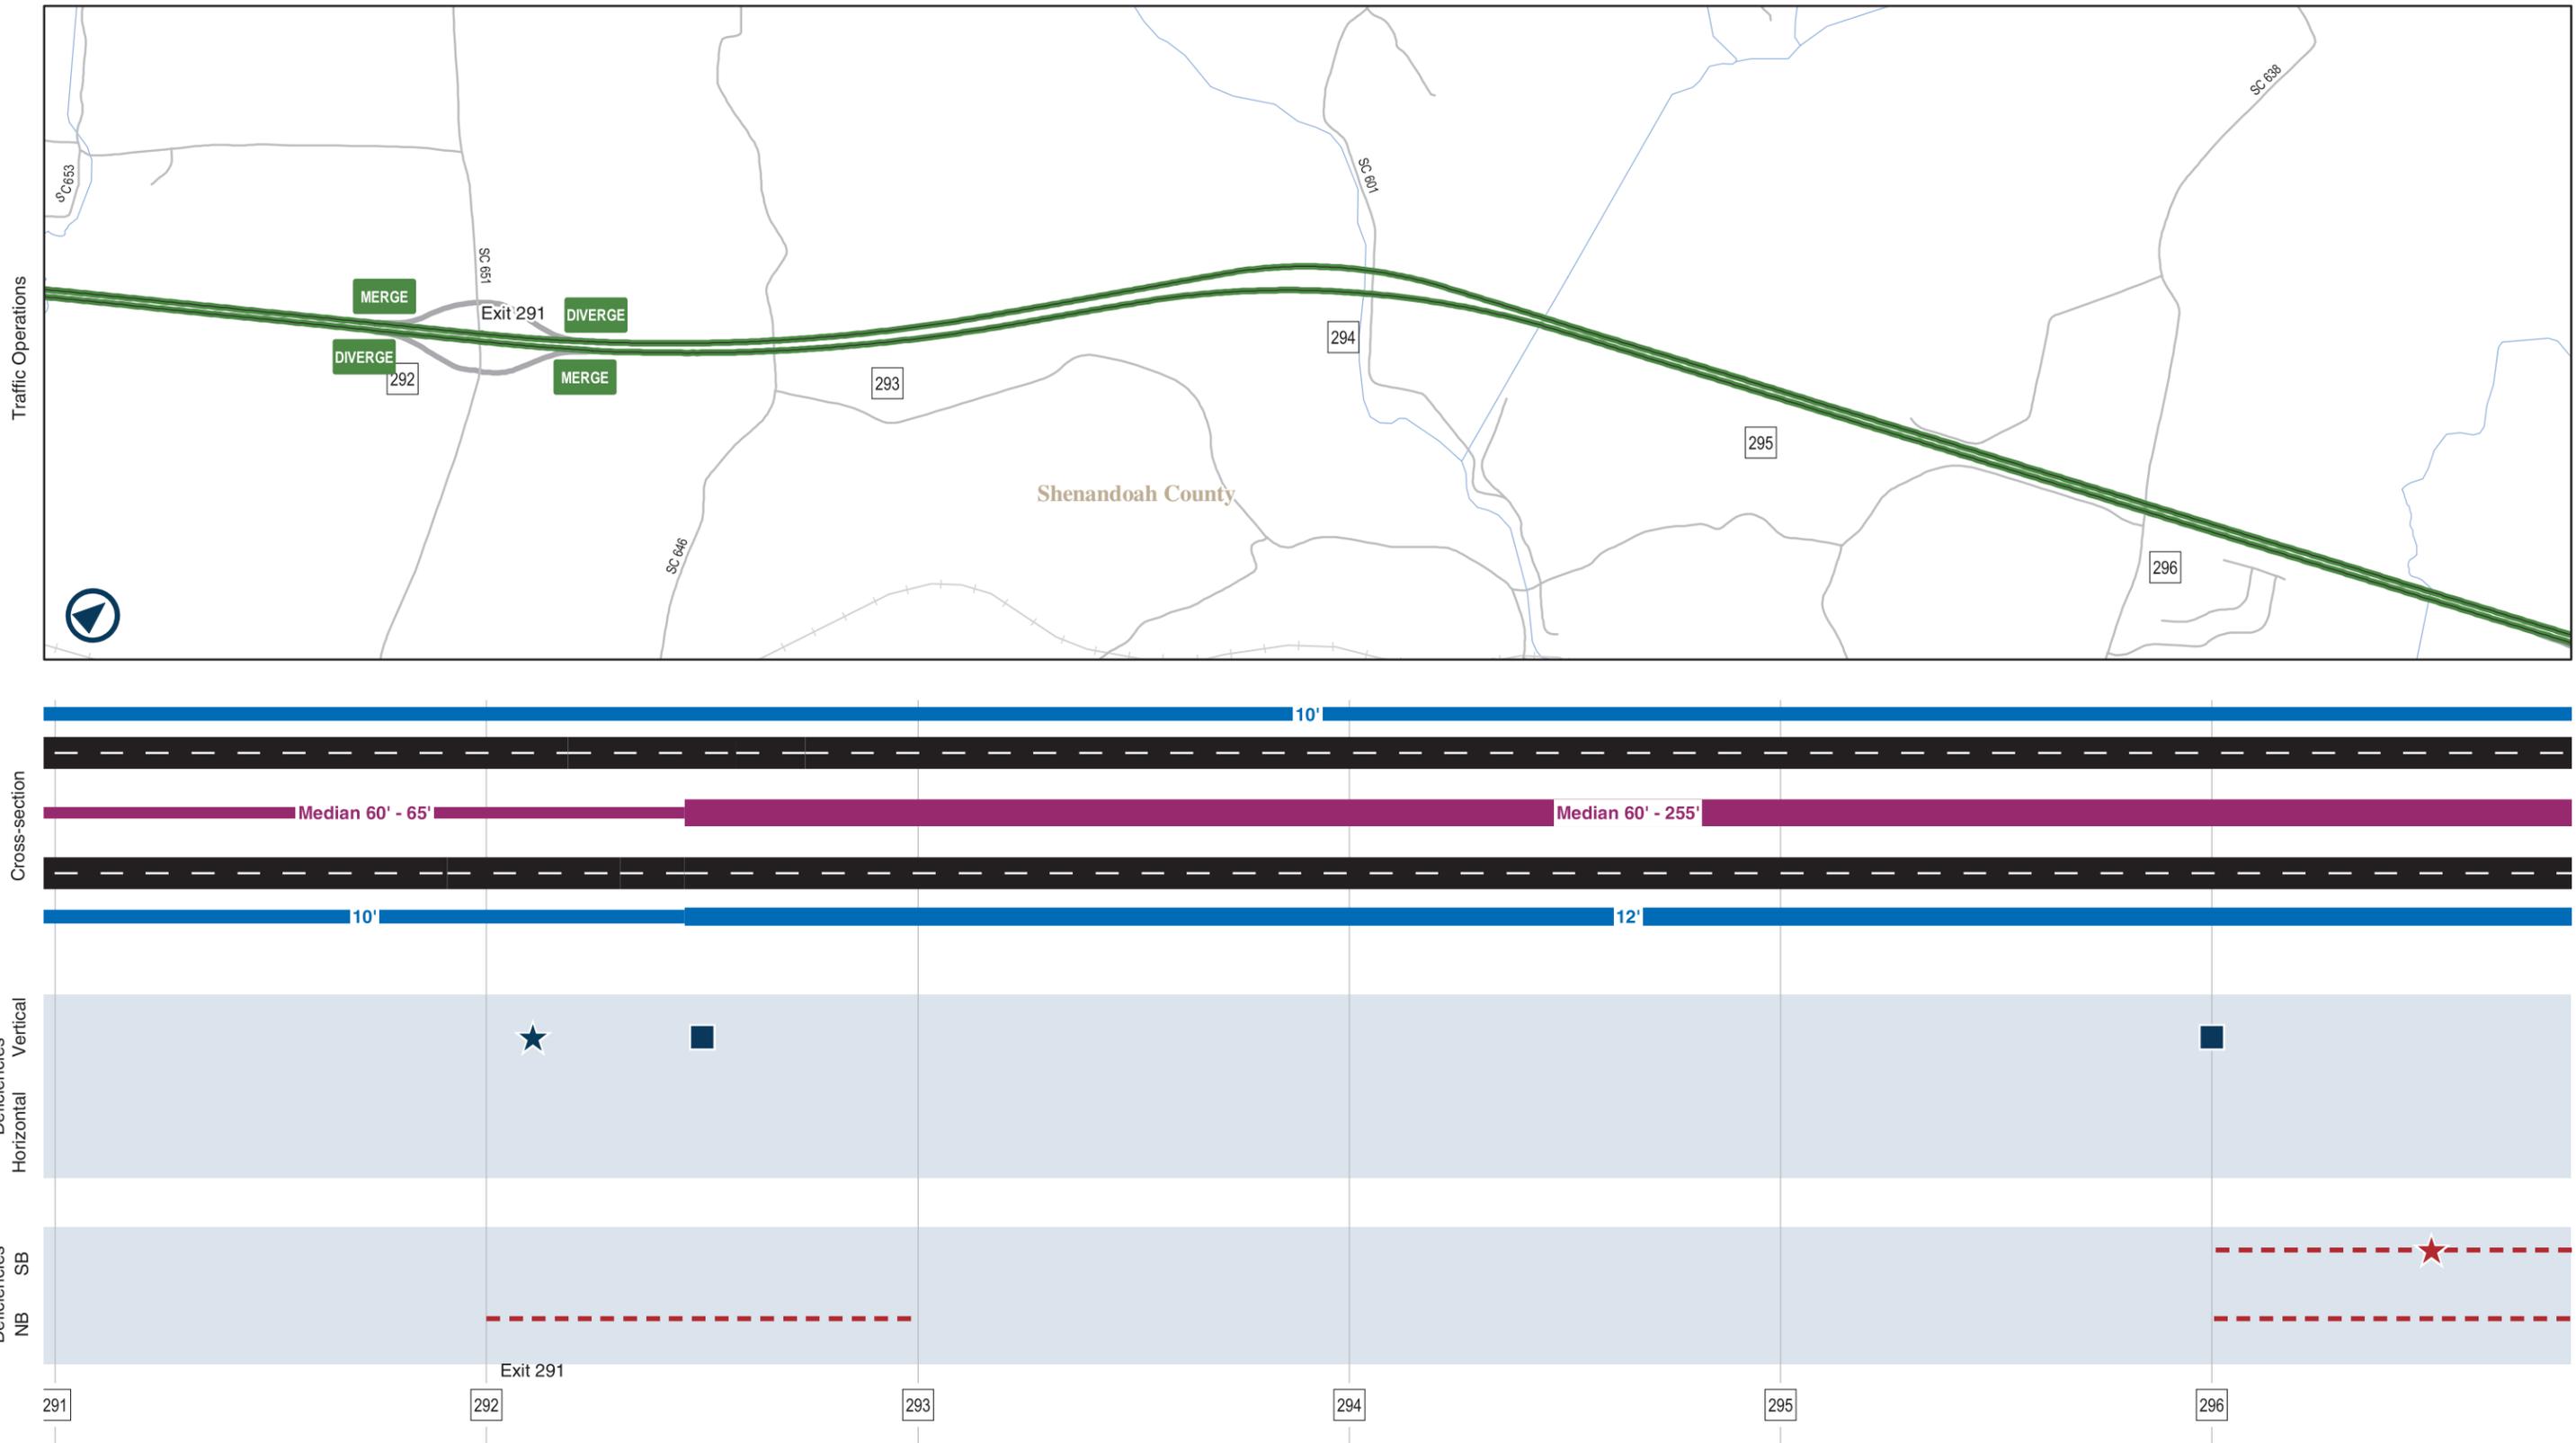
Sheet 52 of 57

# Milepost	Ramp LOS	Mainline LOS	Cross-section	Vertical Deficiencies*	Horizontal Deficiencies*	Safety Deficiencies (2000-2002)
	Ramp MERGE A/B	A/B	SB Shoulder	▲ Grade Exceeds Standard	— Segment	★ Fatal Crash
	Ramp MERGE C Urban	C Urban	SB Roadway	■ Insufficient Sight Distance	● Location	- - - High Crash Segment
	Ramp MERGE C Rural	C Rural	Median	● Substandard Vertical Curve	See Table 3-4 for Interchange Deficiencies	
	Ramp MERGE D	D	NB Roadway	★ Substandard Vertical Clearance		
	Ramp MERGE E/F	E/F	NB Shoulder

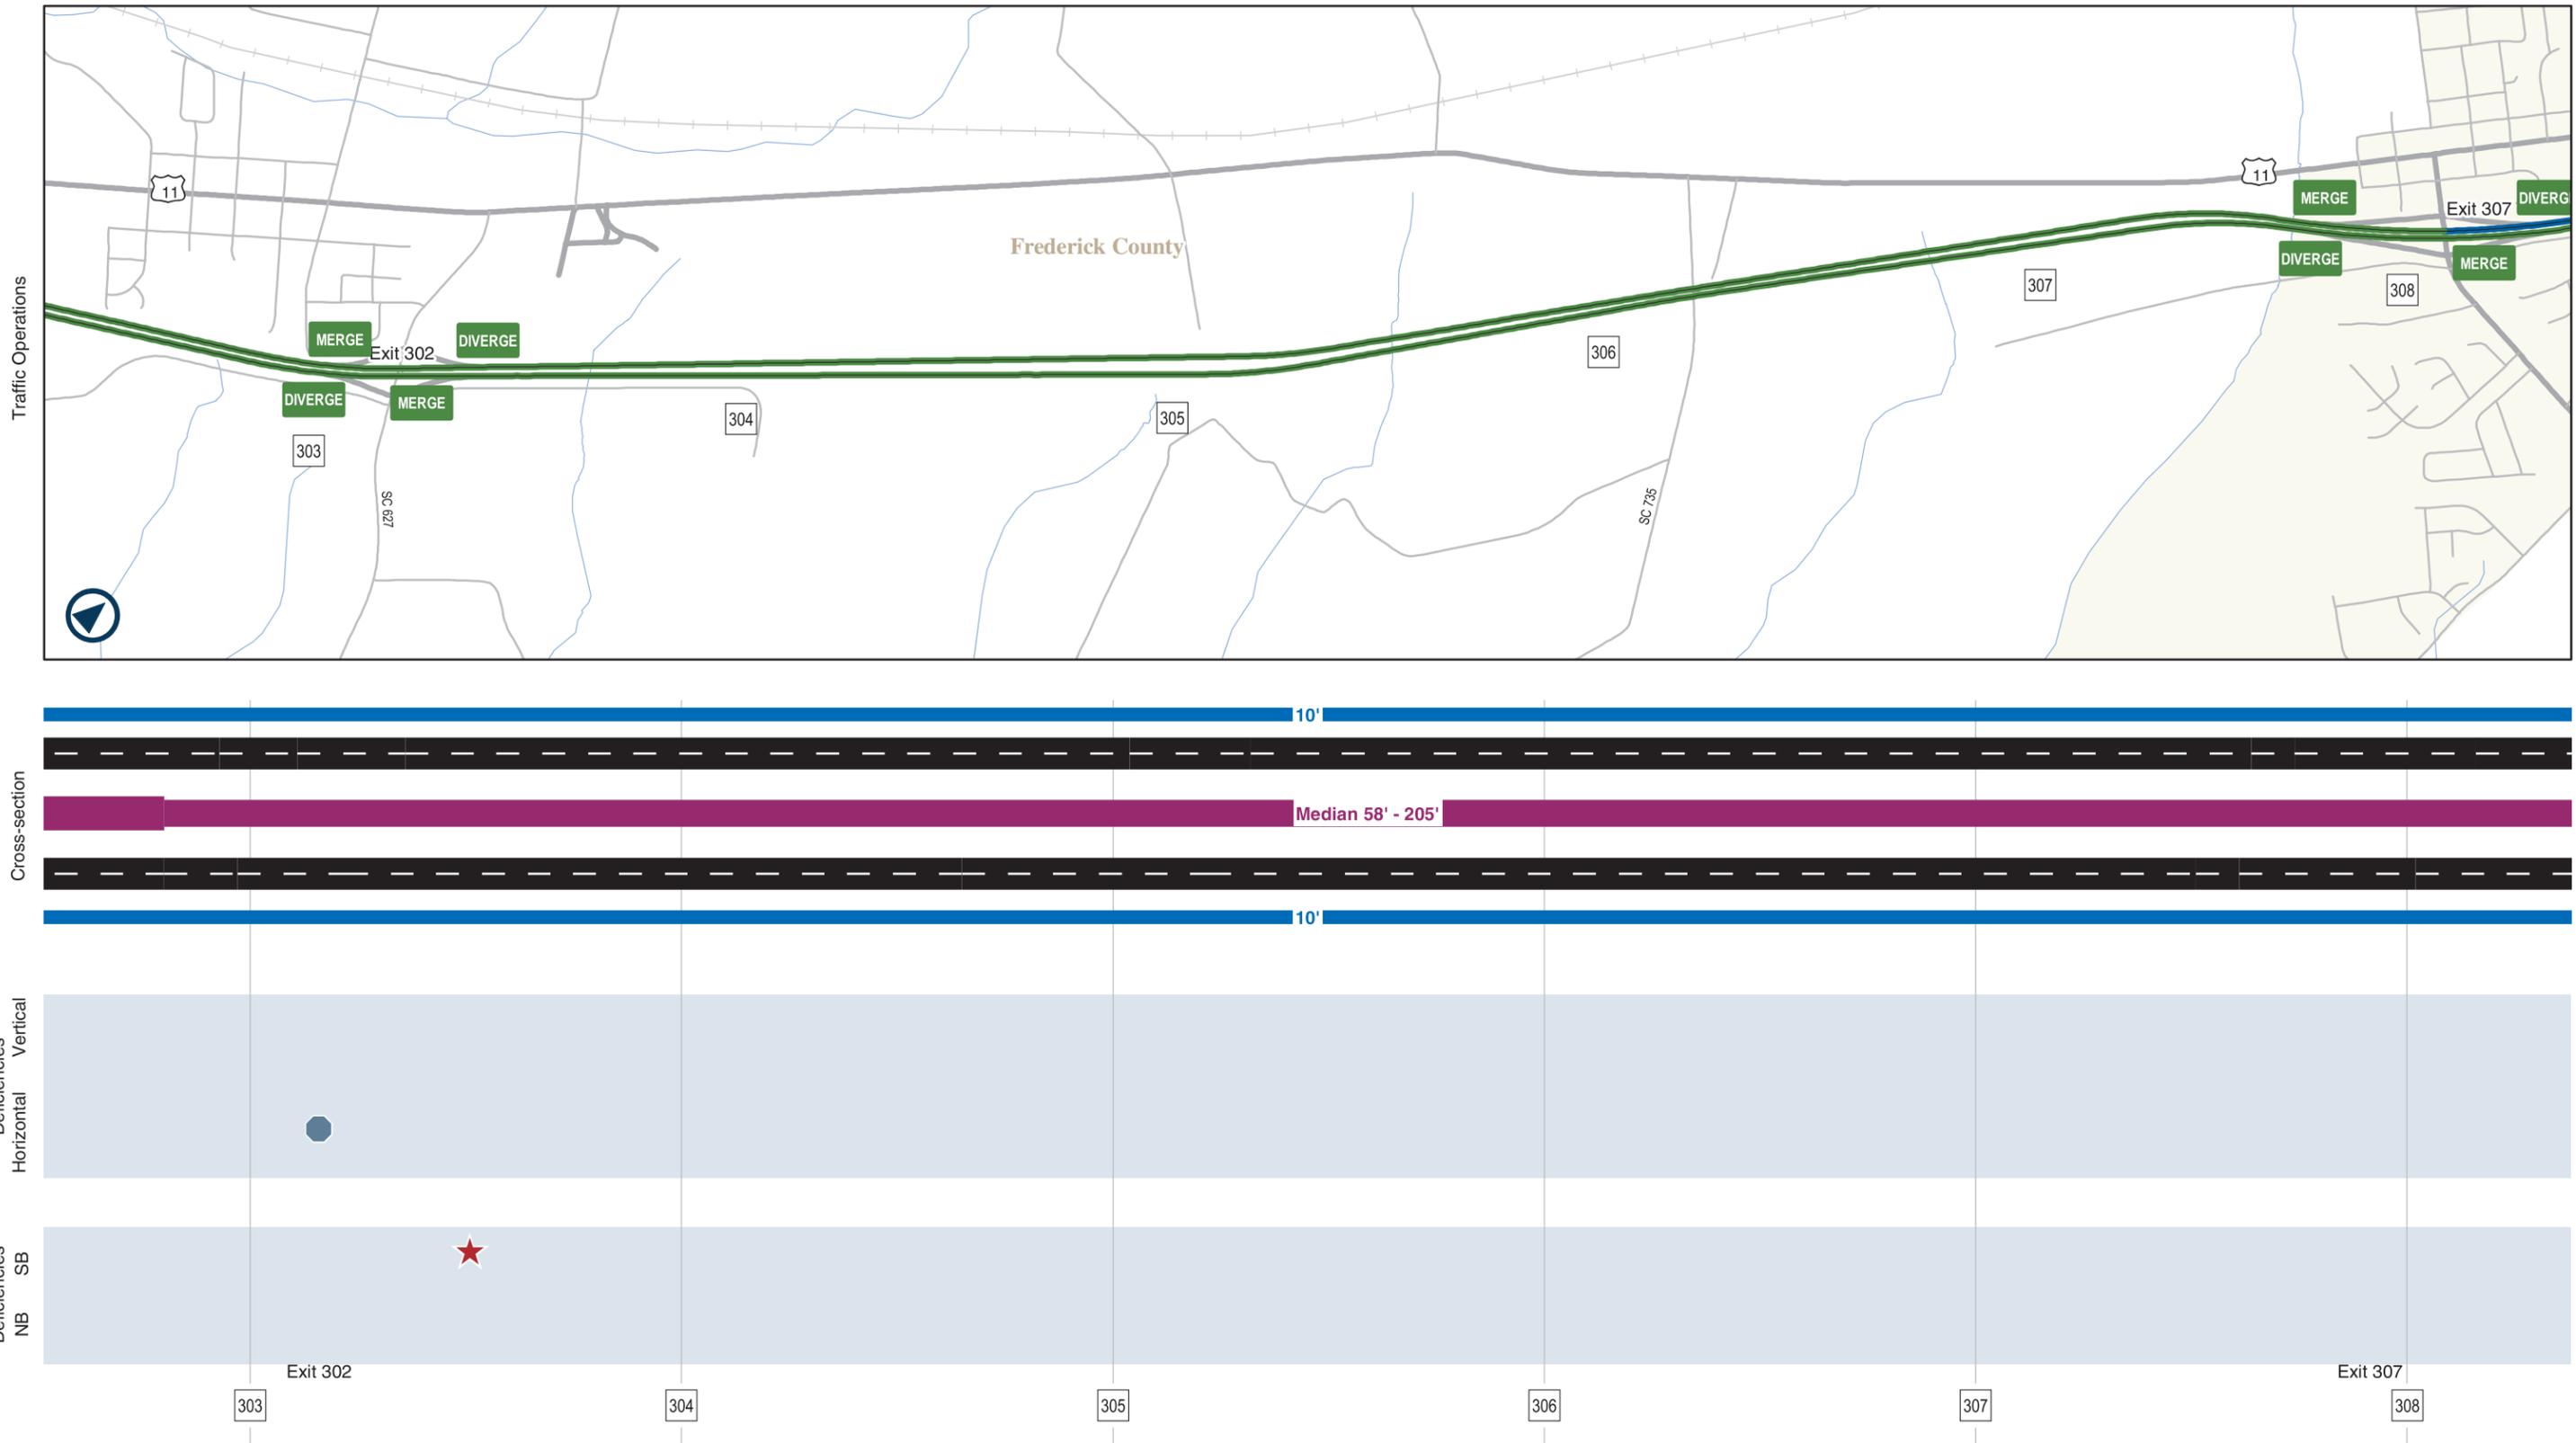
Sheet 54 of 57

# Milepost	Ramp LOS	Mainline LOS	Cross-section	Vertical Deficiencies*	Horizontal Deficiencies*	Safety Deficiencies (2000-2002)
	Ramp MERGE A/B	A/B	SB Shoulder	▲ Grade Exceeds Standard	— Segment	★ Fatal Crash
	Ramp MERGE C Urban	C Urban	SB Roadway	■ Insufficient Sight Distance	● Location	--- High Crash Segment
	Ramp MERGE C Rural	C Rural	Median	● Substandard Vertical Curve	See Table 3-4 for Interchange Deficiencies	
	Ramp MERGE D	D	NB Roadway	★ Substandard Vertical Clearance		
	Ramp MERGE E/F	E/F	NB Shoulder

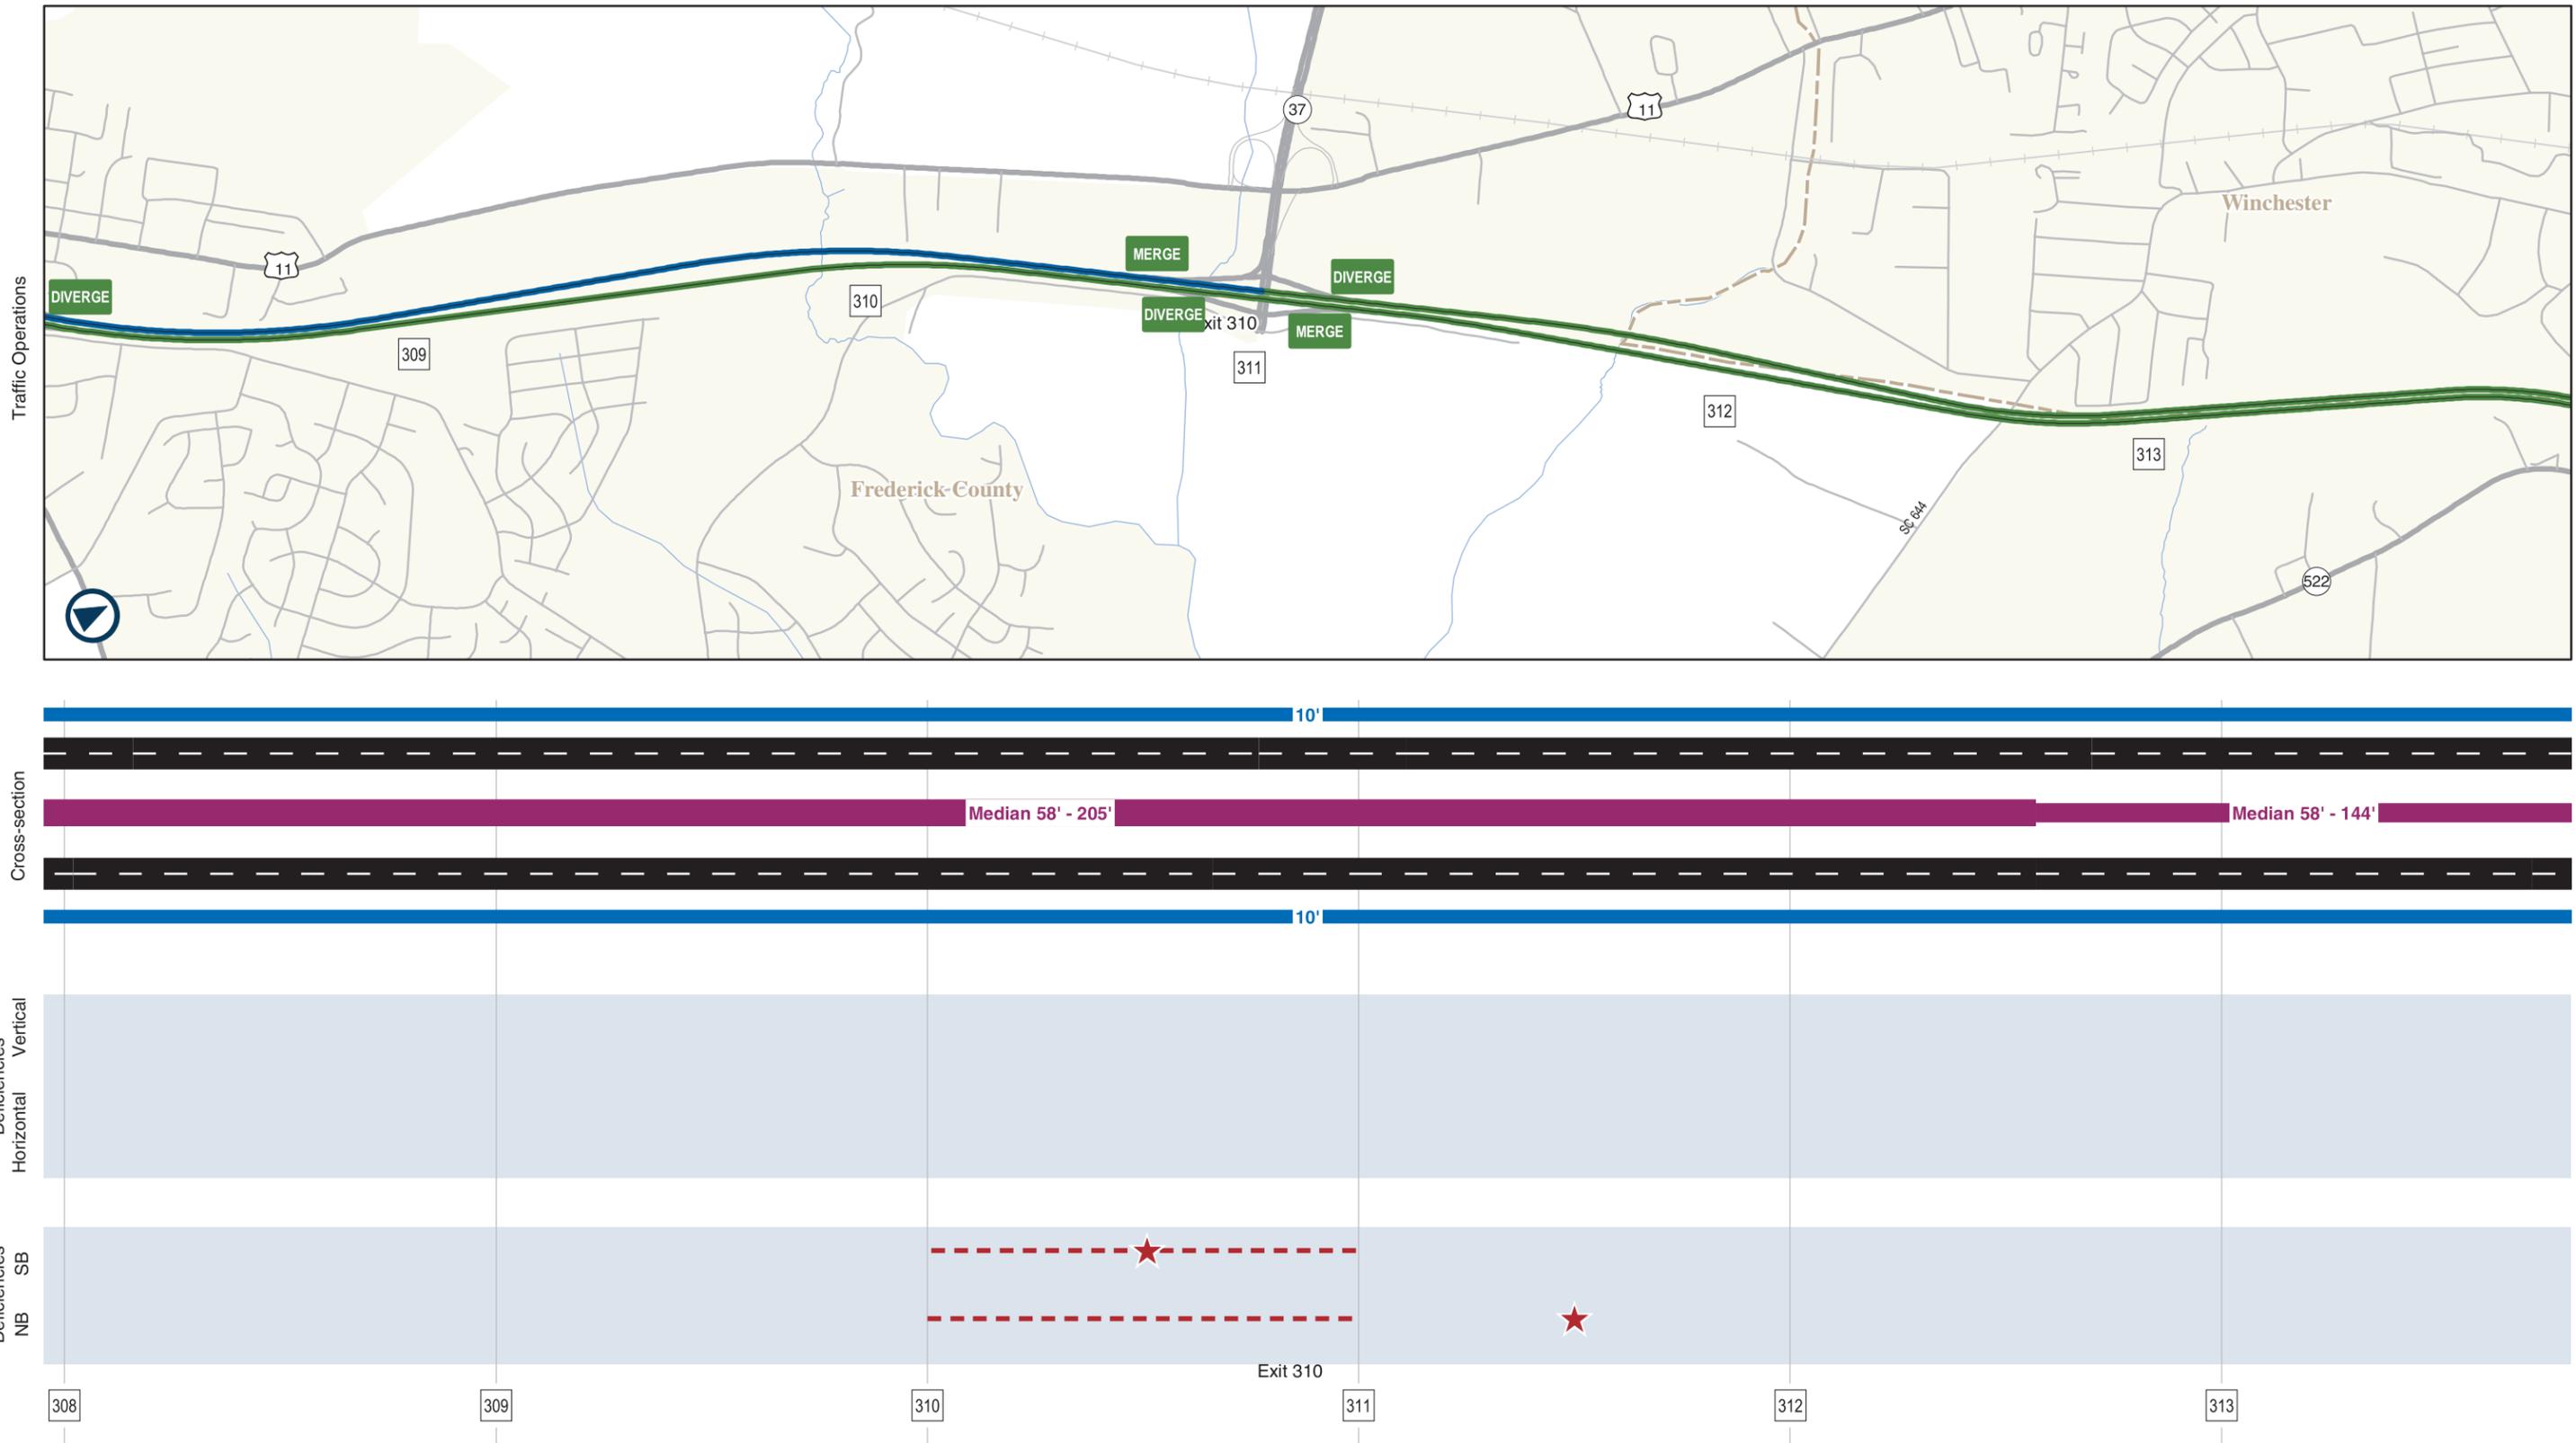
Sheet 55 of 57

# Milepost	Ramp LOS	Mainline LOS	Cross-section	Vertical Deficiencies*	Horizontal Deficiencies*	Safety Deficiencies (2000-2002)
	Ramp MERGE A/B	A/B	SB Shoulder	▲ Grade Exceeds Standard	— Segment	★ Fatal Crash
	Ramp MERGE C Urban	C Urban	SB Roadway	■ Insufficient Sight Distance	● Location	- - - High Crash Segment
	Ramp MERGE C Rural	C Rural	Median	● Substandard Vertical Curve	See Table 3-4 for Interchange Deficiencies	
	Ramp MERGE D	D	NB Roadway	★ Substandard Vertical Clearance		
	Ramp MERGE E/F	E/F	NB Shoulder

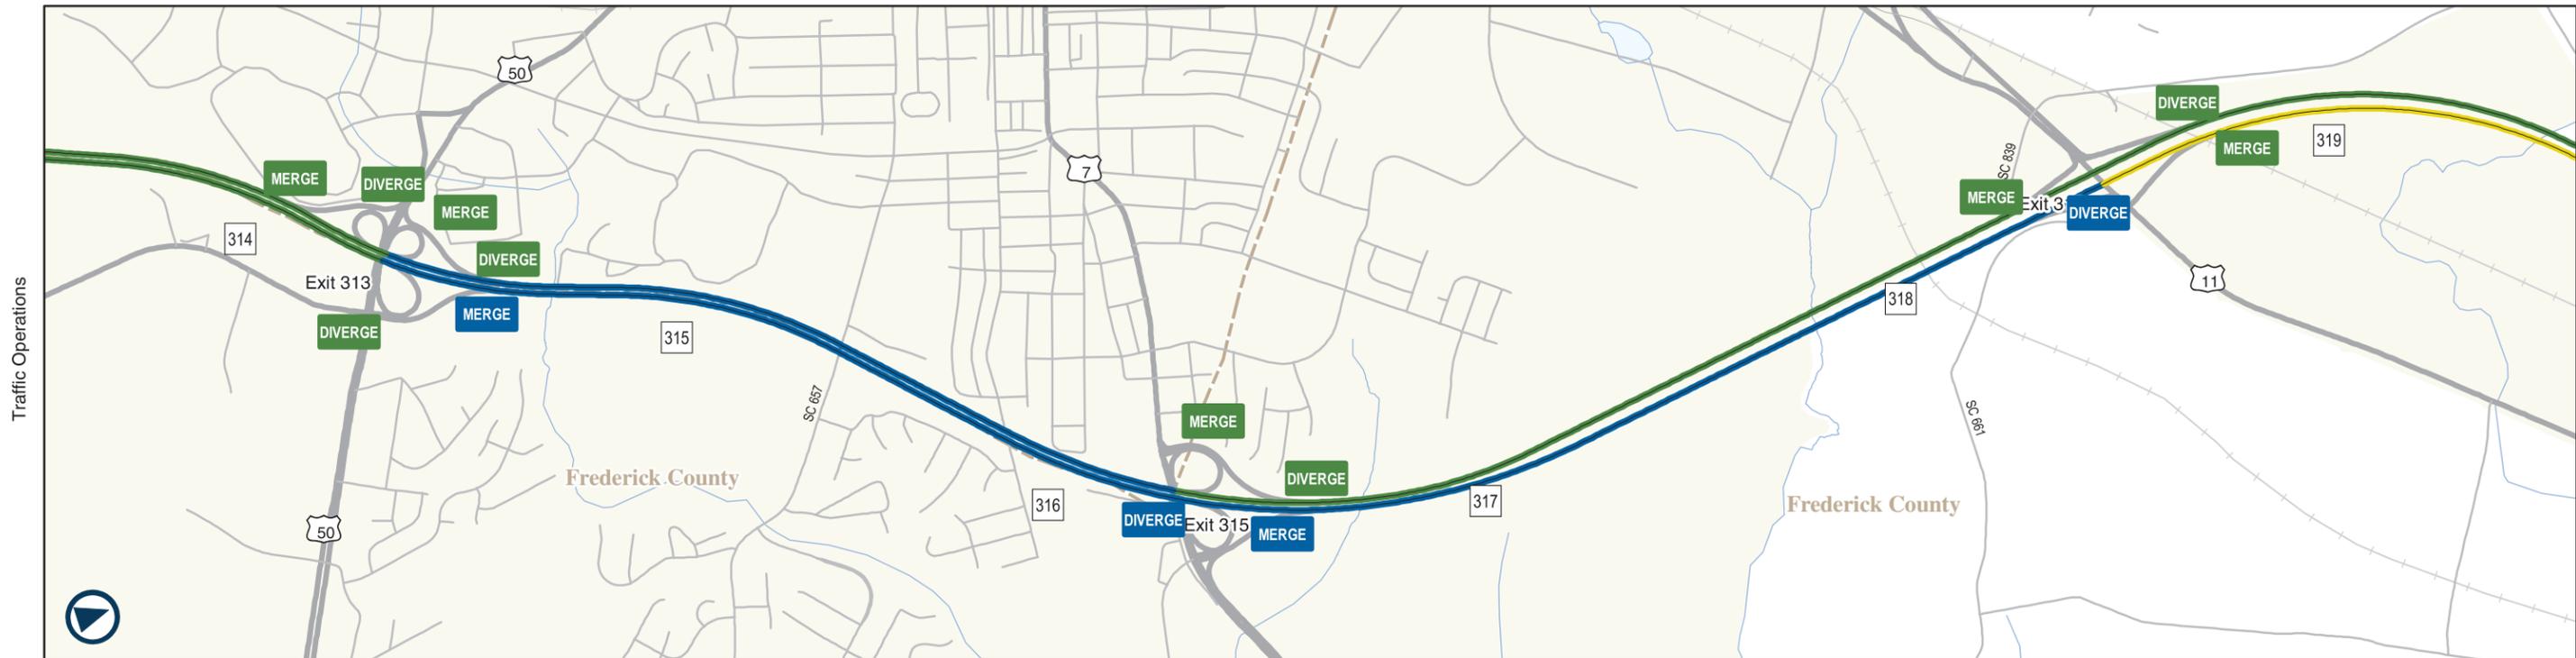
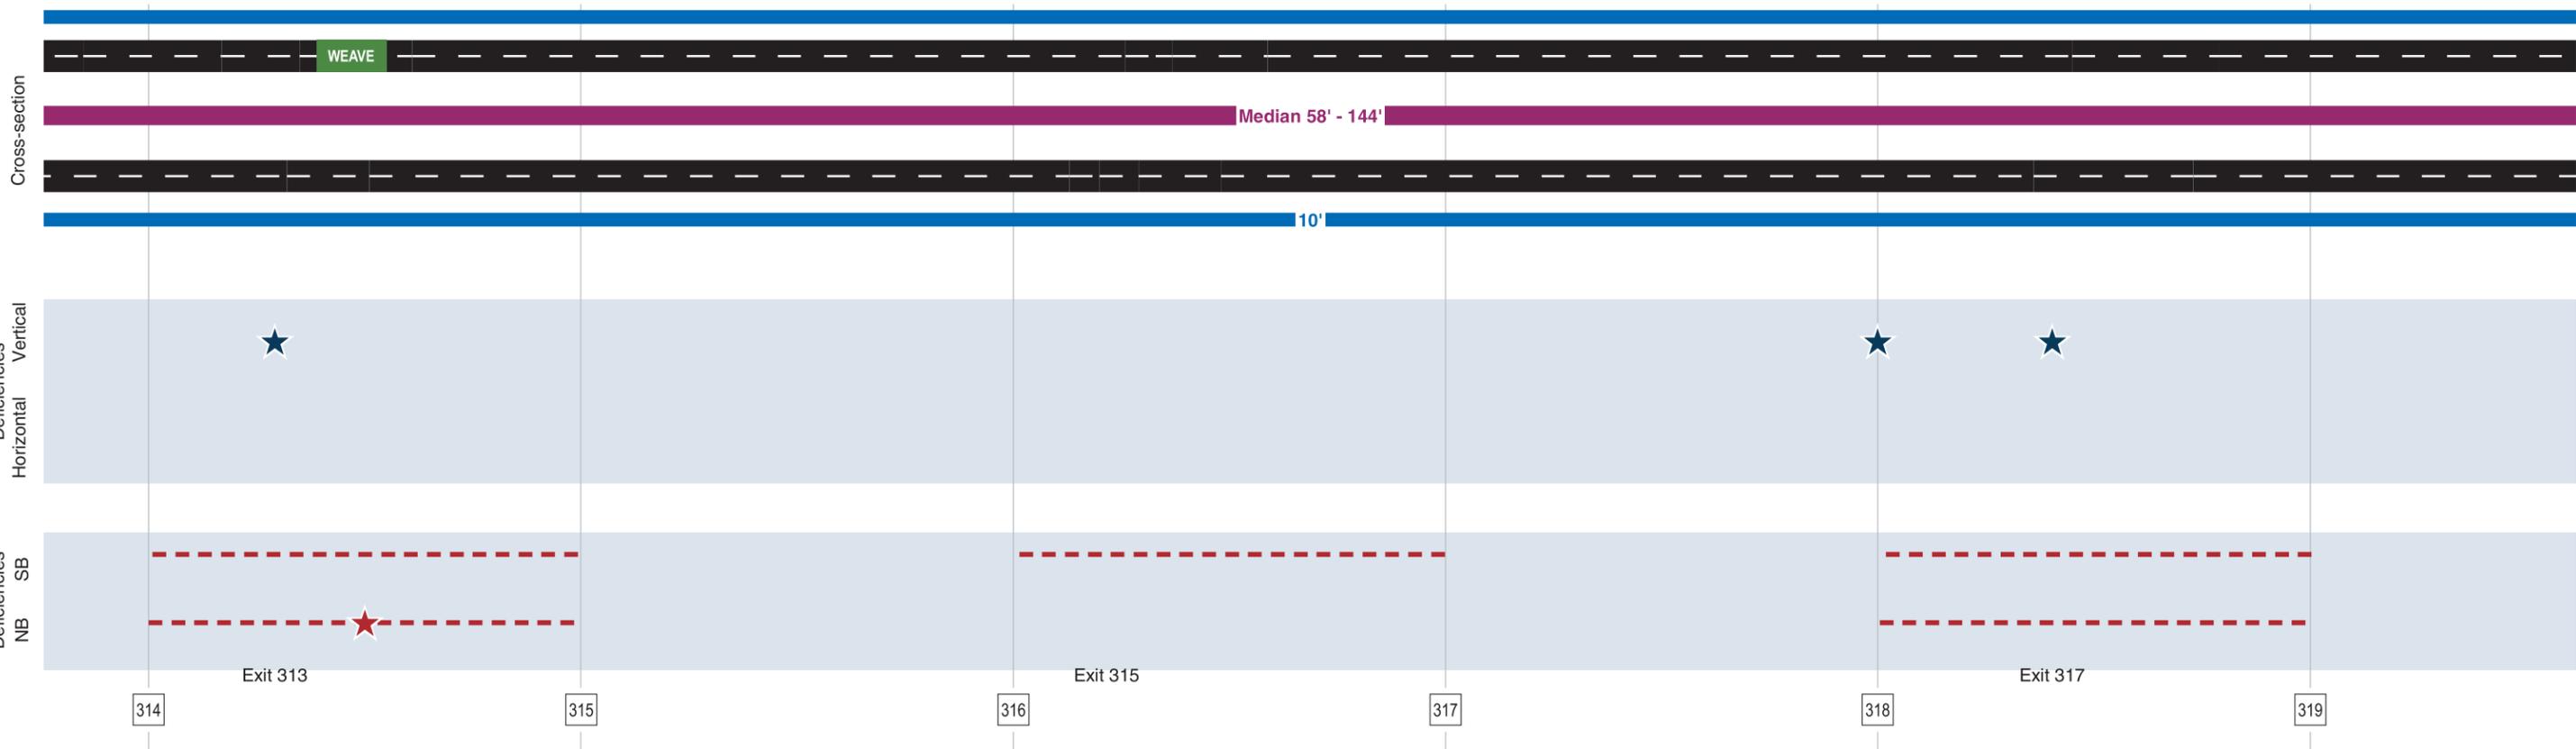
Sheet 56 of 57

- # Milepost
- Ramp LOS**
 - MERGE A/B
 - MERGE C Urban
 - MERGE C Rural
 - MERGE D
 - MERGE E/F
- Mainline LOS**
 - A/B
 - C Urban
 - C Rural
 - D
 - E/F
- Cross-section**
 - SB Shoulder
 - SB Roadway
 - Median
 - NB Roadway
 - NB Shoulder
- Vertical Deficiencies***
 - ▲ Grade Exceeds Standard
 - Insufficient Sight Distance
 - Substandard Vertical Curve
 - ★ Substandard Vertical Clearance
- Horizontal Deficiencies***
 - Segment
 - Location

See Table 3-4 for Interchange Deficiencies
- Safety Deficiencies (2000-2002)**
 - ★ Fatal Crash
 - - - High Crash Segment
