Existing Corridor Conditions

Figure 3-5

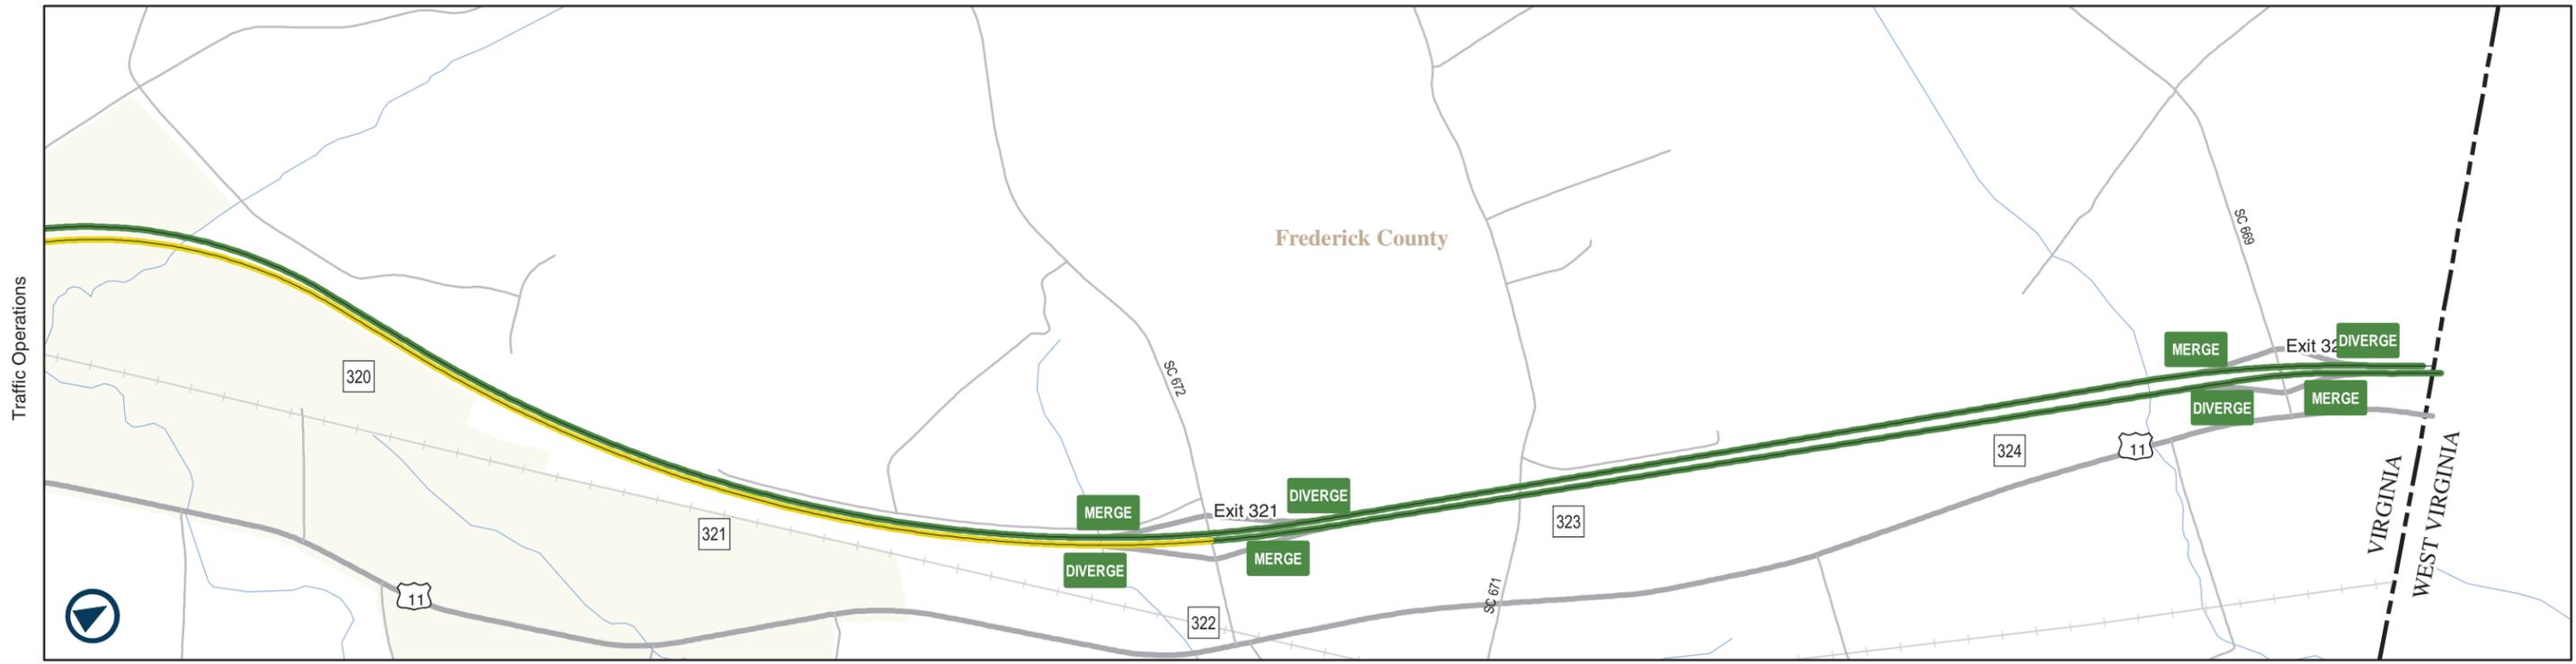
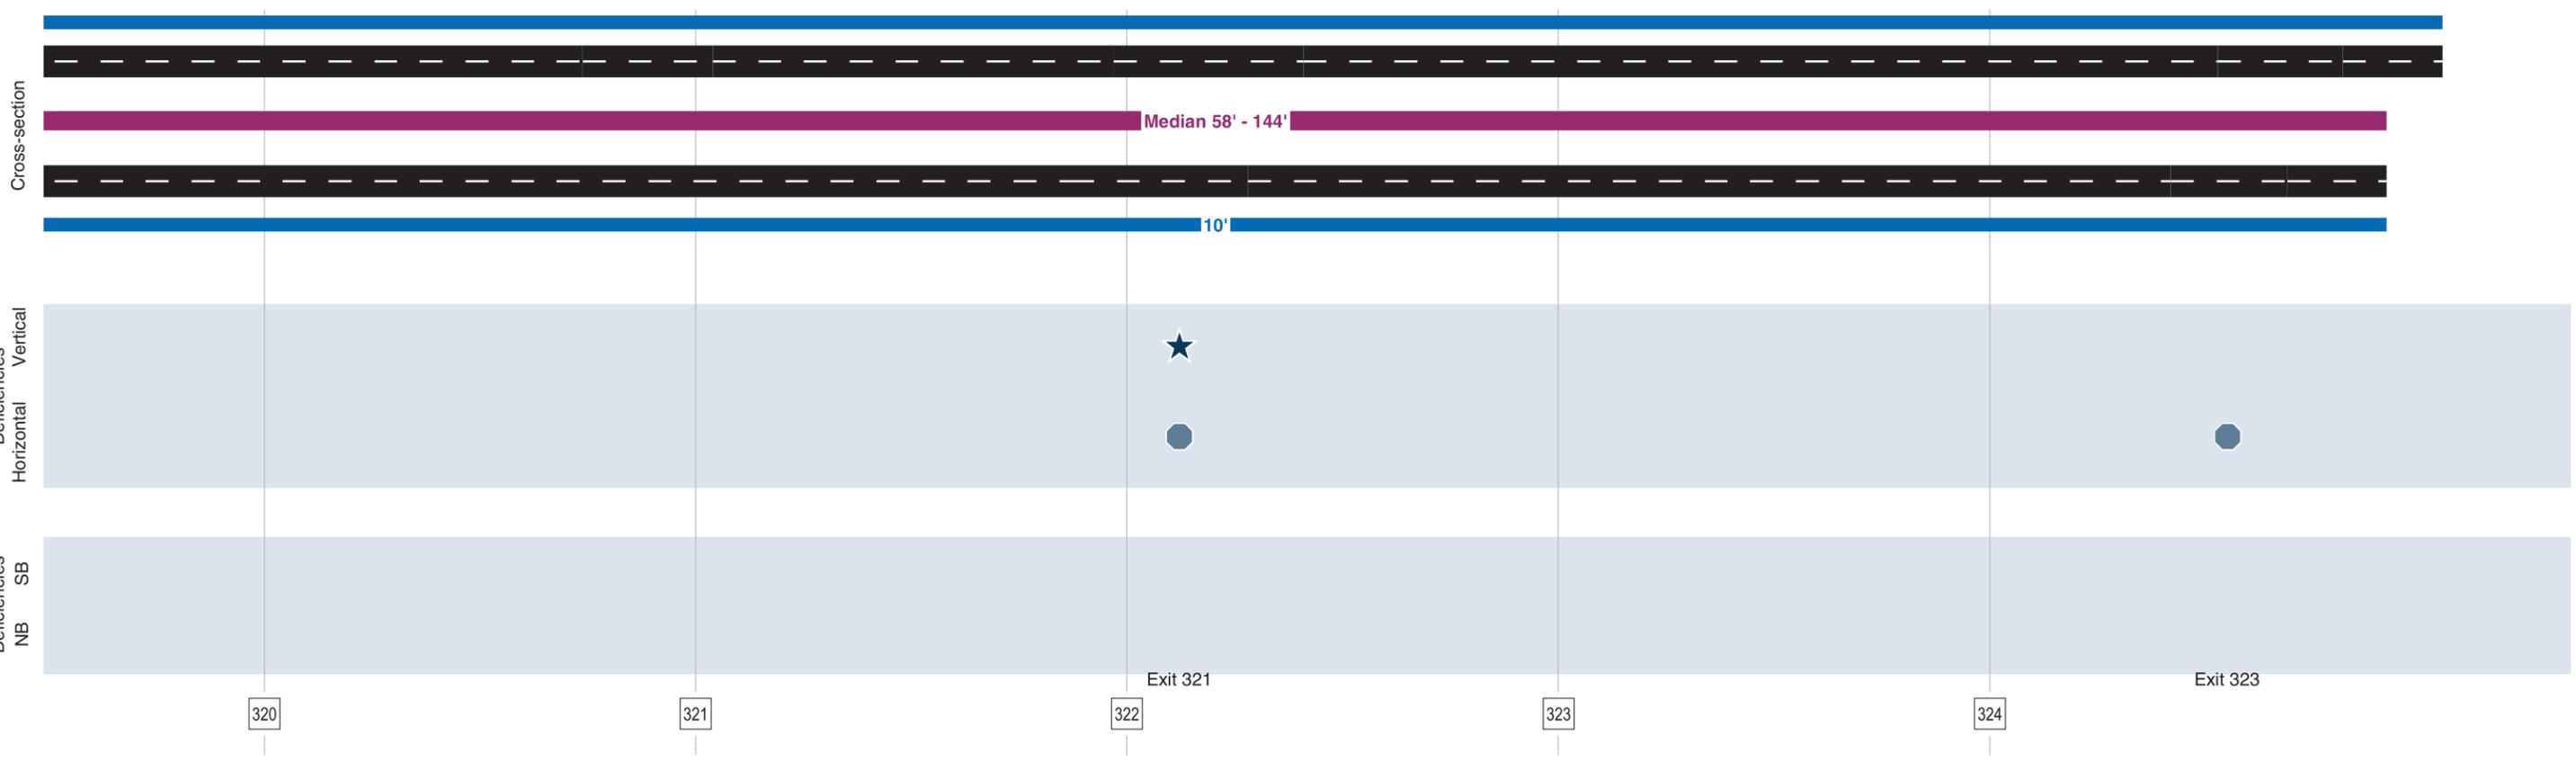
Sheet 57 of 57

# Milepost	Ramp LOS	Mainline LOS	Cross-section	Vertical Deficiencies*	Horizontal Deficiencies*	Safety Deficiencies (2000-2002)
	Ramp MERGE A/B	— A/B	— SB Shoulder	▲ Grade Exceeds Standard	— Segment	★ Fatal Crash
	Ramp MERGE C Urban	— C Urban	— SB Roadway	■ Insufficient Sight Distance	● Location	--- High Crash Segment
	Ramp MERGE C Rural	— C Rural	— Median	● Substandard Vertical Curve	See Table 3-4 for Interchange Deficiencies	
	Ramp MERGE D	— D	— NB Roadway	★ Substandard Vertical Clearance		
	Ramp MERGE E/F	— E/F	— NB Shoulder

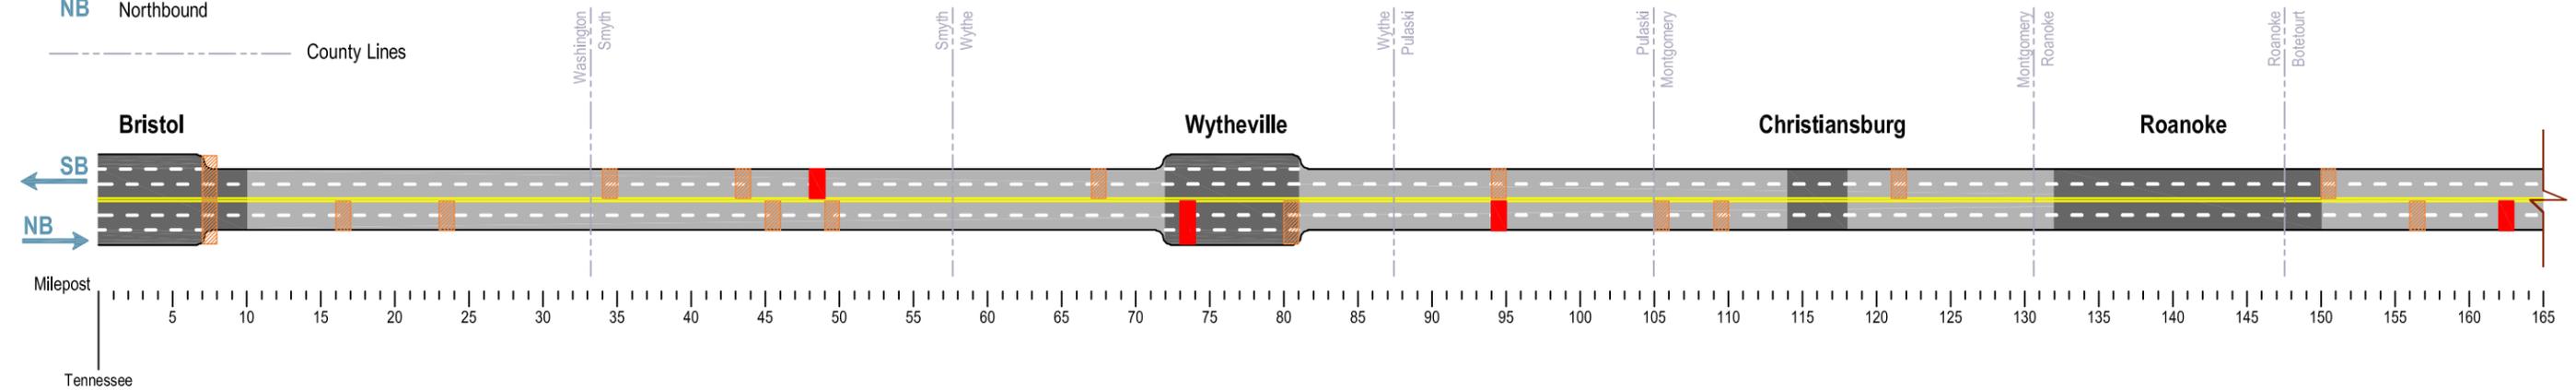
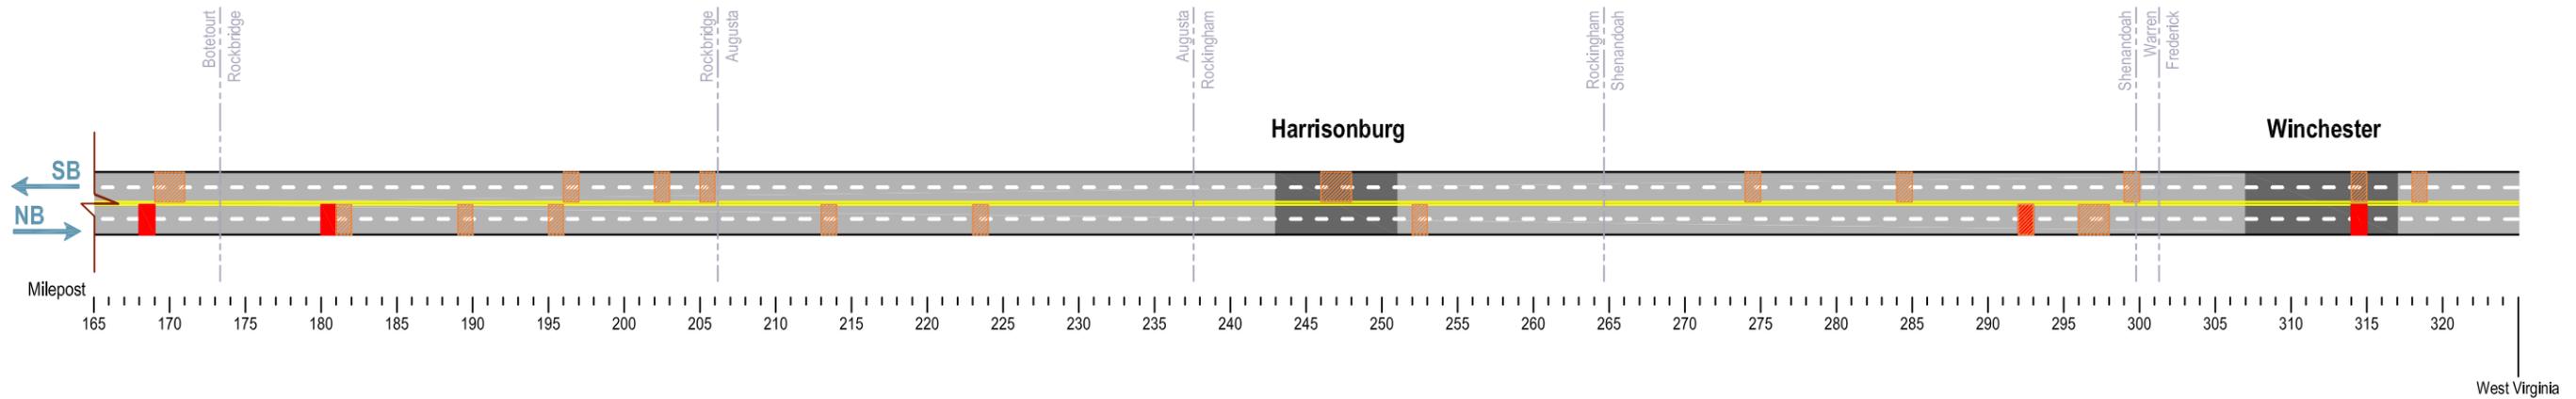
I-81 High Crash Rate Locations

- Segments identified with crash rates more than double the statewide weighted average
- Segments identified with crash rates more than 25% higher than the statewide weighted average

Note: The cross-section shown above represents the existing I-81 cross-section.
