6 Site Specific Analysis

6.1 Introduction

Table 6.1.
U.S. Route 13 Segment Locations.

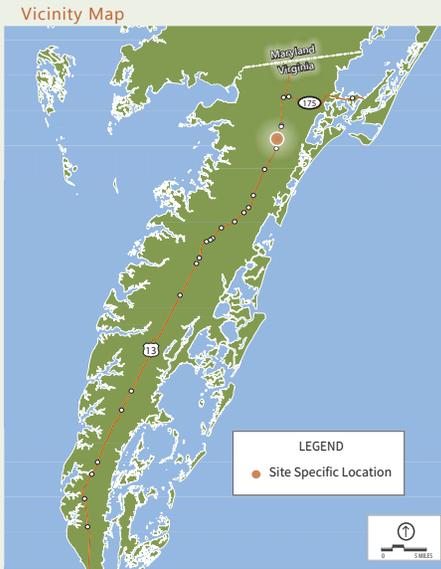
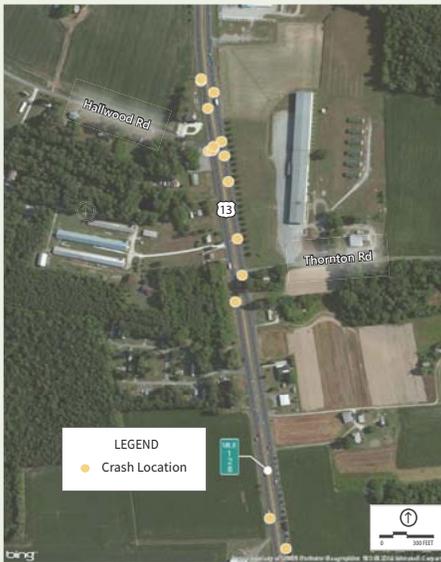
6.21 Site Specific Location #20 Hallwood Road (MP 128.23 - 128.37)

- ◆ Short northbound right turn lane at Thorton Road intersection. Trees obstruct the intersection in northbound direction, and the intersection is located immediately after on-street market parking.
- ◆ Lack of expectancy at both Hallwood and Thorton Road intersections.
- ◆ Ability of drivers from side streets to judge acceptable gaps.
- ◆ Hallwood Road and U.S. Route 13 intersection is skewed limiting the northbound sight distance.
- ◆ At Hallwood Road the stop sign is posted in the median island. There is no right-side posted stop sign as recommended in the MUTCD.
- ◆ Wide open access to parking lot at the southwestern corner of the Hallwood Road intersection.

- ▶ Review ditches to see if the depth and slope can be reduced. If not, widen shoulder and add guardrail or pipe ditch to eliminate hazard within clear zone.

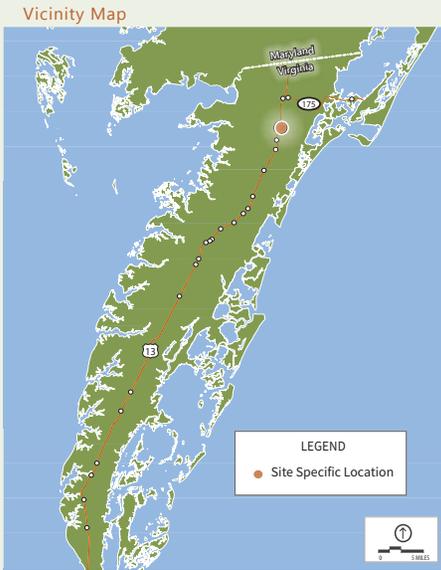
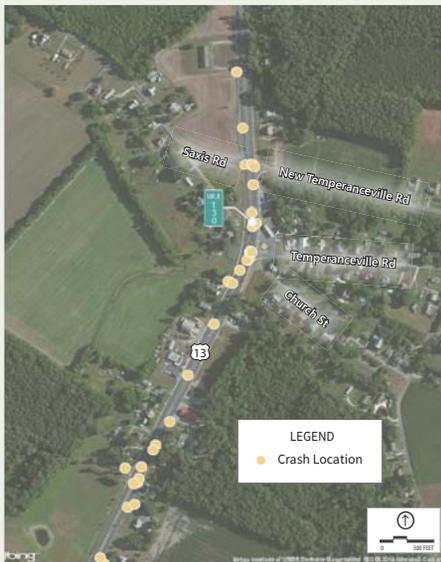
6.22 Site Specific Locations #21 and #22 Temperanceville Road (MP 129.64 – 130.47)

Throughout this roughly 3,800-foot corridor segment of U.S. Route 13, there is gutter pan located on both sides of the roadway. During a night field review, the RSA team noted the lack of positive roadside guidance for drivers unlike other parts of the corridor where edge line and raised pavement markers were present.

Narrow sidewalks are present throughout this portion of the corridor. Beginning at New Temperanceville Road and extending approximately 1,500 feet south of Temperanceville Road, the sidewalk is present along both sides of the road. The sidewalk is present along the eastern side of U.S. Route 13 from New Temperanceville Road to approximately 1,200 feet to the north of New Temperanceville Road. During the field review no pedestrians were viewed and a local resident noted that there is only the occasional pedestrian.

Fifty-five (55) percent of the crashes were angle crashes and 32 percent were roadway departure crashes. Of the 12 angle crashes, eight (8) involved drivers misjudging available gaps when turning from the side street, driveway, or making a left-turn off of U.S. Route 13. Six (6) of the angle crashes involved vehicles crossing the center line and hitting a vehicle in the opposite direction or losing control and hitting a vehicle traveling in the same direction. Five (5) of the angle crashes had incomplete narrative to determine the sequence of events; however, it was noted for all five of these that the driver did not have the right of way. Two (2) of the crashes involved vehicles turning right off of U.S. Route 13 when they were struck by another vehicle.

Of the 38 total crashes, 39 percent of those occurred during dark conditions. The majority of the crashes that occurred during dark periods were fixed object off road (53 percent) and 33 percent were angle crashes. In total, 67 percent of fixed object-off road crashes occurred during dark conditions.

- ◆ Lack of adequate gaps for vehicles attempting to turn onto U.S. Route 13 or drivers turning left off of U.S. Route 13 and on to a side street/driveway.
- ◆ Horizontal curve and high speeds reduce driver's ability to maintain control.
- ◆ Horizontal curve also limits intersection sight distance.
- ◆ Lack of positive roadside guidance.
- ◆ Pedestrian facilities with narrow sidewalk in poor condition. Ramps did not appear to meet ADA standards and no pedestrian crossing measures were present.
- ◆ Debris in gutter pan, within intersections/driveway entrances, and on sidewalk.
- ◆ Numerous conflict points due to number of lanes on U.S. Route 13 along with the proximity of intersections and driveway entrances.
- ◆ Eastbound approach at New Temperanceville Road intersection has a limited sight distance to the north due to horizontal curve.

- ▶ Trim/remove vegetation on the northeast corner of the New Temperanceville intersection to improve sight distance to the north.
- ▶ Install 12-inch street name signs at both intersections to conform to MUTCD recommendation.

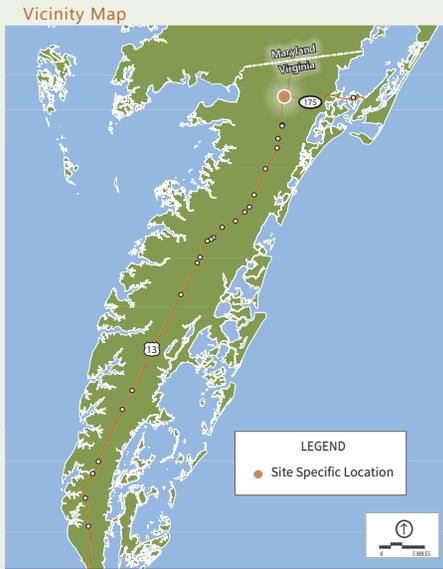
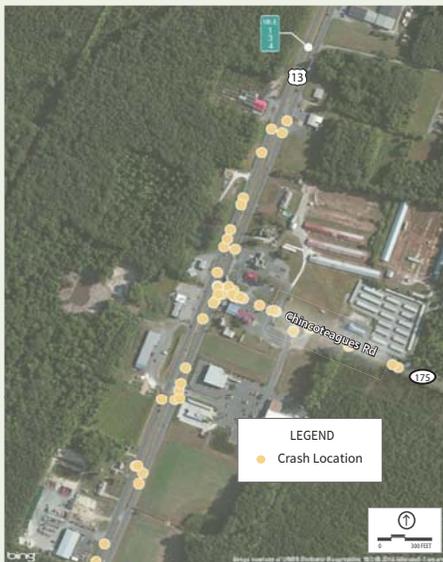
6.23 Site Specific Location #23 Chincoteague Road (MP 133.73)

Twelve of the 27 rear end crashes were related to the inability of drivers to stop for traffic stopped at the signal, and three of the crashes were related to vehicles slowing down to make a turn. The action of most of the remaining crashes were noted as "following too close". Forty (40) percent of the rear end crashes occurred on eastbound Route 175, heading away from the traffic signal.
