## **VDOT Hi-Polymer Asphalt – Implementation of NCAT Test Track Research**

**Virginia Asphalt Association Fall Conference  
Richmond, VA**

**David P. Shiells, P.E.  
District Materials Engineer**

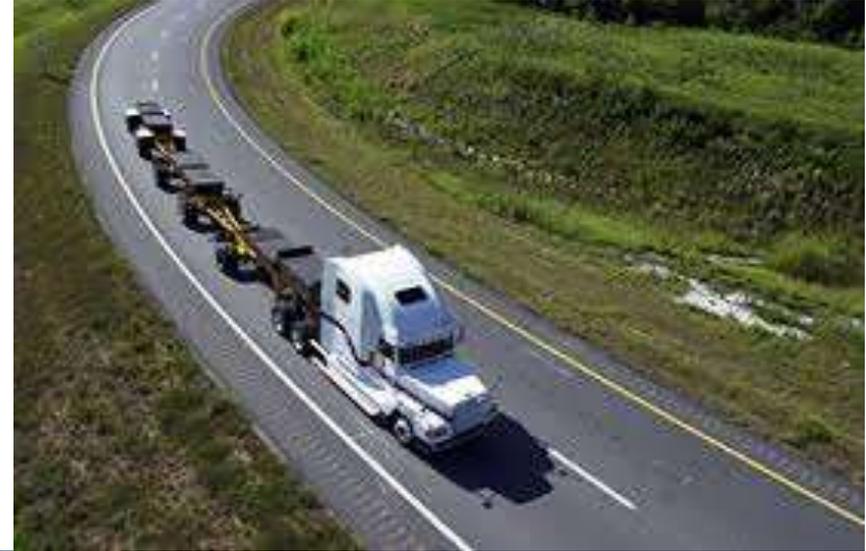
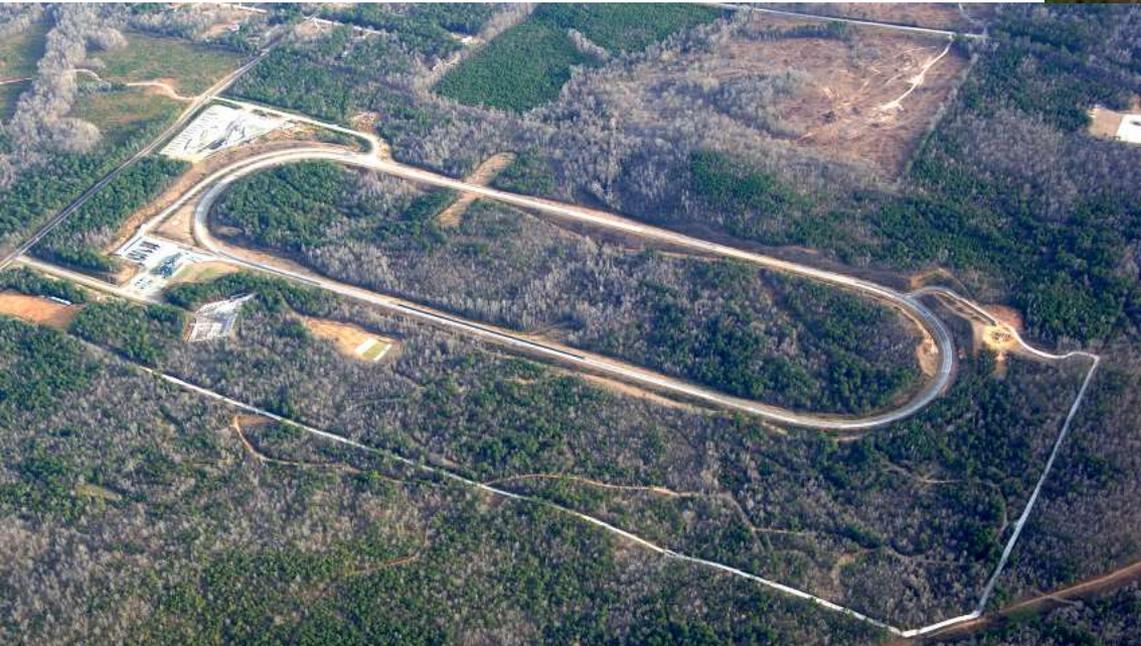
## Test Section N7 (2009)

- Hi-Polymer mixes
- 5.75" Hi-Polymer section
- 7" control section
- Hi-Polymer section - less rutting

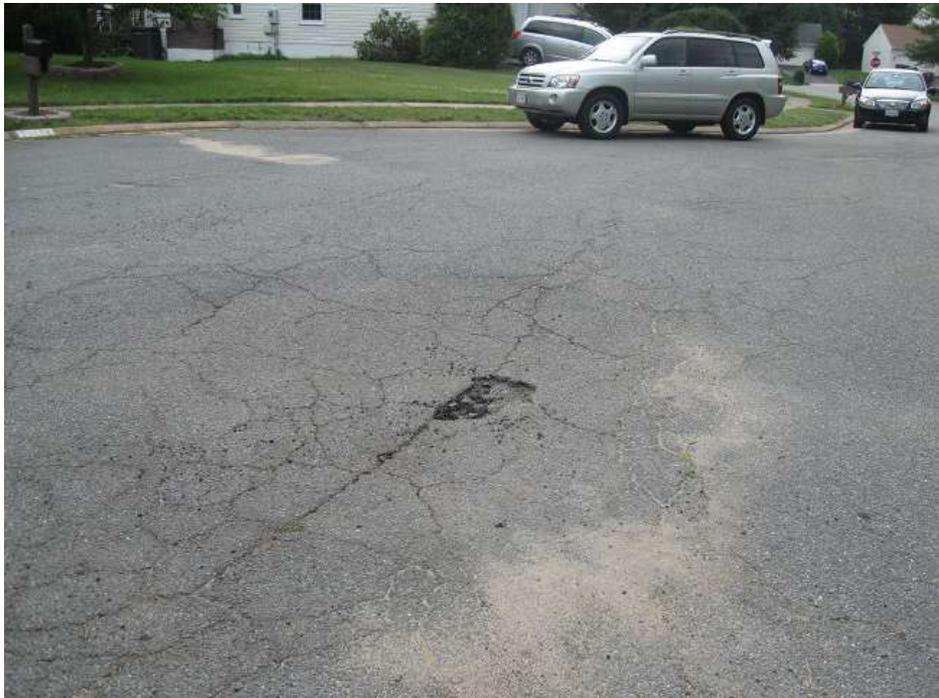
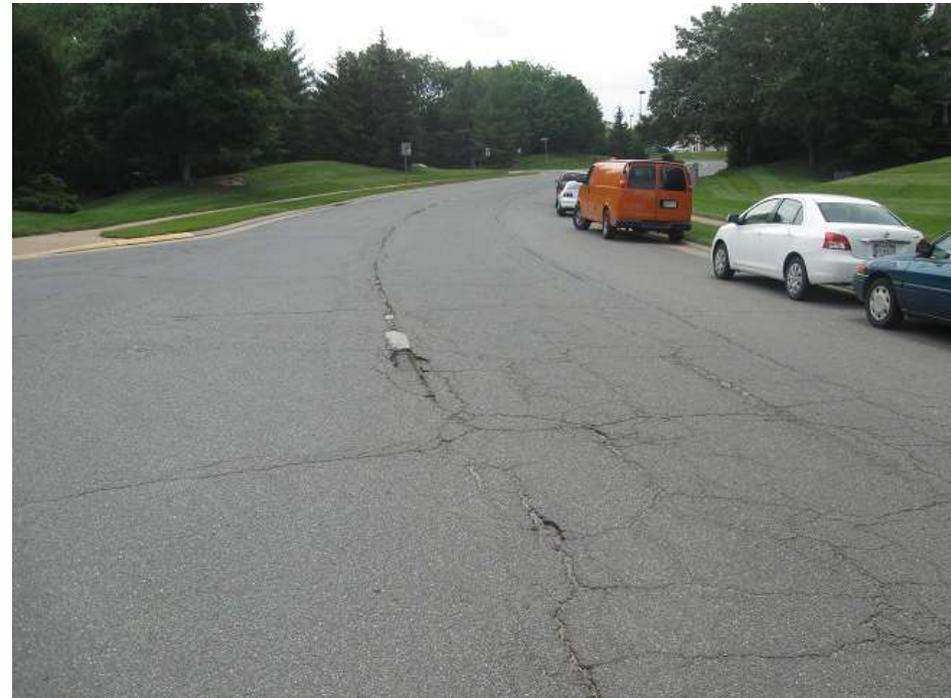
## Background

- Typical subdivision streets
- CCI ratings 6 to 34, average 20

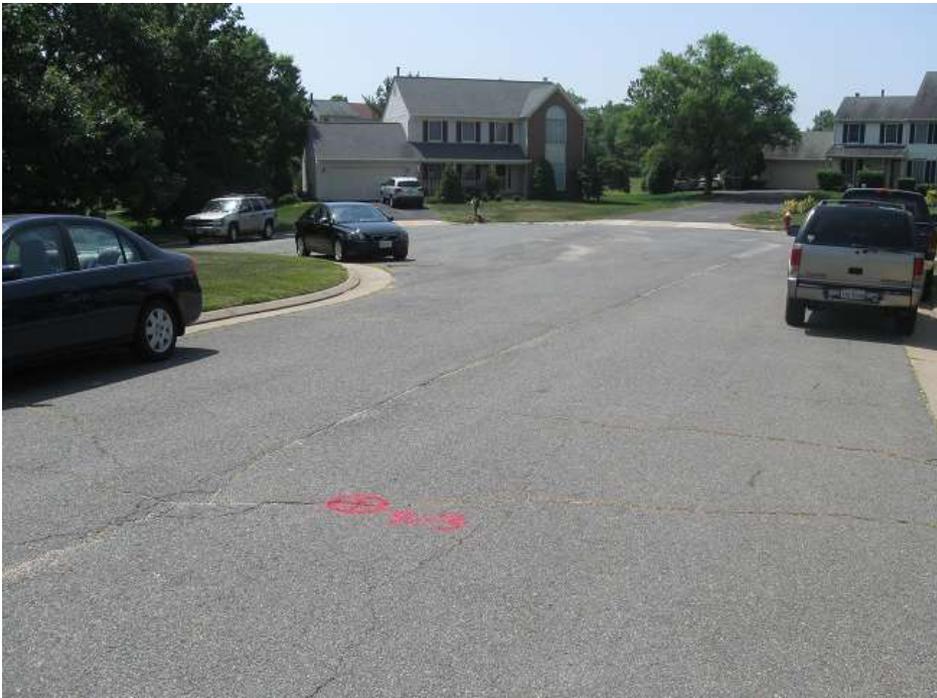
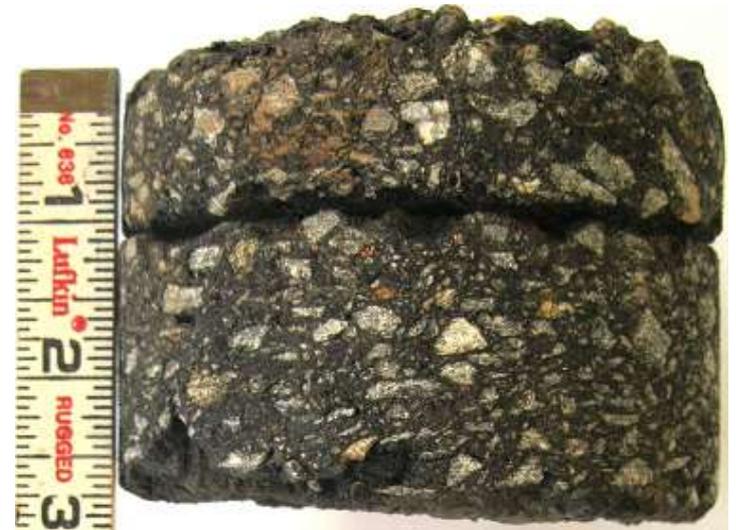
## Pavement Structures

- Cul-de-sac
- Typically 3" AC over 6" aggregate
- Fatigue and thermal/environmental cracking

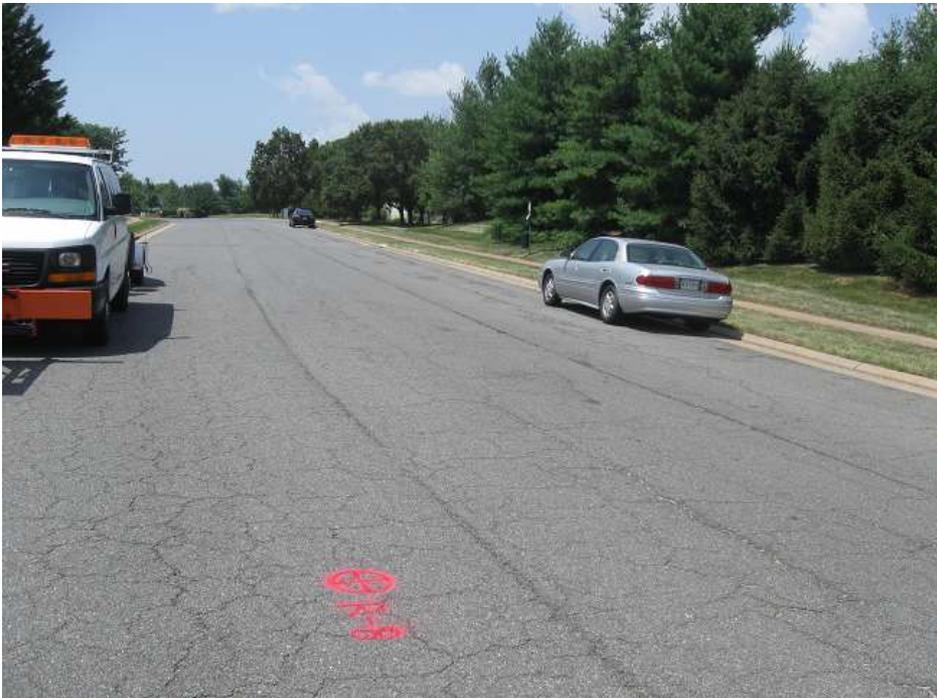
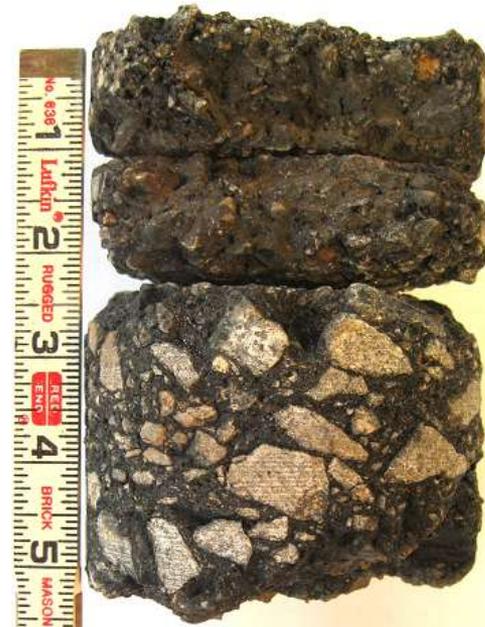
## Pavement Structures

- Summerwood Circle
- Typically 4.5" AC over 8" aggregate
- Thermal /environmental cracking

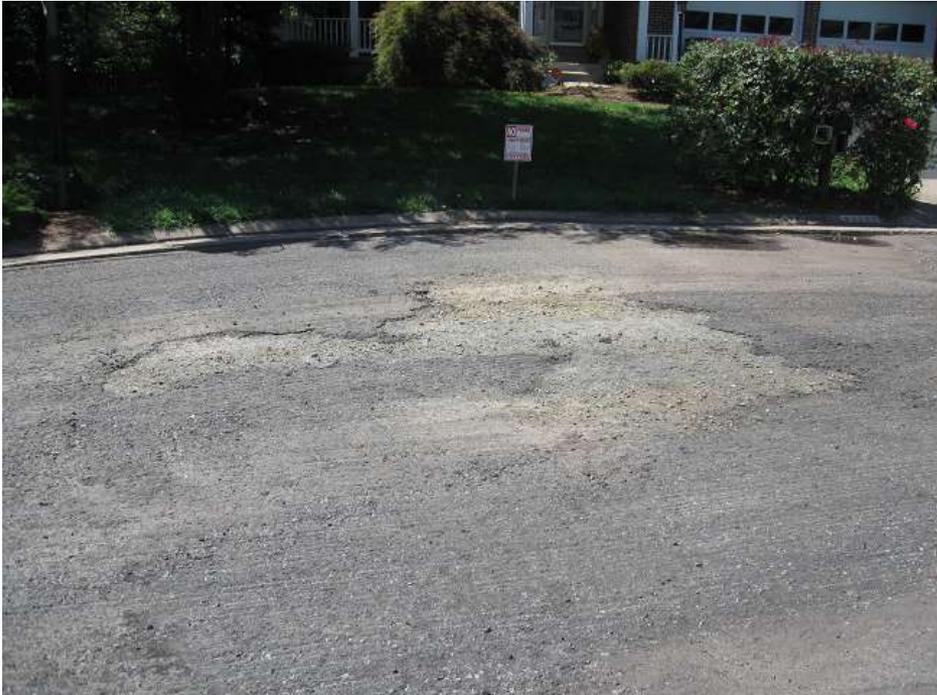
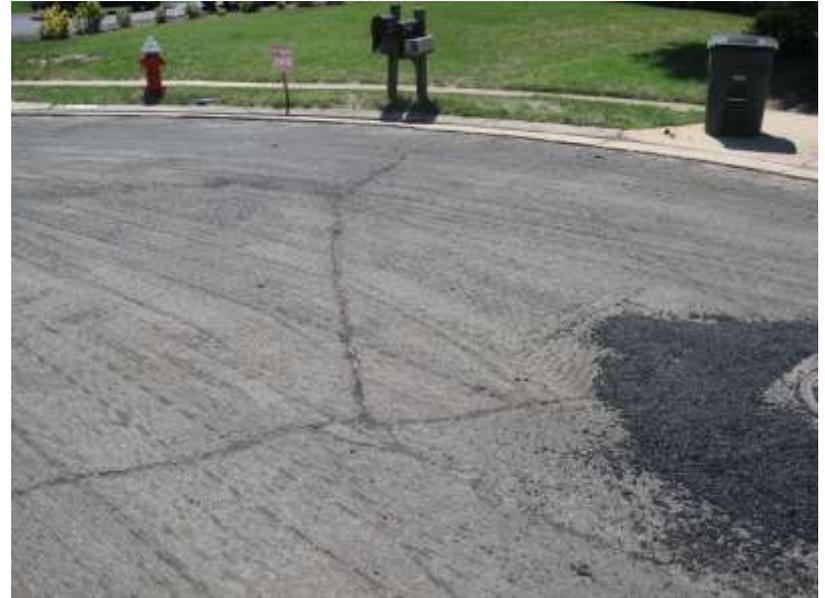
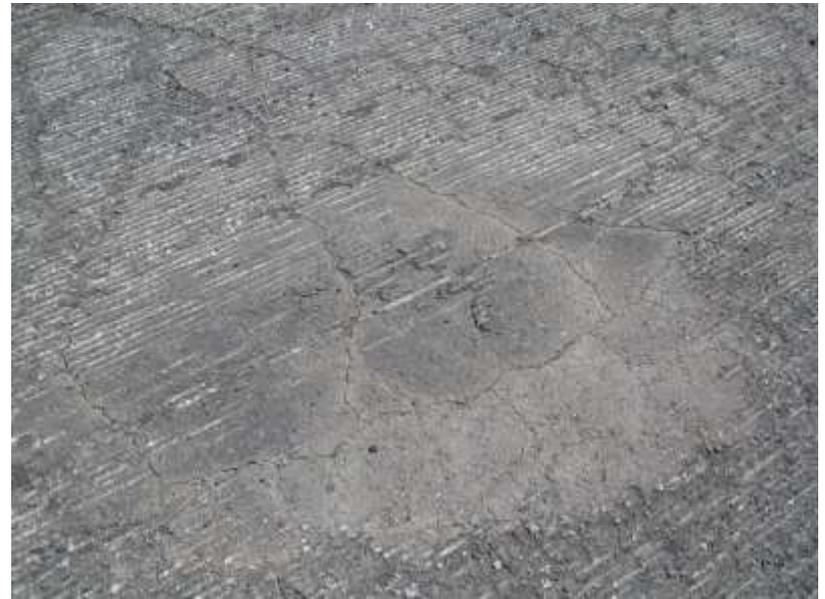
## Milled Surfaces (Cul-de-sacs)

- Thin structures
- Base layers cracked

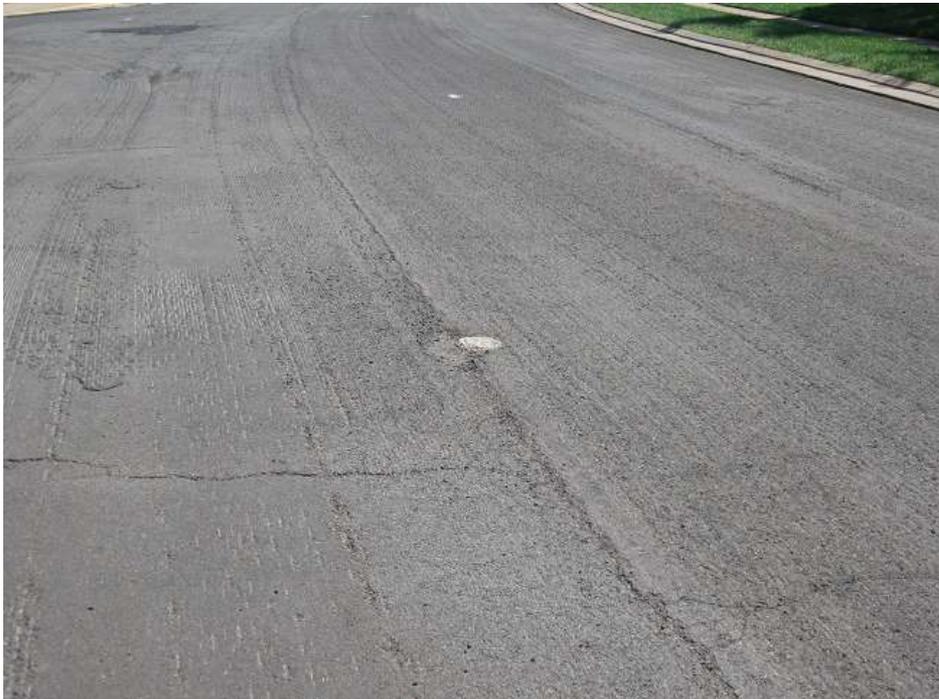
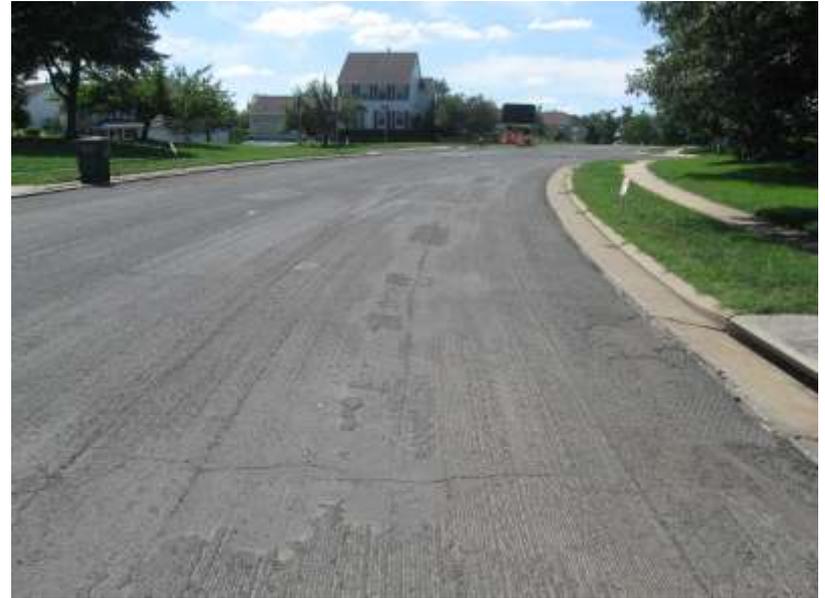
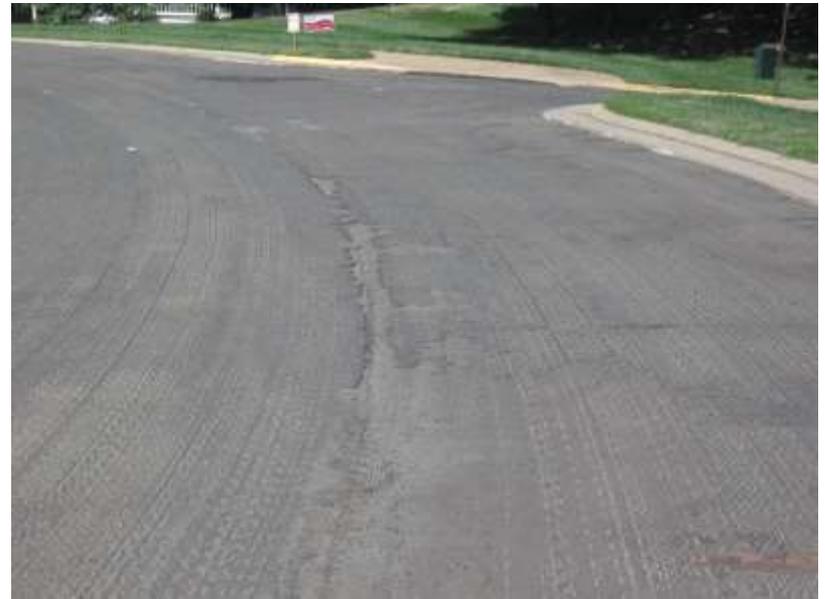
## Milled Surfaces – Summerwood Circle

- Thicker structure
- Mostly block cracking

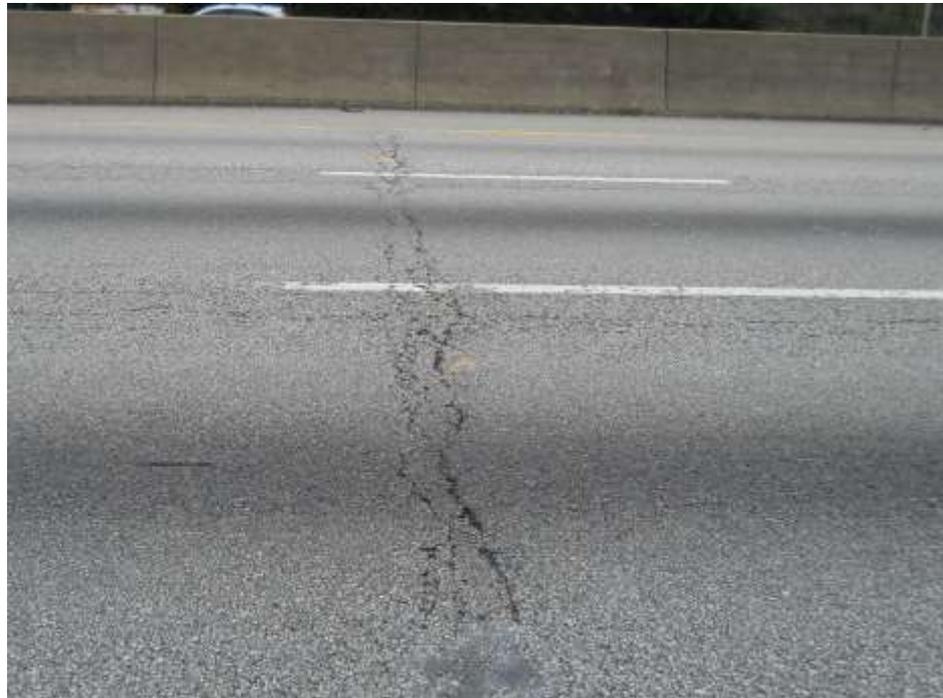
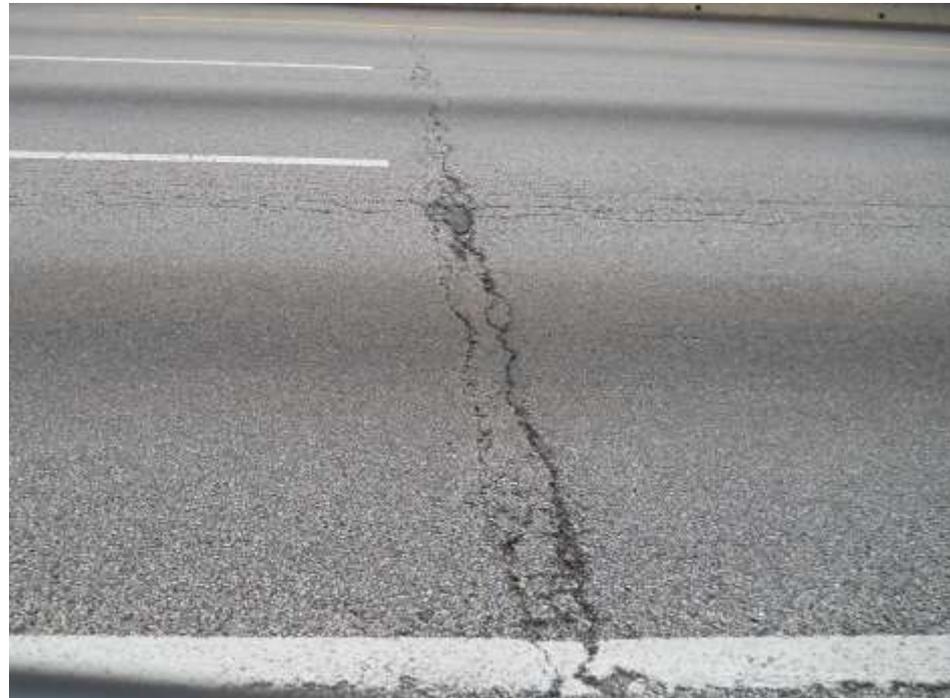
## Reflective Cracking

- Medium Severity

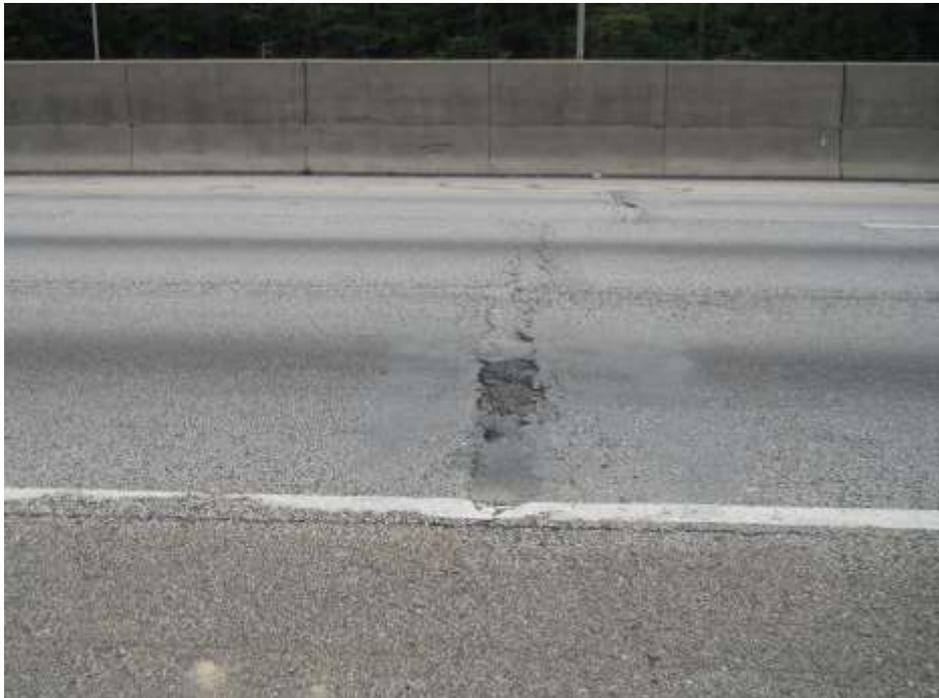
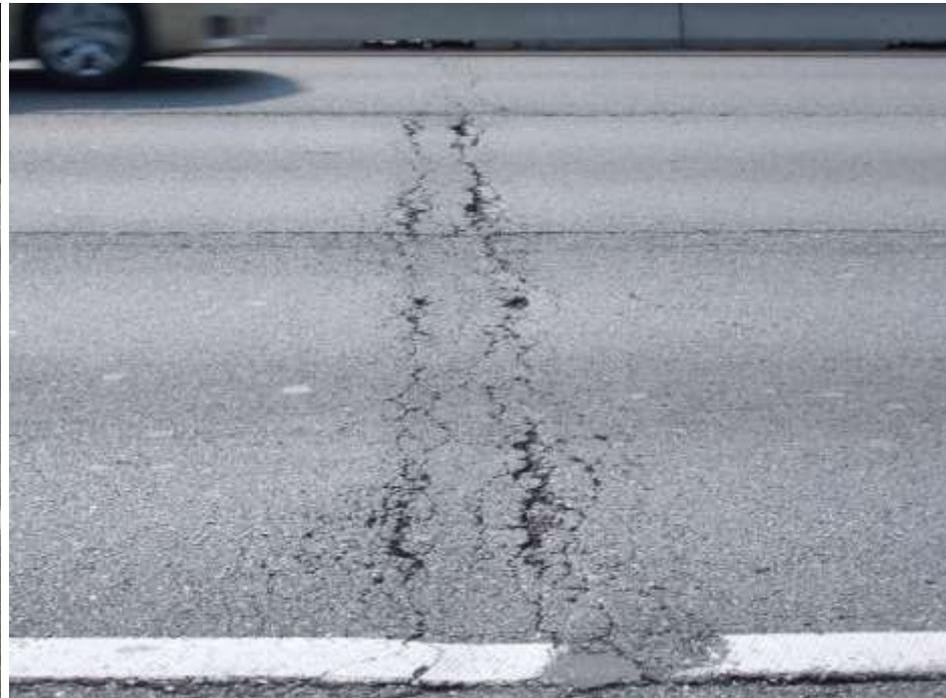
## Reflective Cracking

- High Severity

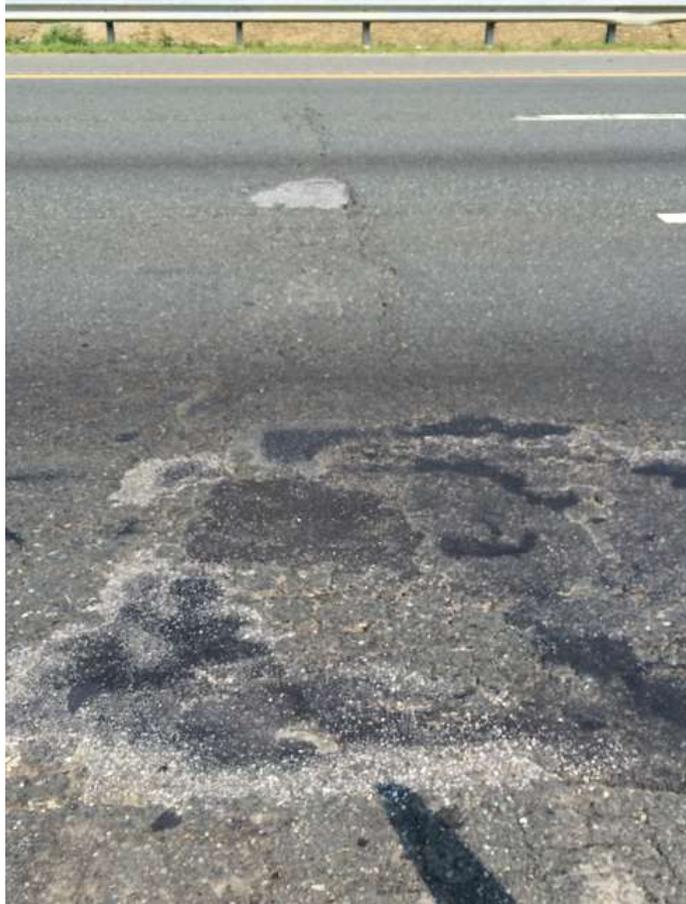
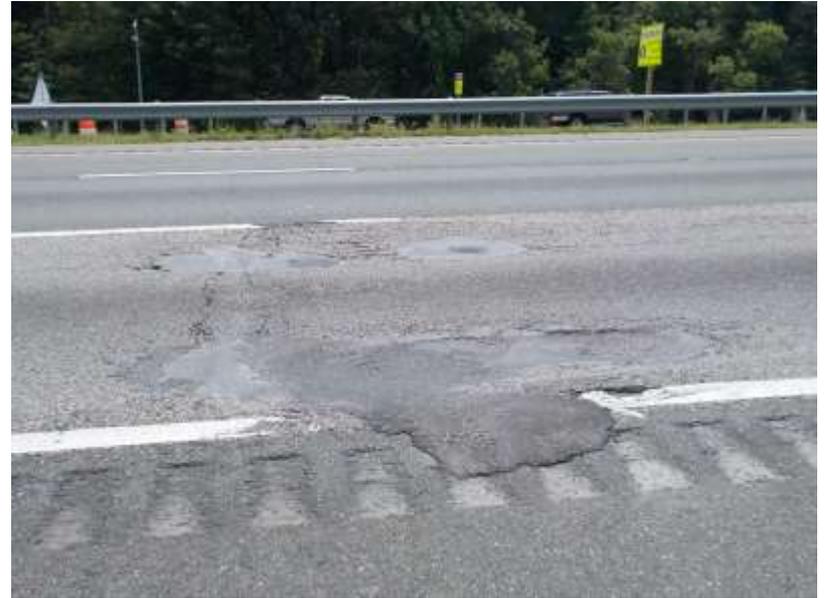
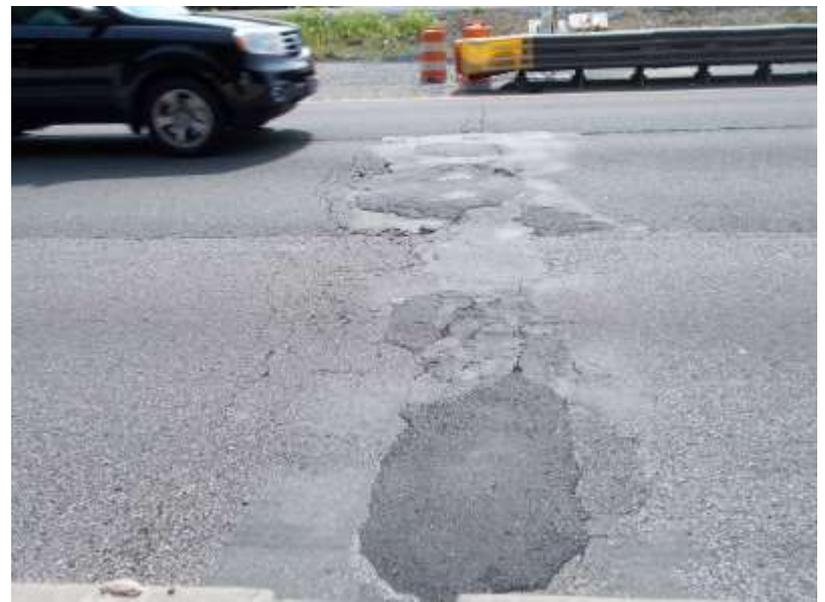
## Complete Failure

- Very high severity cracking
- Base failure
