**REEVALUATION FOR  
COALFIELDS EXPRESSWAY, SECTION II  
FROM POUND BYPASS TO THE U.S. ROUTE 460 CONNECTOR  
WISE, DICKENSON, AND BUCHANAN COUNTIES, VIRGINIA  
State Project No. 0121-013-772, PE-101; UPC 85126  
VDHR FILE # 1997-0950**

**ARCHITECTURAL SURVEY**

**PREPARED FOR:  
THE VIRGINIA DEPARTMENT OF TRANSPORTATION  
RICHMOND, VIRGINIA  
and  
PARSONS TRANSPORTATION GROUP, INC., OF VIRGINIA  
FAIRFAX, VIRGINIA**

**FEBRUARY 2009**

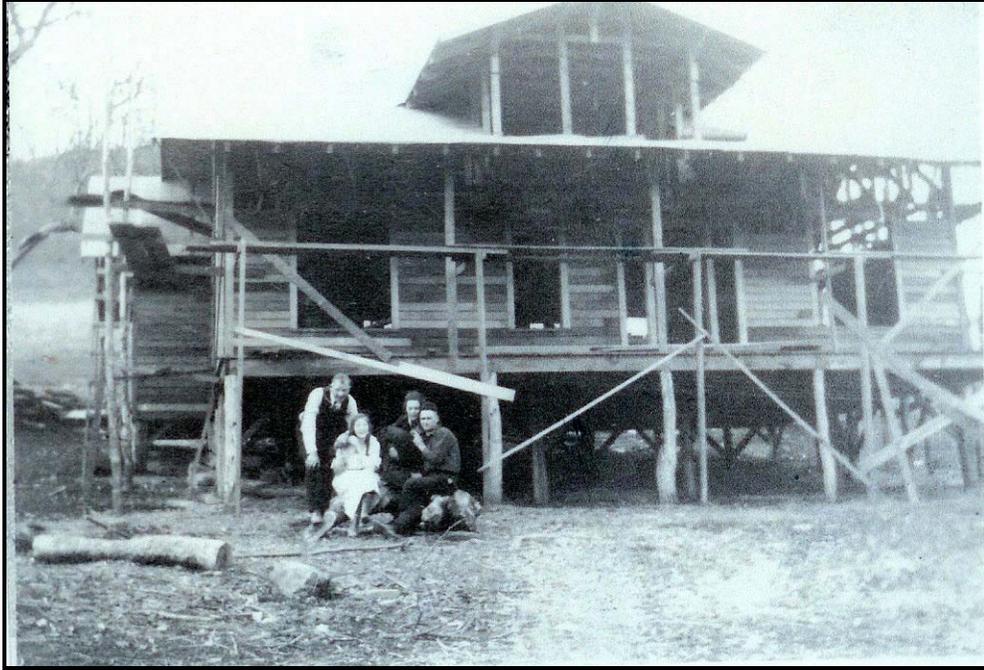
Figure 3: Sunnydale Farm Dwelling (VDHR #097-0403) in 1918.

The c. 1918 house (Figure 3) was built by Mr. Powers, the grandfather of Francis Gary Powers the American U2 spy plane pilot that was shot down while over the Soviet Union in 1960. The house was built for Mary Kelly, but she refused to live in the new house and chose to live in the tenant house to the northeast of the c. 1918 house. The c. 1918 house (Figure 4) is a Frame Vernacular style house that features a wooden frame structural system that rests on a solid foundation of uncoursed stone. A portion of the stone foundation in the southwest corner of the house been replaced with concrete block. The exterior walls are covered in vinyl siding, and the side-gabled roof is clad in asphalt shingles. Originally, there was a brick chimney located in the center of the roof, but it has been removed. The front elevation (Figure 5) currently features two gabled dormers; each contains two, three-over-one wooden double-hung sash windows. Some of the original widows have been replaced; three of the original three-over-one double-hung sash windows on the northeast façade have been replaced, one of the windows on the southwest elevation has been replaced, four of the basement level windows on the southwest elevation have been replaced, and the two picture windows on the front elevation have been replaced. Fenestration consists of three-over-one, two-over-one, and

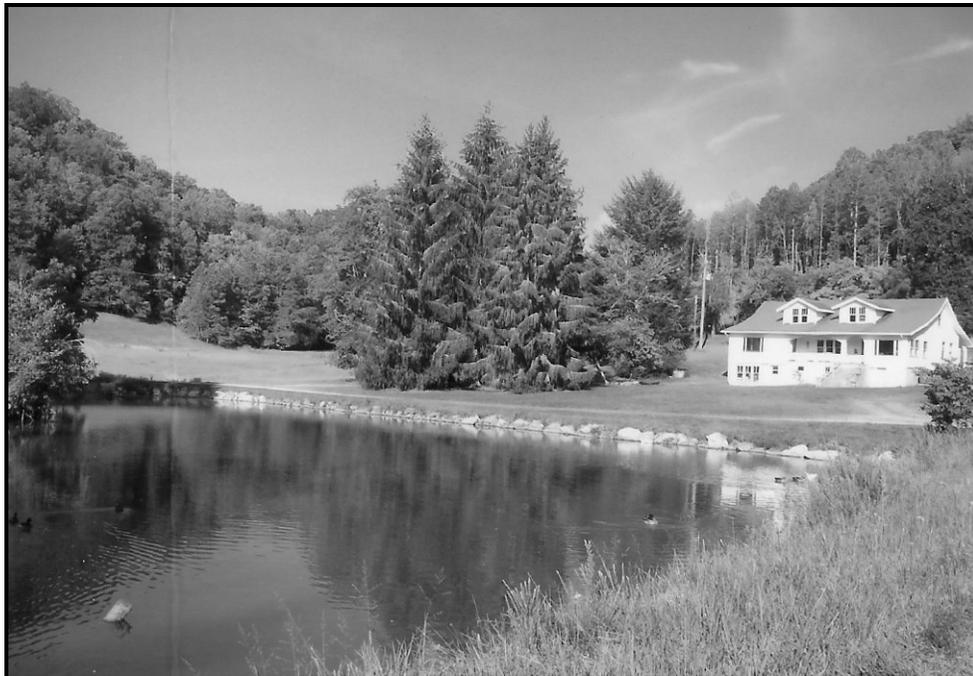
Figure 4: Sunnydale Farm Dwelling (VDHR #097-0403) in 2008.

one-over-one wooden double-hung sash windows, and there are two picture windows on the front façade. The front integral porch is two bays wide and displays two arched openings. One arch provides access to the porch, and a larger arch contains the porch railing. The semi-subterranean basement is exposed on the front elevation. There are two entrance doors located in the basement level on the front elevation. An integral porch supported by square wooden posts spans the entire length of the rear façade. The rear porch features a concrete patio. Northeast of the house is a barn, chicken house, cemetery, and old tenant house site. The c. 1918 barn is covered in weatherboard siding with a gabled roof clad in standing-seam metal. An enclosed shed-roofed addition has been appended to the west elevation, and an open shed addition with square wooden supports is located on the east elevation. The barn contains an old blacksmith shop that was utilized by the Kelly family. Also to the northeast is a c. 1918 chicken house that is clad in vertical boards with a shed roof covered in standing-seam metal.

Sunnydale Farm is eligible for its association with Chant Kelly, "The Father of Pound" who committed his life to the improvement of Pound. This resource is not recommended eligible for the NRHP under Criterion C. While the house is well maintained, a review of Figures 3 and 4 indicate that the northeast (left) side of the house was added at a later date. The house also exhibits a design common for the period, and due to the addition of the vinyl siding, the replaced windows, the altered rear porch, the replaced roofing material, and a section of the original foundation has been replaced the house maintains a low level of architectural integrity.

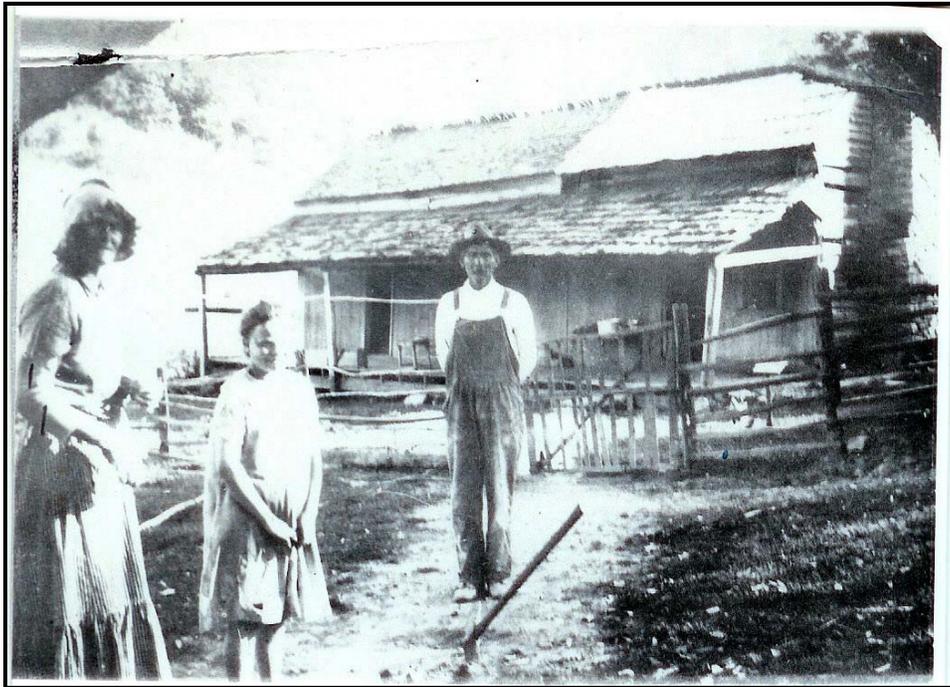
Figure 7: Log House Formerly Located on Sunnydale Farm (VDHR #097-0403). Mary Branham, Chances Kelly, and Chant Kelly.

***RECOMMENDATIONS FOR NRHP ELIGIBILITY:*** This resource is recommended for evaluation as being potentially eligible for the NRHP under Criterion B for its association with Chant Kelly, “The Founding Father of Pound,” who was instrumental in the development of the Town of Pound. Chant was born in Cumberland Gap, Tennessee in April 1894 to Mary Branham Kelly and John W. Kelly (Brown 1993). Mary was the daughter of Martin Branham, Sr. one of the earliest settlers of the Pound area, and she was the grand-daughter of John W. Brannam, an Englishman who immigrated to America to work for a British-owned coal company. Chant’s parents separated when he was very young, and his mother returned to her family’s farm (Sunnydale Farm) in the Mill Creek section of Pound to raise her son, Chant. The family lived in a log house that was located to the west of the c. 1918 house before it was demolished (see Figure 7). From an early

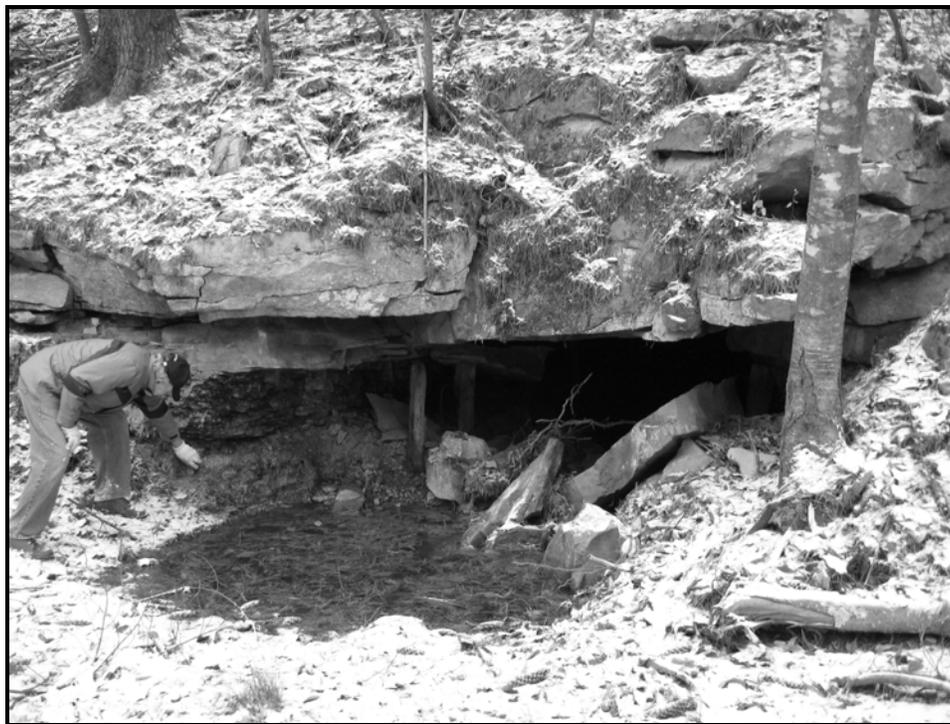
Figure 8: Mine Located on Sunnydale Farm (VDHR #097-0403).

East of the house is a coal mine (Figure 8) that was utilized by the Kelly family and members of the community for their personal needs. The mine contains metallurgical coal. The mine entrance is supported by wooden poles and is approximately five feet in height and ten feet wide. The entrance is at the base of a hill and the mine extends over 150 feet; oxygen was fed into the mine by a pump and hose. The mine was in use during the first half of the twentieth century before closing sometime in the 1950s (Paul Varson, personal communication 2008).

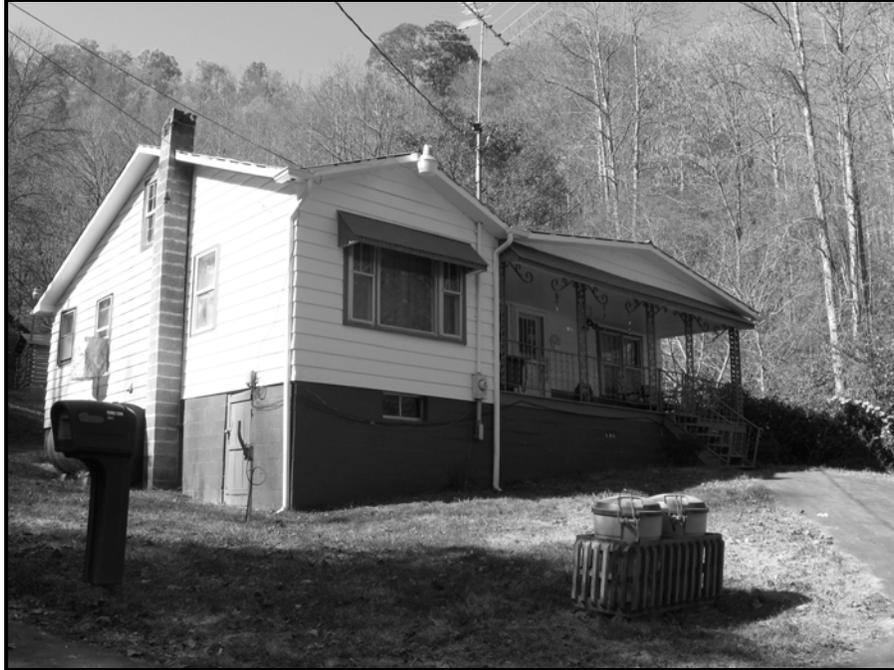
Figure 9: Julia Deel House, Located at 1099 Hazard Road (VDHR #013-5175).

**DESCRIPTION:** This one-story wooden frame dwelling (Figure 9) rests on a solid concrete block foundation. The exterior walls are clad in aluminum siding, and the gabled roof is covered in standing-seam metal. The front porch is three-bays wide and covered by a front-gabled roof supported by cast metal posts. Some of the original six-over-six wooden double-hung sash windows have been replaced with one-by-one aluminum sash windows. There are three chimneys. A brick chimney is located on the interior portion of the roof, a concrete block chimney is located on the exterior side, and another concrete block chimney is located on the rear exterior wall. West of the house are four log outbuildings including two sheds, an animal pen, and barn. Shed (A) is a one-story log structure with a gabled roof covered in standing-seam metal. Shed (B) is constructed into a bank and features a concrete block lower level and a log upper level. The log structures feature batten doors with fixed light windows. The animal pen is a one-story log structure with a small door and no windows. The animal pen features a shed roof covered in standing-seam metal. The two-story log barn is located in the woods and is in poor condition. The barn features a gabled roof covered in standing-seam metal. To the southeast of the house are a shed and wood shed. Shed (C) rests on a concrete block foundation with a shed roof covered in standing-seam metal. The wood shed features exterior walls that are clad in board and batten siding, and a shed roof covered in standing-seam metal.

**RECOMMENDATIONS FOR NRHP ELIGIBILITY:** This dwelling exhibits a design common for the period. This resource has no apparent association with any event or person important in our nation's history, lacks architectural significance, and does not appear to have the ability to yield important information. This resource is recommended as not eligible for the NRHP under Criteria A, B, C, or D.

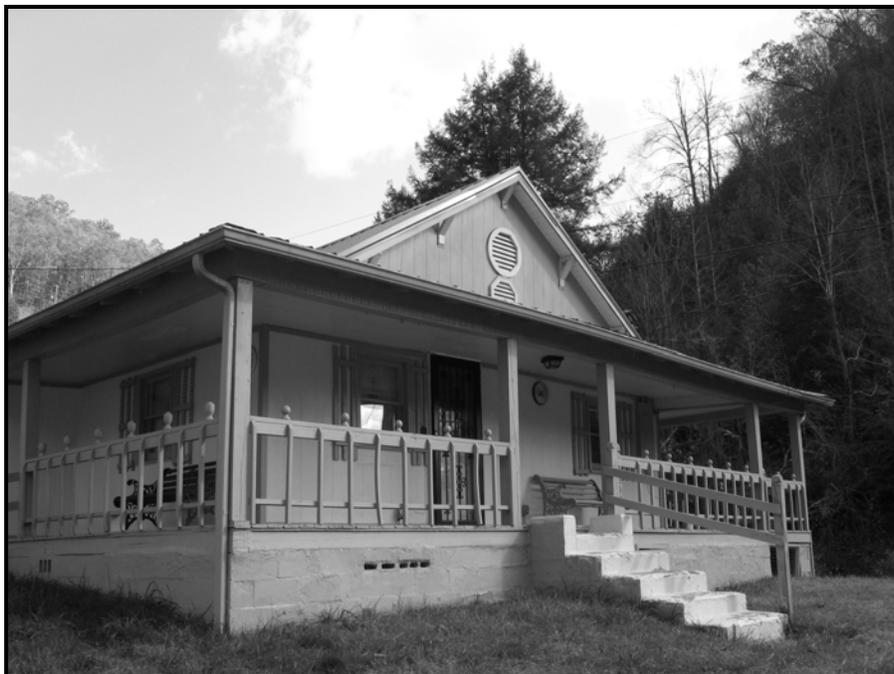
Figure 10: Single Dwelling, Located at 1074 Garry Yates Road (VDHR #013-5183).

**DESCRIPTION:** This one-story house (Figure 10) features a wooden frame structural system that rests on a solid concrete block foundation. The exterior walls of the house are covered in vinyl and T-111 siding, and the front-gabled roof is covered in 5-V crimped metal. Triangular brackets are located under the eaves. The three-bay front porch wraps around the front (west) and north elevations of the house. The porch features a hipped roof and is supported by square wooden posts. The windows are one-over-one wooden double-hung sash windows with decorative shutters. Northeast of the house is a shed with exterior walls that are clad in T-111, and a gabled roof covered in asphalt shingles.

**RECOMMENDATIONS FOR NRHP ELIGIBILITY:** This dwelling exhibits a design common for the period. This resource has no apparent association with any event or person important in our nation's history, lacks architectural significance, and does not appear to have the ability to yield important information. Also, due to multiple alterations including the replaced siding, replaced windows, and altered front porch, this house maintains a low level of architectural integrity. This resource is recommended as not eligible for the NRHP under Criteria A, B, C, or D.

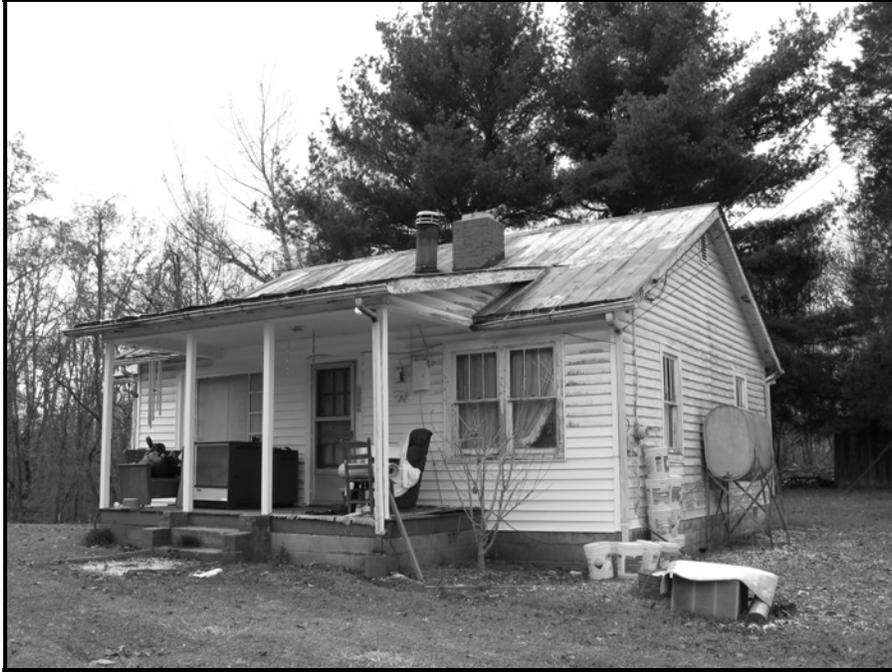
Figure 11: Hawkins House Located on West Side of Dwale Lane (VDHR #025-5116).

**DESCRIPTION:** This one-story dwelling (Figure 11) features a wooden frame structural system that rests on a concrete block foundation. The exterior walls are covered in vinyl siding, and the side-gabled roof is clad in standing-seam metal. A brick chimney and metal stove pipe are located in the center of the roof. The front porch is a simple structure with no railing, a shed roof, and square wooden supports. Fenestration consists of three-over-one wooden double-hung sash windows and one picture window on the front façade. There are six outbuildings and a cemetery associated with this house. Southeast of the house is c. 1940 shed (A), which features exterior walls clad in vertical boards and a shed roof covered in 5-V crimped metal. To the north is a c. 1940 shed (B) that features exterior walls that are clad in vertical boards and a shed roof covered in standing-seam metal. To the west are sheds (C) and (D). Built c. 1940, sheds (C) and (D) both feature exterior walls clad in vertical boards and shed roofs covered in standing-seam metal. To the northwest are two privies (A) and (B); they are both clad in T-111 siding and feature shed roofs covered in standing-seam metal. Northwest of the house is the Hawkins Cemetery, which includes the graves of Joe James Hawkins, 1939-1994; William O. Hawkins, 1913-1990; Julia Hawkins, 1918-1992; Helen Hawkins Harriger, 1941-2007; and Roger Dale Mullins, 1952-1992. All of the graves feature granite markers, except for Joe James Hawkins' grave, which displays a wooden cross with his name inscribed.

**RECOMMENDATIONS FOR NRHP ELIGIBILITY:** This dwelling exhibits a design common for the period. This resource has no apparent association with any event or person important in our nation's history, lacks architectural significance, and does not appear to have the ability to yield important information. This resource is recommended as not eligible for the NRHP under Criteria A, B, C, or D. The graves do not lend themselves to comparative archaeological or physical anthropological studies. The

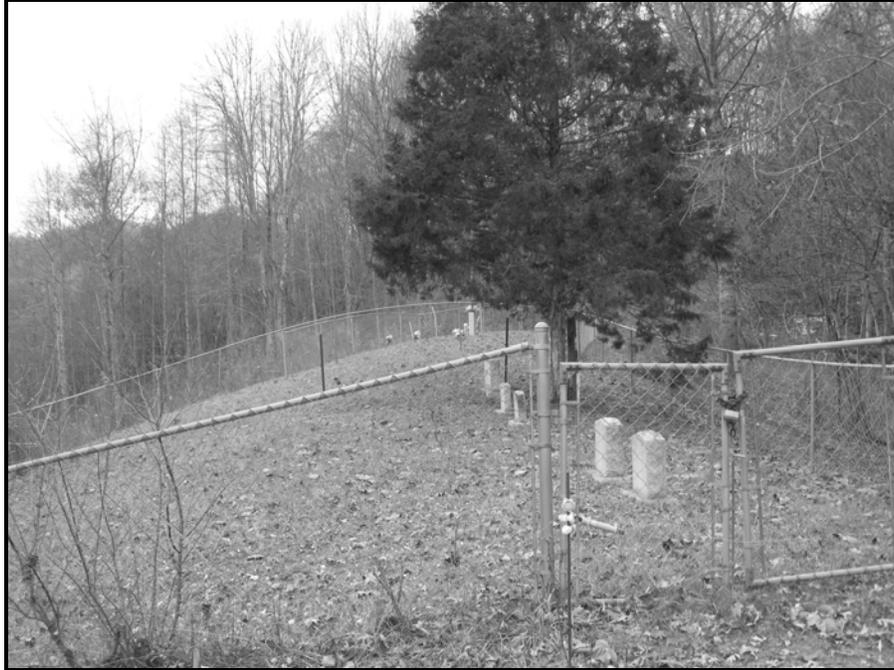
Figure 13: Company Cemetery, Located on West Side Brush Creek Road (Route 631) (VDHR #025-5146).

**DESCRIPTION:** This resource is a collection of four groupings of graves that are located in very close proximity to one another along the top of a mountain ridge. The Company Cemetery (Figure 13) is the name that refers to the entire collection of all four groups of graves. Each grouping of graves is defined by its own fence. The graves in the first grouping, which are located the farthest to the northeast, are enclosed by a wire and post fence. The earliest grave in that grouping is for Sallie Mullins, d. 1914. Other graves include; Don Avery Phipps, d. 1939; Clara June Phipps, d. 1921; Florena Mullins, d. 1918; Alger Mullins, d. 1931; Polly Riley, d. 1919; and Juanita Mone, d. 1942. The next group of graves, to the southwest, includes members of the Keel family. This group of 10 graves is enclosed by a chain-link fence. The third grouping of graves, to the southwest, is for the Kelley family, and includes five graves enclosed in a chain-link-fence. The Kelley graves include Carl Kelley, d. 1938; Bessie Kelley, d. 1958; Danny Cox, d. 1961; Michael Kelley, d. 1960; and one with no inscription. The fourth grouping of graves, to the southwest, contains the two graves of Becky France, d. 2001 and Fern France, d. 1968. These two graves are enclosed in a chain-link fence.

**RECOMMENDATIONS FOR NRHP ELIGIBILITY:** This cemetery does not lend itself to comparative archaeological or physical anthropological studies. The cemetery is recommended as not eligible for the NRHP under Criteria A, B, C, or D. It is also recommended as not eligible under Criteria Consideration C for association with important persons or Criteria Consideration D, as it contains no graves of important persons, is not of great age, contains no special design elements, and is not associated with significant events. However, relevant local and state statutes regarding the protection and relocation of cemeteries must be followed.
